Final City of Salinas Sanitary Sewer Master Plan Update

City of Salinas
Final Sanitary Sewer Master
Plan Update
May 2023

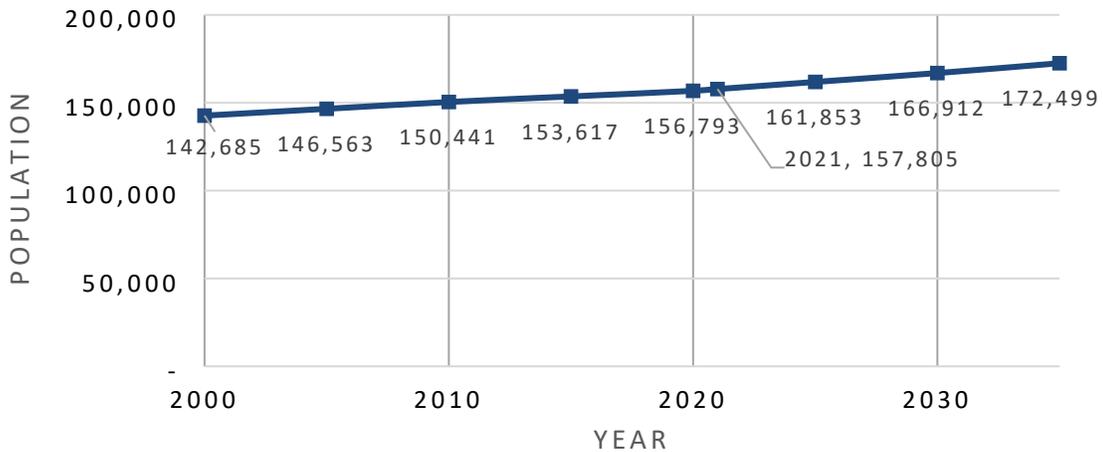
FIGURE 2-7: CITY POPULATION GROWTH

The City’s existing population and historic population growth are important factors to understand past trends and project future wastewater flows. Figure 2-7 shows the City’s population growth forecast as shown in the City’s Housing Element, with a projected 2021 population of 157,805.

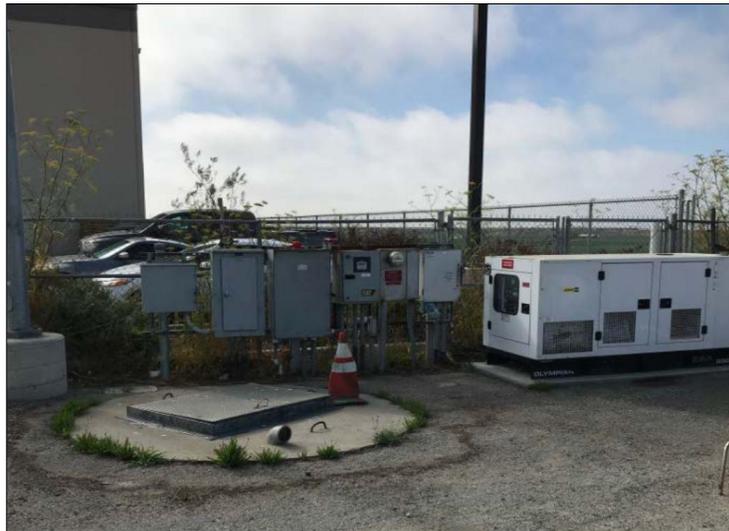
Airport (Moffett) Lift Station

Airport Lift Station is located in the northwest corner of the property at 730 La Guardia Street near the Municipal Airport and serves approximately 584 acres. This lift station collects flow from the commercial and industrial area south of the airport. This is a duplex lift station with submersible Flygt pumps each rated at 550 gpm. At over 3,700 lineal feet, the force main for this station has the longest run of the stations in the Salinas collection system. This lift station has a dedicated backup generator on an automatic transfer switch and bypass capabilities.

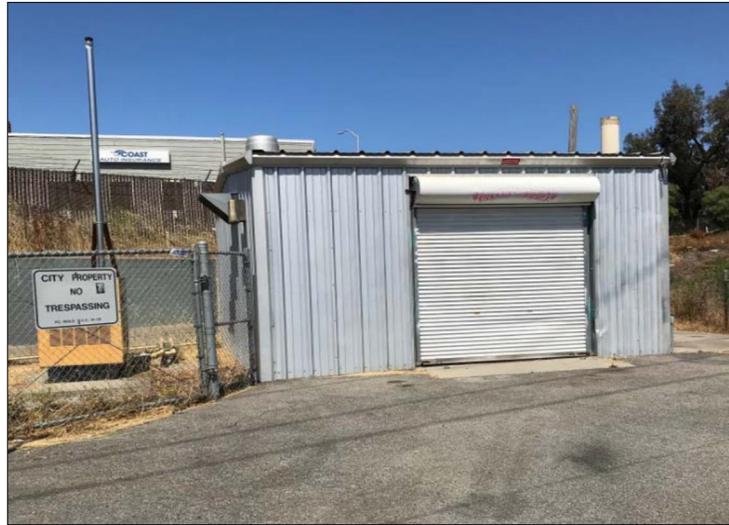
Carpenter Hall Lift Station is located near the center of the sewer collection system behind the building at 512 North Main Street. There is an access road off North Main Street near 422 North Main Street that leads to the lift station. This lift station collects flow from approximately 508 acres of residential, commercial, industrial properties, and schools in the area. This is a duplex lift station with Smith & Loveless pumps each rated at 2,250 gpm located in a dry pit. The pumps are controlled by VFDs. This lift station has a dedicated backup generator on an automatic transfer switch but no power receptacle or bypass capabilities. This is the City's second largest lift station.

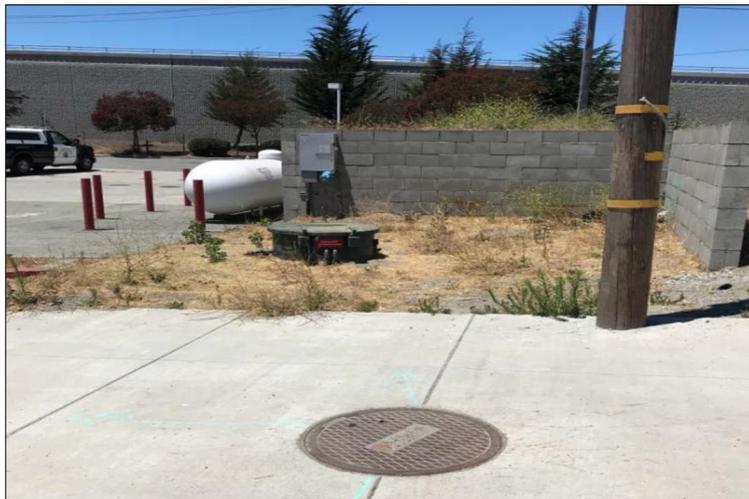
De La Torre Lift Station is located in the southwest corner of the property adjacent to 1222 De La Torre Street near the Municipal Airport. This lift station collects flow from approximately 10 acres of commercial properties and hotels in the area west of the airport. This is a duplex lift station with Smith & Loveless pumps each rated at 200 gpm located in a dry pit. This lift station has facilities to connect a portable backup generator but has no permanent electrical generator or bypass capabilities.

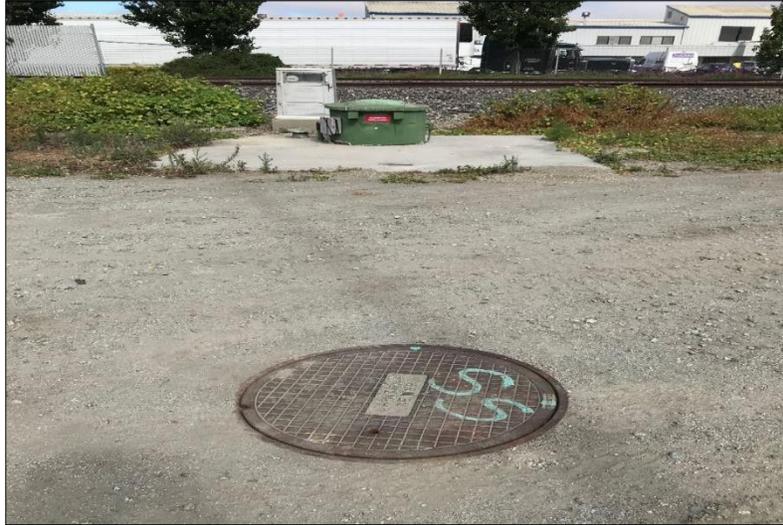
Harkins Road Lift Station is located near the southern boundary of the sewer collection system between Harkins Road and the railroad tracks. This lift station collects flow from approximately 146 acres of commercial and industrial properties in the area. This is a duplex lift station with Smith & Loveless pumps each rated at 350 gpm located in a dry pit. This lift station has no permanent electrical generator and an unsafe or transfer switch to connect a portable backup generator. It also has no bypass capabilities.

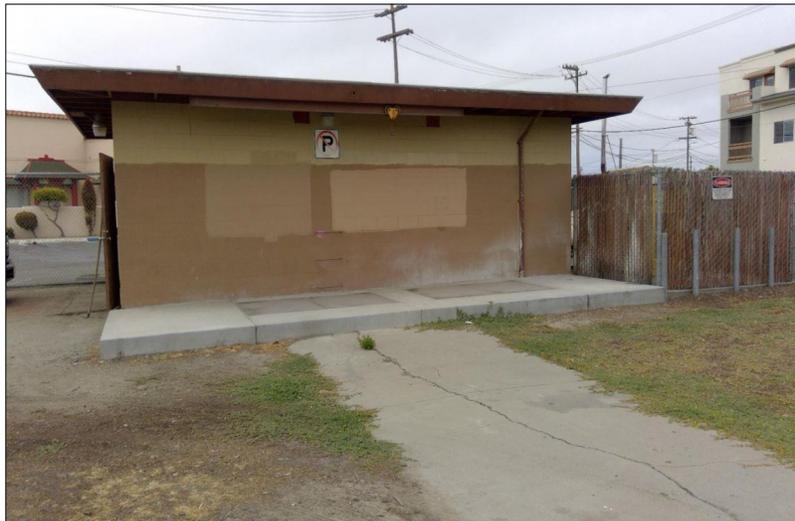
Lake Street Lift Station is located near the center of the sewer collection system near Carr Lake at 146 East Rossi Street. This lift station collects flow from residential, commercial, industrial, hotels, and schools from a large upstream area of approximately 4,108 acres. This is a triplex lift station with Flygt pumps each rated at approximately 2,800 gpm located in a dry pit. The pumps are controlled by VFDs. This lift station has a dedicated backup generator on an automatic transfer switch and bypass capabilities. This is the City's largest lift station.

- ❖ Lake Street Lift Station is the only triplex lift station in the system. Lake Street Pump #1 is connected to 12" dia. force main. Pumps #2 and #3 discharge to 14" dia. force main. Operating the lift station in simplex, duplex, and triplex modes without speed reduction from the VFDs causes the force main velocities to be 7.4 feet per second for the 12" dia. force main, and 6.1 and 9.7 feet per second, respectively, for the 14" dia. force main.

This lift station receives approximately 1,930 gpm under average daily flow conditions, and 6,375 gpm under peak flow conditions. Based on these inflows it is anticipated that this station operates in simplex or triplex mode under average and peak flows, respectively. The lift station pumps are controlled by VFDs. In the event that the VFDs were disengaged, the pumps would cycle approximately 100 times per hour under average flow and peak hour dry weather flow. Although not required, the wet well operating volume, estimated as 690 gallons, could be increased in the event that the VFDs are disengaged. This is based on estimated pump cycling times without VFDs and the estimated total wet well volume of 26,000 gallons. Also, the pumps and force mains appear to be undersized based upon the high pumping times, high sewage inflow rate, and high velocities in the force mains.

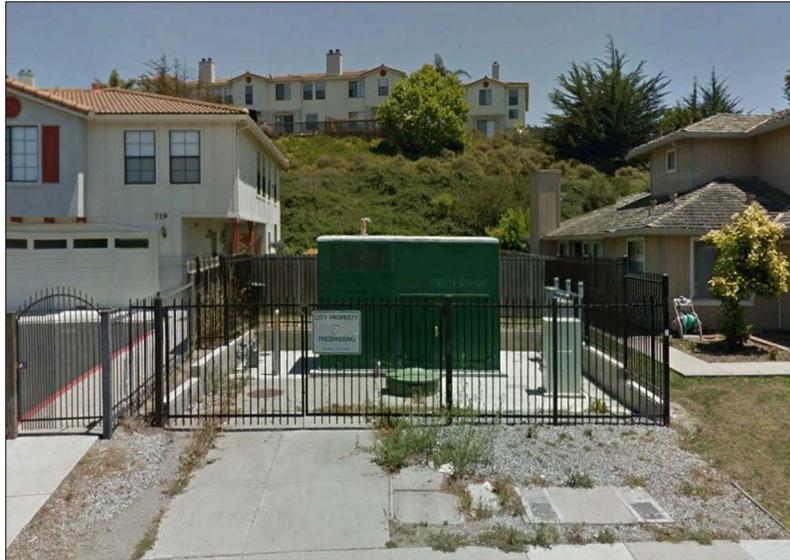
Las Casitas Lift Station is located near the eastern edge of the sewer collection system in a residential area at 721 Las Casitas Drive. This lift station collects flow from approximately 38 acres of residential properties and schools in the area. This is a duplex lift station with Smith & Loveless pumps each rated at 150 gpm located in a dry pit. This lift station has a dedicated backup generator on an automatic transfer switch but does not have bypass capabilities.

- ❖ Las Casitas Lift Station pumps have a design rating of 150 gpm at 50 feet Total Dynamic Head (TDH). However, the calculated and measured pumping rates are 395 gpm and 350 gpm, respectively. The force main flow velocity at the design pumping rate of 150 gpm is 1.5 fps. Although this is lower than the recommended minimum flow rate of 2 fps, the flow rate at 395 gpm is 2.5 fps, which is acceptable.

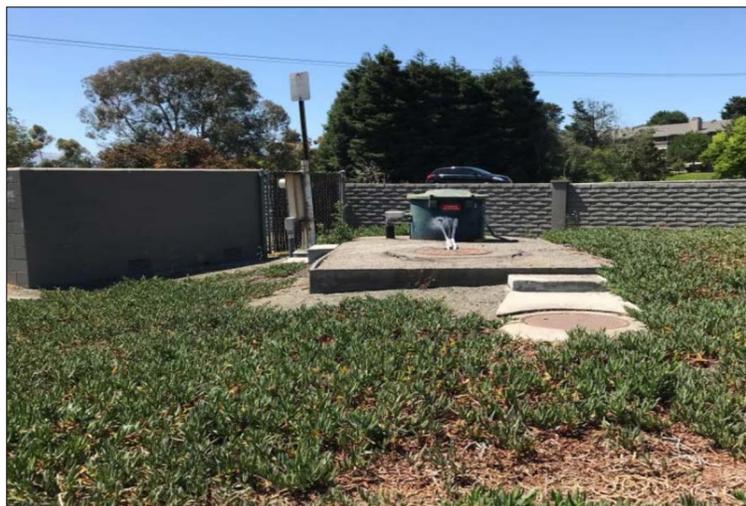
Mill Lake Lift Station is located near the western edge of the sewer collection system in a residential area at 81 Gardenia Drive. This lift station collects flow from approximately 43 acres of residential and commercial properties in the area. This is a duplex lift station with Smith & Loveless pumps each rated at 500 gpm located in a dry pit. This lift station has a dedicated backup generator on an automatic transfer switch but does not have bypass capabilities.

- ❖ Mill Lake Lift Station operating in simplex and duplex modes causes the force main velocity to be 5.8 and 7.1 feet per second, respectively.
- ❖ Santa Rita Lift Station operating in simplex and duplex modes causes the force main velocity to be 5.8 and 7.1 feet per second, respectively.

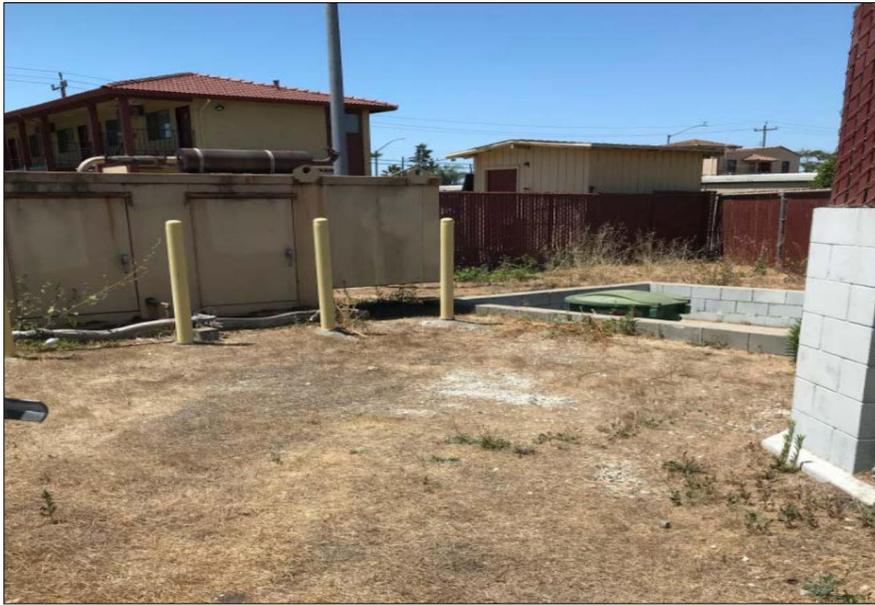
Santa Rita Lift Station is located near the northern edge of the sewer collection system in a commercial and residential area at 2021 Sucre Court. This lift station collects flow from residential, commercial, industrial, hotels, and schools from the upstream area of approximately 348 acres, including a small portion of flows through the Bolsa Knolls special assessment district. This is a duplex lift station with Smith & Loveless pumps each rated at 1,530 gpm located in a dry pit. This lift station has a dedicated backup generator on an automatic transfer switch but does not have bypass capabilities. This is the City's third largest lift station.

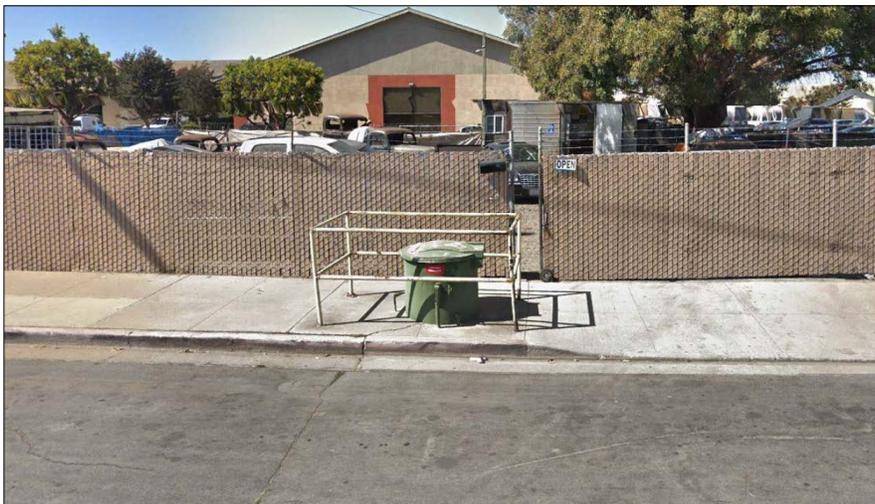
Spicer Lift Station is located in a commercial and industrial area at 59 Spicer Street. This lift station collects flow from approximately 79 acres of residential, commercial, industrial properties, and hotels in the area. This is a duplex lift station with Smith & Loveless pumps each rated at 400 gpm located in a dry pit. This lift station cannot have a dedicated backup generator and currently does not have a safe receptacle for a transfer switch and no bypass capabilities.

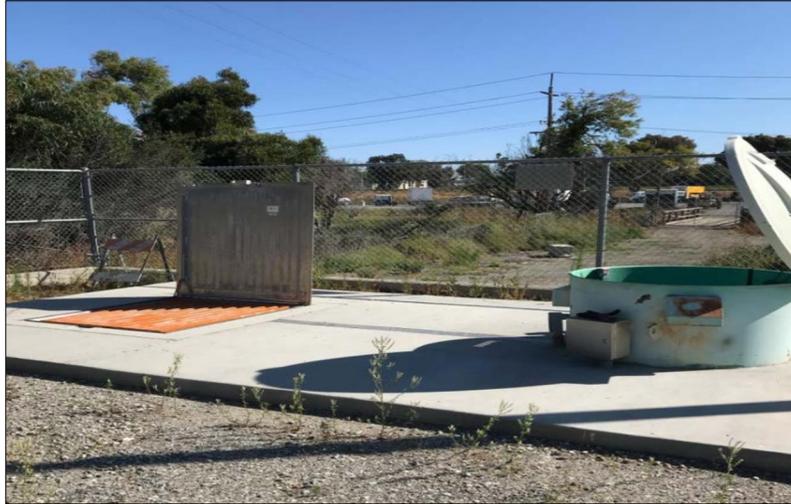
TP2 Lift Station is located near Spicer Lift Station in a commercial and industrial area at 650 Elvee Drive. This lift station collects flow from residential, commercial, industrial, hotels, and schools from the upstream area of approximately 136 acres. This is a duplex lift station with Smith & Loveless pumps each rated at 400 gpm located in a dry pit. The pumps are controlled by VFDs set at 48 Hertz maximum output to control vibration. This lift station has a dedicated backup generator on an automatic transfer switch but no bypass capabilities.

- ❖ TP2 Lift Station operating in simplex and duplex modes without speed reduction from the VFDs causes the force main velocity to be 8.4 and 11.9 feet per second, respectively. Reducing the pump output to 80% approximates the measured flow but still causes excessive force main velocity of 6.3 and 9.2 feet per second in simplex and duplex modes, respectively.

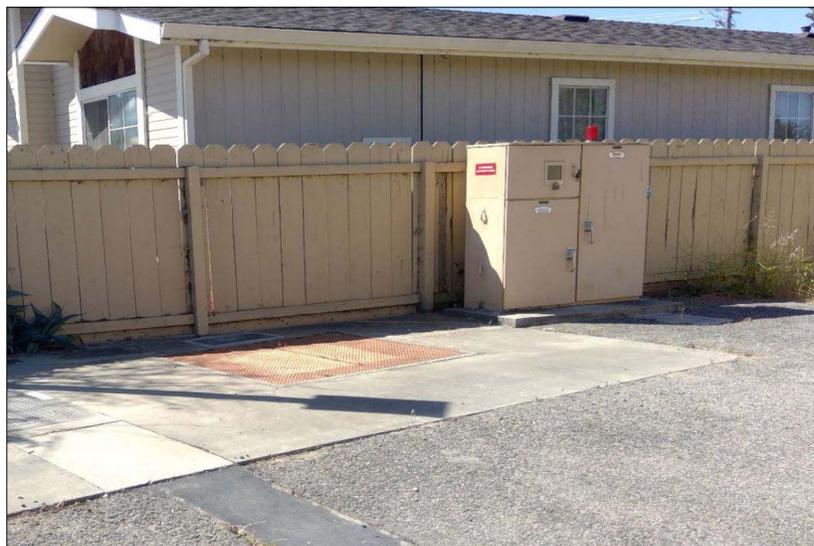
Vista Nueva Lift Station is located near the western edge of the collection system in a residential area at 704 Garner Avenue. This lift station collects flow from the approximately 6 acres of residential properties in the area. This is a duplex lift station with submersible Flygt pumps each rated at 175 gpm. This lift station does not have a dedicated backup generator but does have receptacle and transfer switch for a portable generator and bypass capabilities.

- ❖ Vista Nueva Lift Station operating in simplex and duplex modes causes the force main velocity to be 5.4 and 6.4 feet per second, respectively.

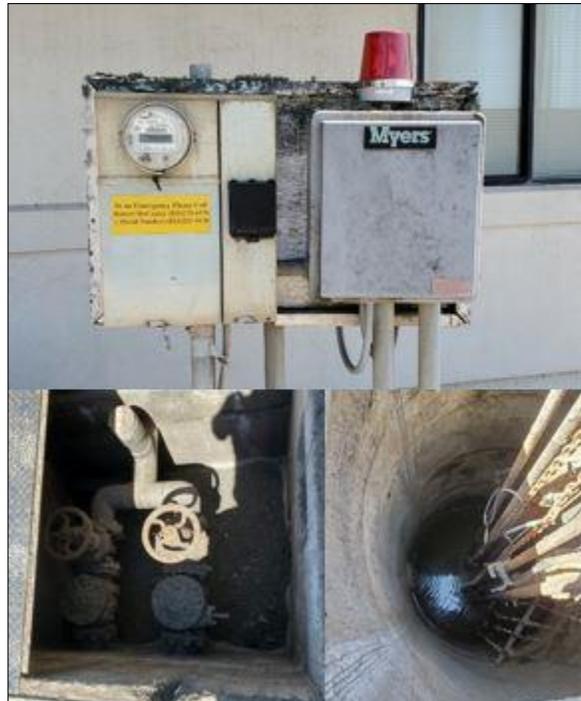
Harris Road Lift Station

Harris Lift Station is a private lift station located in the industrial area south of the sewer collection system at 1 Harris Place. This lift station collects flow from the industrial in the area. This is a duplex lift station with submersible pumps (manufacturer unknown) rated at approximately 100 to 140 gpm. This lift station does not have a dedicated backup generator or bypass capabilities, but does have a receptacle and transfer switch for a portable generator..

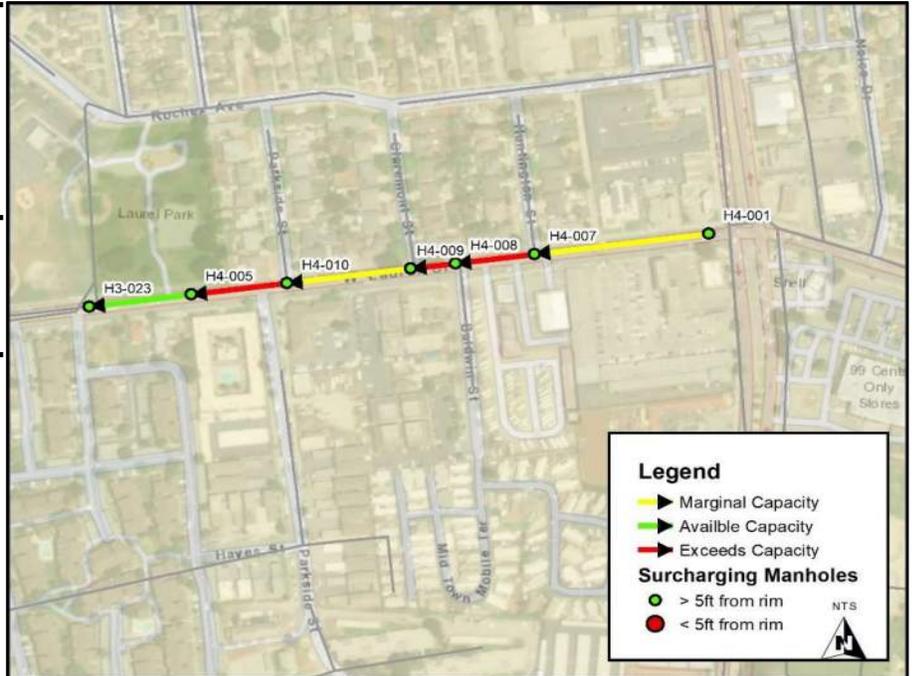
The West Laurel Drive Future CIP recommends upsizing approximately 1,550 ft. of 12-inch to 15-inch from MH-H4-001 at N Main St to MH-H3-023 near Laurel Park. Under peak future conditions, this segment on West Laurel Drive runs 66-88% full.

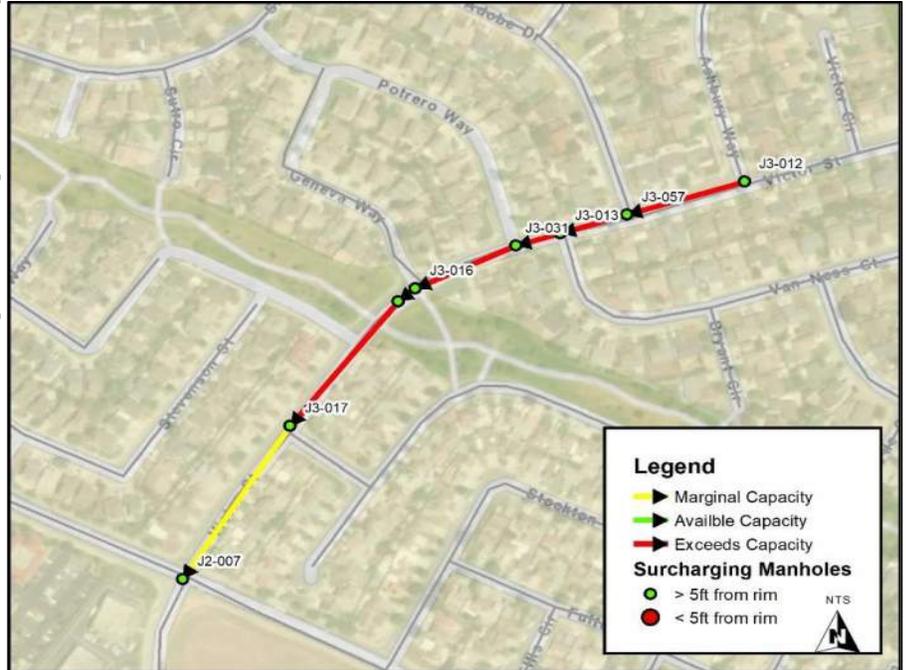
The Victor Street Future CIP project recommends upsizing approximately 1,600 ft. of 15-inch to 18-inch from MH-J3-012 at Ashbury way to MH-J2-007 at W Rossi St. Under peak future conditions, this segment along Victor St runs 73-98% full.

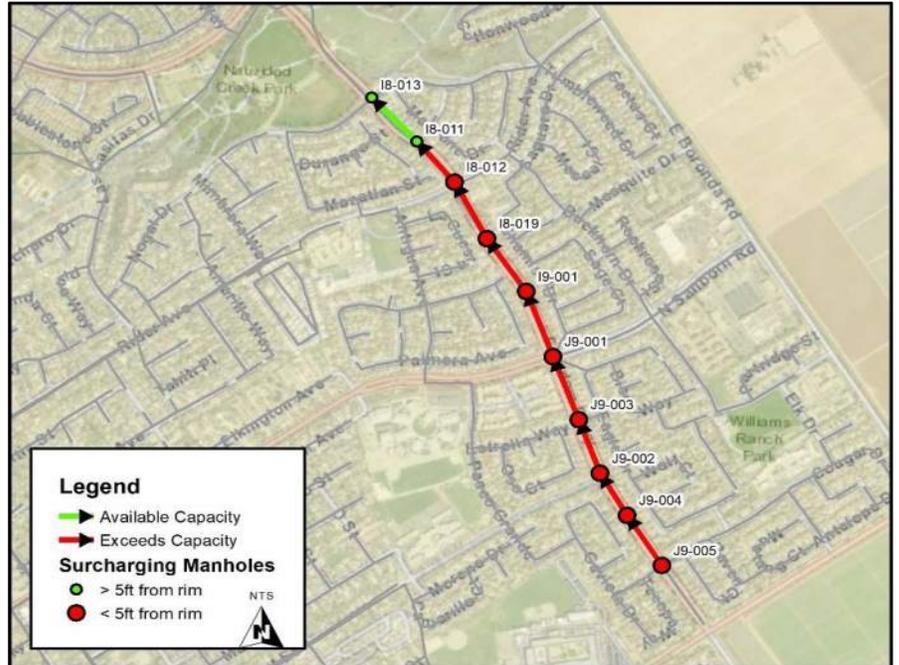
The Freedom Parkway Future CIP project recommends the upsize of approximately 2,025 ft of 10-inch pipe to 15-inch from MH-J9-005 at Estrella Way to MH-J9-001 at N Sanborn Rd. An additional 2,725 ft of 12-inch pipe from MH-J9-001 to MH-I8-013 at Nogal Dr should be upsized to 18-inch. Under peak future conditions, this segment on Freedom Parkway runs 50-100% full and 8 manholes are surcharging within 5 ft. of the manhole rims.

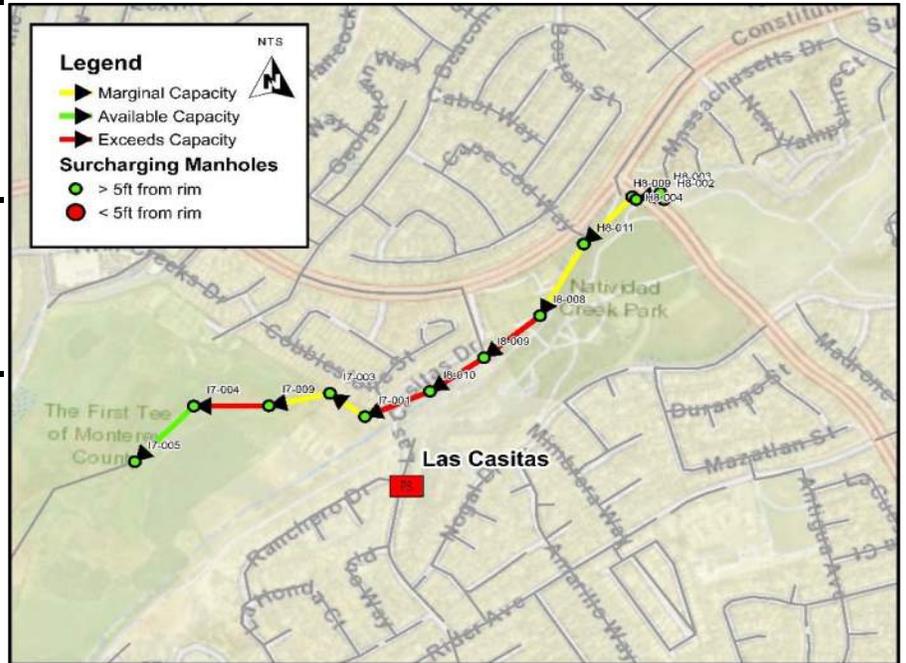
The Natividad Creek Park Future CIP project recommends upsizing approximately 230 ft of 18-inch to 21-inch from MH-H8-002 to MH-H8-004 and approximately 3,800 ft of 24-inch to 27-inch from MH-H8-004 at Freedom Pkwy to MH-I7-005 at the Twin Creeks Golf Course. Under peak future conditions, this segment through Natividad Creek Park runs 76-100% full.

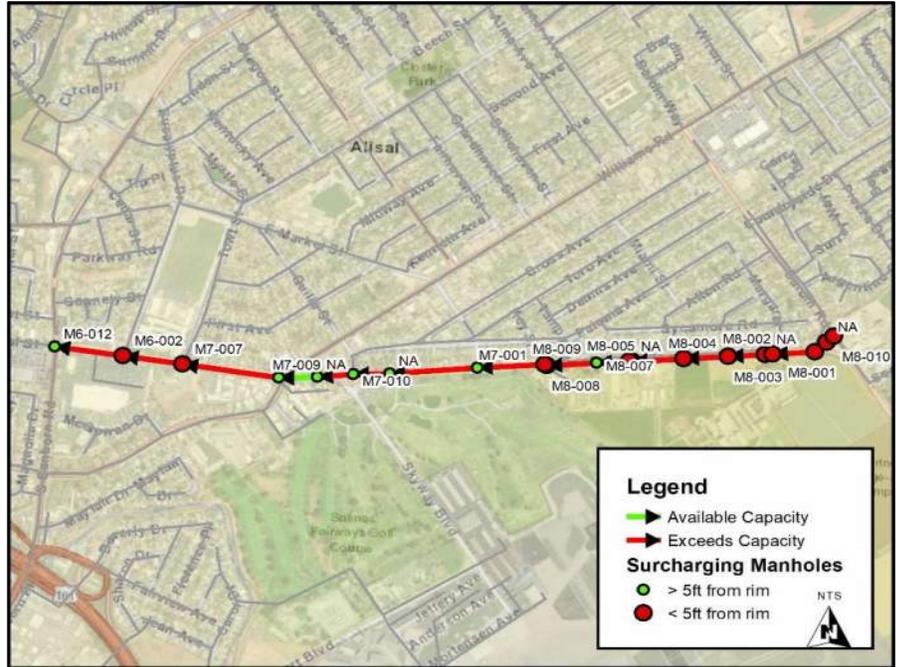
The East Alisal Street Future CIP project recommends upsizing approximately 5,400 ft. of 15-inch to 18-inch from MH-M8-010 near Bardin Rd to MH-M7-009 at Williams Rd. Additionally, approximately 2,200 ft of 18-inch should be upsized to 21-inch from MH-M7-009 to MH-M6-012 at N Sanborn Rd. Under peak future conditions, this segment runs 67-100% full and 14 manholes are surcharging within 5 ft of the manhole rims.

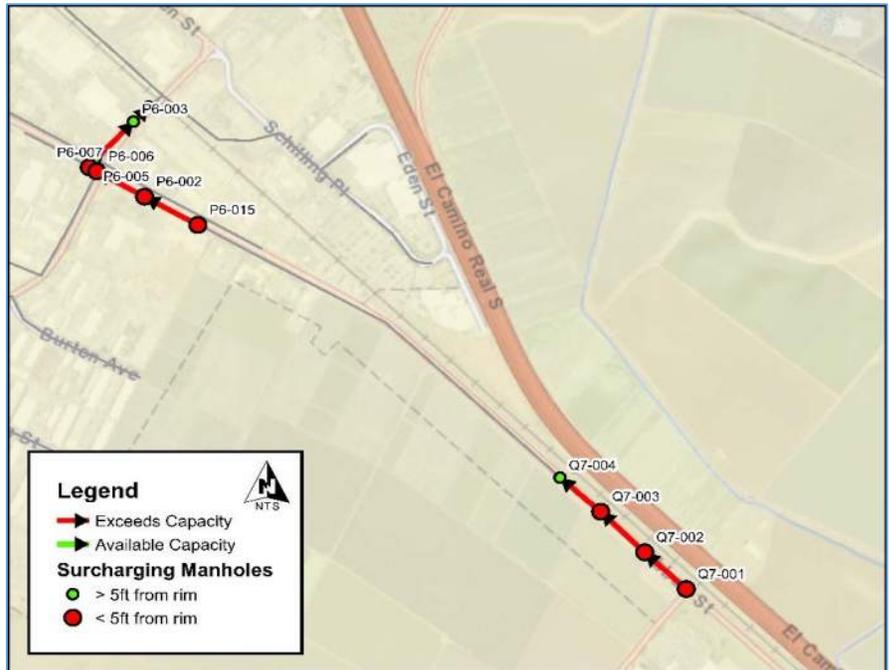
The Abbot Street Future CIP project recommends upsizing approximately 1,300 ft of 12-inch to 15-inch from MH-Q7-001 at Harris Rd to MH-Q7-004. Between MH Q7-004 and P6-015, there is an existing 15-inch pipe that does not need to be upsized. An additional 850 ft. of 12-inch pipe from MH-P6-015 to MH-P6-006 at Harkins Rd should be upsized to 15-inch, and 700 ft of 15-inch to 18-inch from MH-P6-006 to the manhole after P6-003 (no City ID). Under peak future conditions, this segment runs 66-100% full. Under future max day flows seven of the manholes are surcharging within 5 ft of the manhole rim.

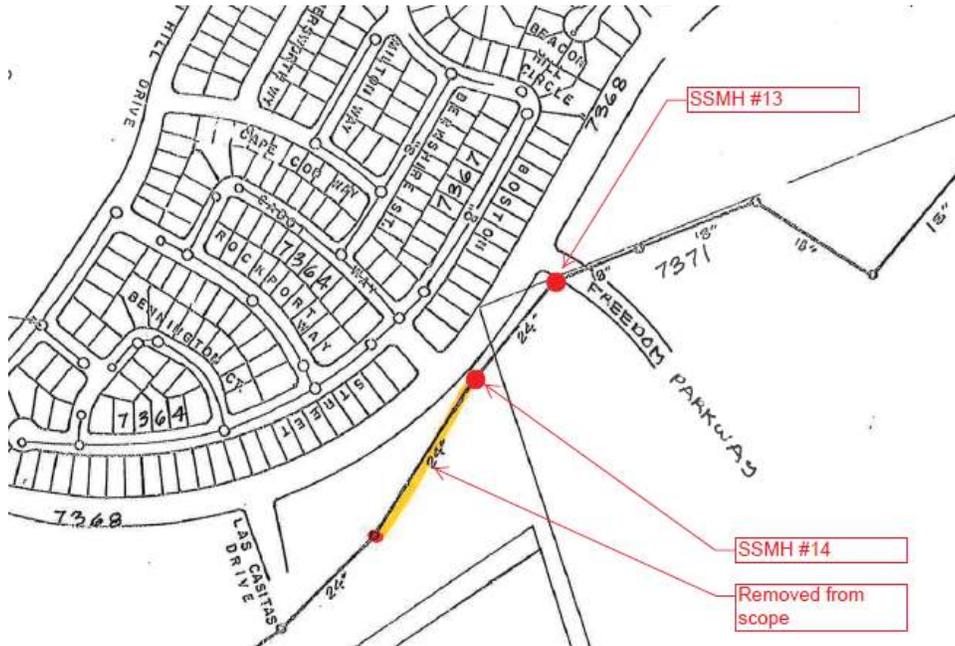
Figure 1

Segments colored in yellow were part of the original project scope. Inability to locate or access manholes resulted in change of scope per City's direction.

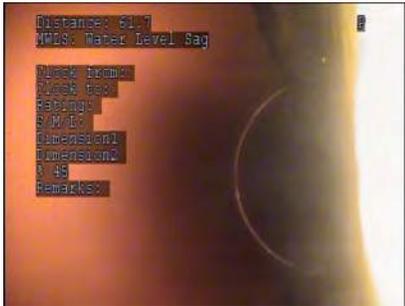
61.7		MWLS	No	/			Structural	
------	--	------	----	---	--	--	------------	--

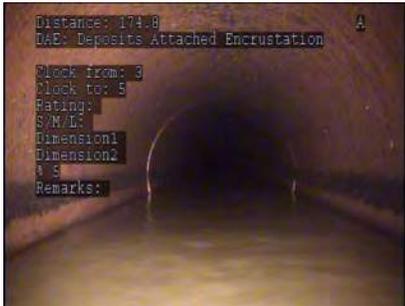
174.7		DAE	No	3 / 5			O&M	
-------	--	-----	----	-------	--	--	-----	--

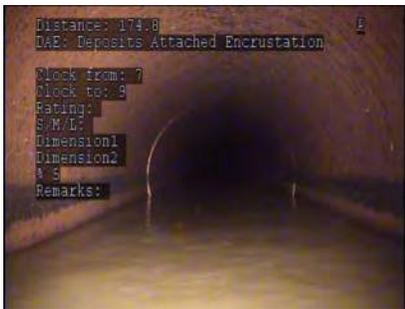
174.8		DAE	No	7 / 9			O&M	
-------	--	-----	----	-------	--	--	-----	--

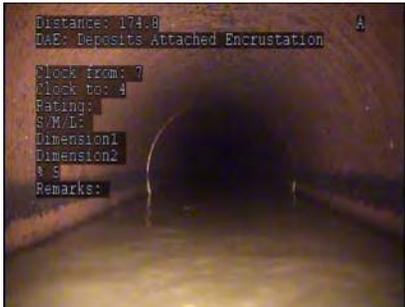
174.8		DAE	No	7 / 4			O&M	
-------	--	-----	----	-------	--	--	-----	--

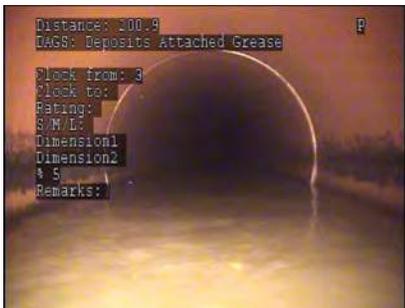
200.9		DAGS	No	3 /			O&M	
-------	--	------	----	-----	--	--	-----	--

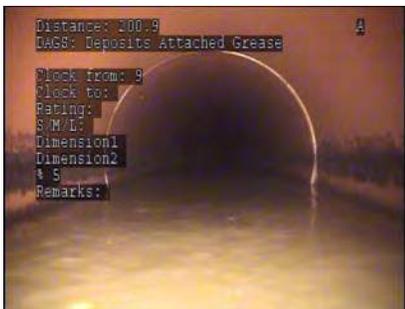
200.9		DAGS	No	9 /			O&M	
-------	--	------	----	-----	--	--	-----	--

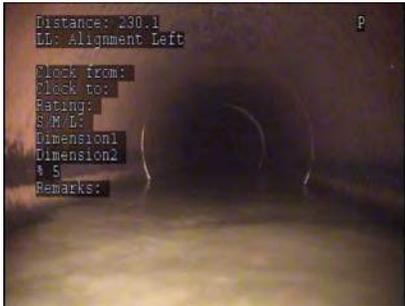
230.1		LL	No	/			O&M	
-------	--	----	----	---	--	--	-----	--

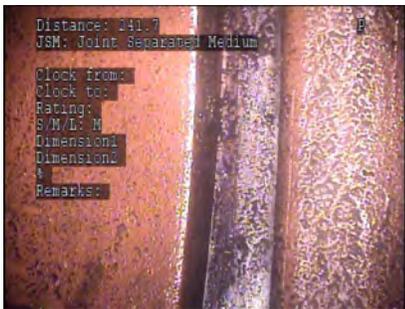
241.7		JSM	No	/			Structural	
-------	--	-----	----	---	--	--	------------	--

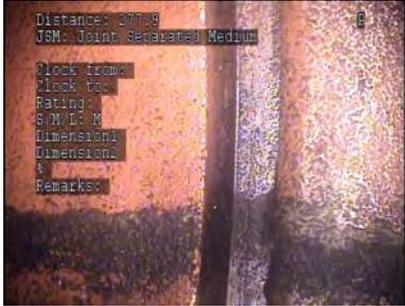
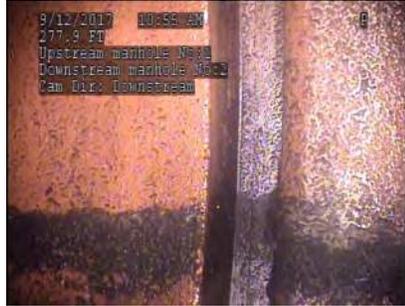
277.9		JSM	No	/			Structural	
-------	--	-----	----	---	--	--	------------	--

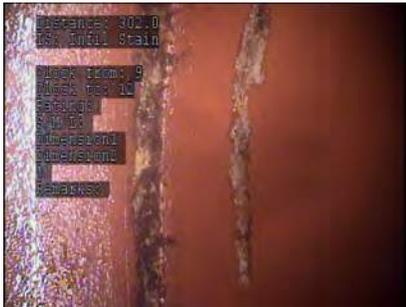
302.0		IS	No	9 / 12				
-------	--	----	----	--------	--	--	--	--

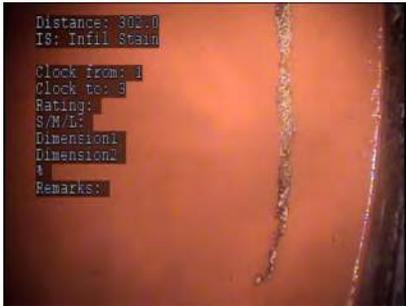
302.0		IS	No	1 / 3				
-------	--	----	----	-------	--	--	--	--

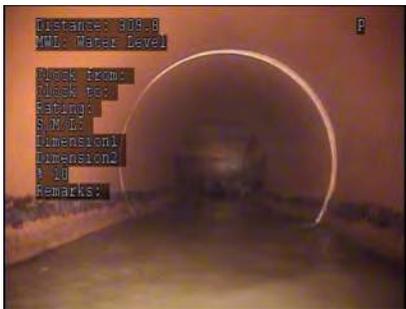
309.8		MWL	No	/				
-------	--	-----	----	---	--	--	--	--

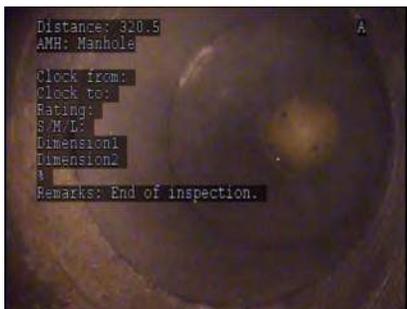
Distance	Length	Code	Reversed	Clock Pos.	Severity	Rating	Category	Comment
320.5		AMH	No	/				End of inspection.

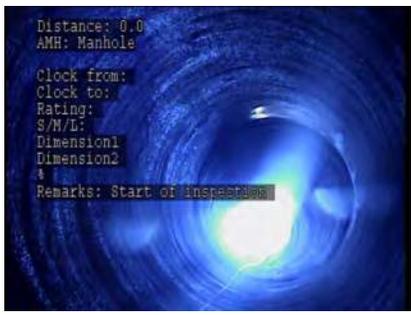
0.0		START WITH FLOW	No	/				
0.0		AMH	No	/				Start of inspection

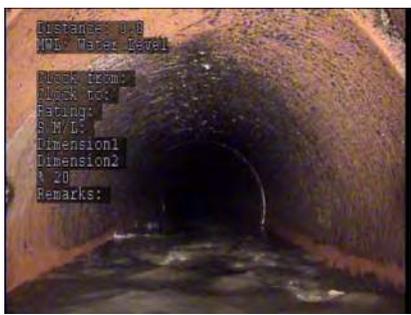
0.0		MWL	No	/				
-----	--	-----	----	---	--	--	--	--

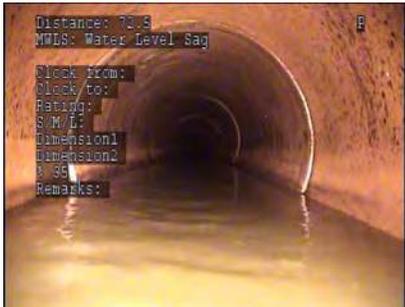
Distance	Length	Code	Reversed	Clock Pos.	Severity	Rating	Category	Comment
72.5		MWLS	No	/			Structural

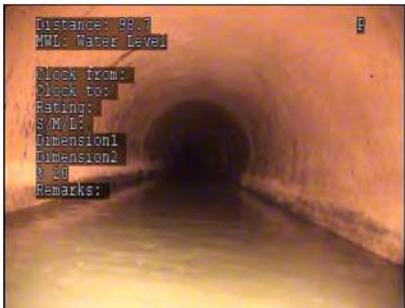
98.7		MWL	No	/				
------	--	-----	----	---	--	--	--	--

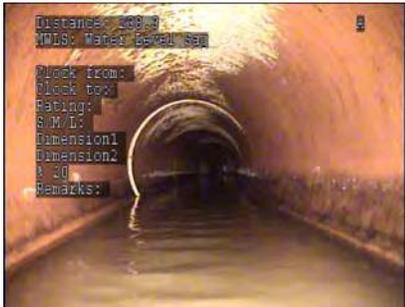
Distance	Length	Code	Reversed	Clock Pos.	Severity	Rating	Category	Comment
238.3		MWLS	No	/			Structural

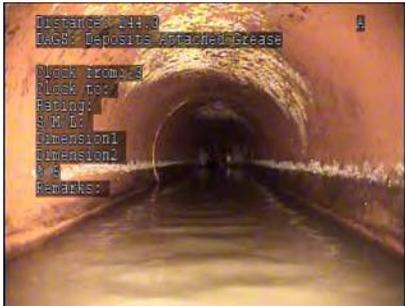
244.3		DAGS	No	3 /			O&M	
-------	--	------	----	-----	--	--	-----	--

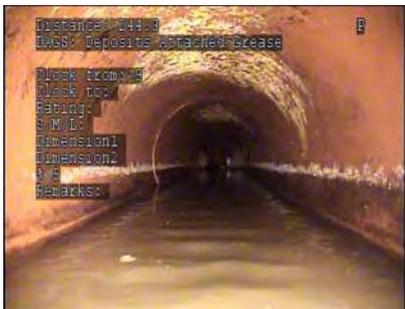
244.3		DAGS	No	9 /			O&M	
-------	--	------	----	-----	--	--	-----	--

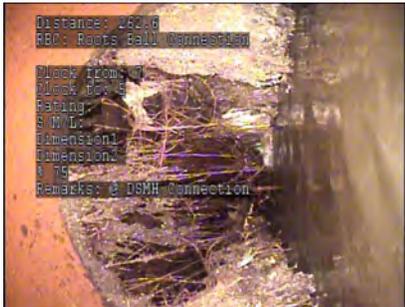
Distance	Length	Code	Reversed	Clock Pos.	Severity	Rating	Category	Comment
261.0		RBC	No	7 / 5			O&M	@ DSMH Connection

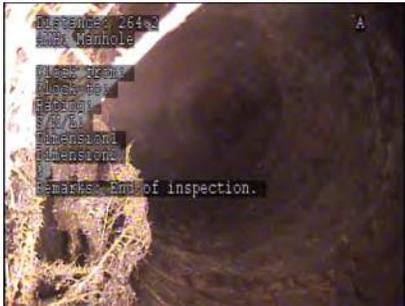
264.2		AMH	No	/				End of inspection.
-------	--	-----	----	---	--	--	--	--------------------

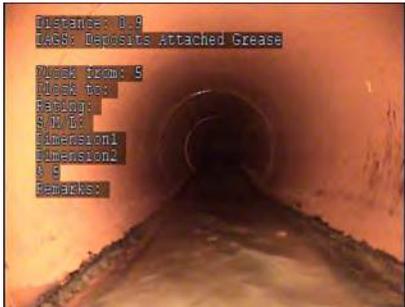
0.9		DAGS	No	5 /			O&M	
-----	--	------	----	-----	--	--	-----	--

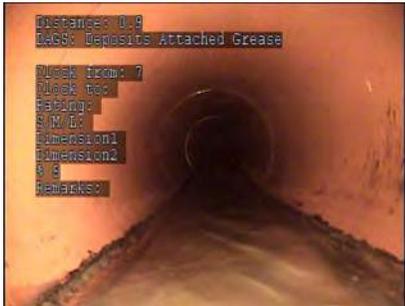
0.9		DAGS	No	7 /			O&M	
-----	--	------	----	-----	--	--	-----	--

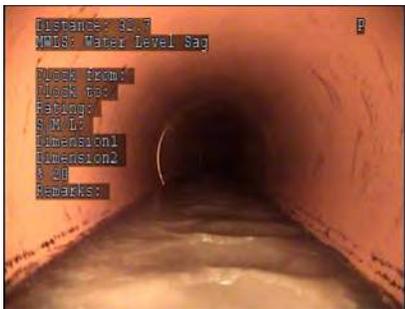
32.7		MWLS	No	/			Structural	
------	--	------	----	---	--	--	------------	--

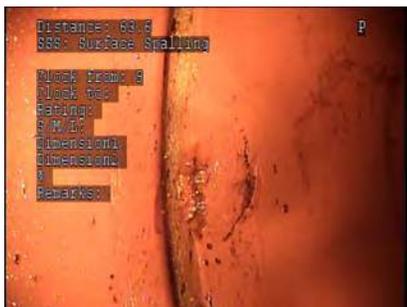
Distance	Length	Code	Reversed	Clock Pos.	Severity	Rating	Category	Comment
63.6		SSS	No	9 /			Structural

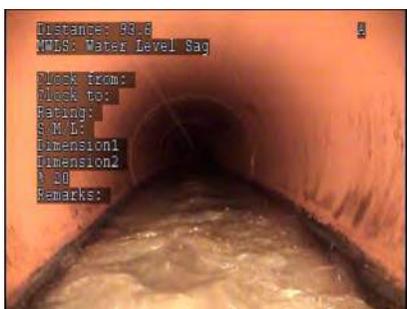
93.6		MWLS	No	/			Structural	
------	--	------	----	---	--	--	------------	--

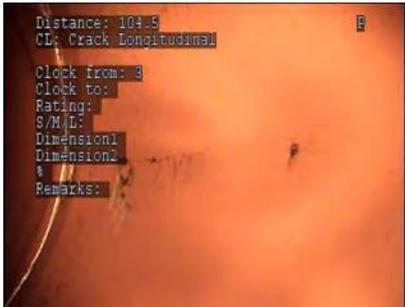
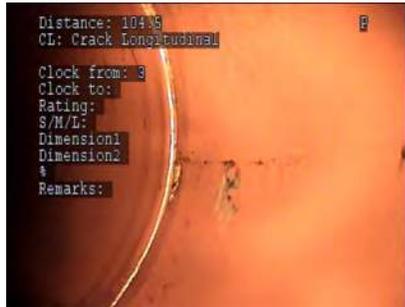
104.5		CL	No	3 /			Structural	
-------	--	----	----	-----	--	--	------------	--

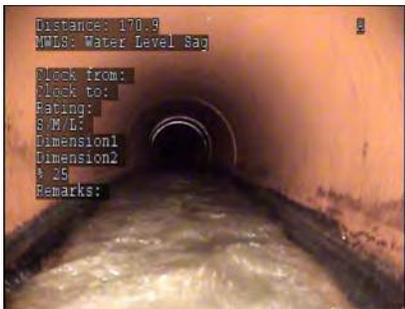
170.9		MWLS	No	/			Structural	
-------	--	------	----	---	--	--	------------	--

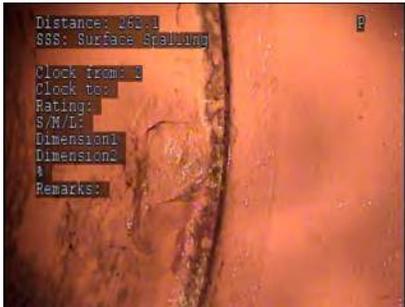
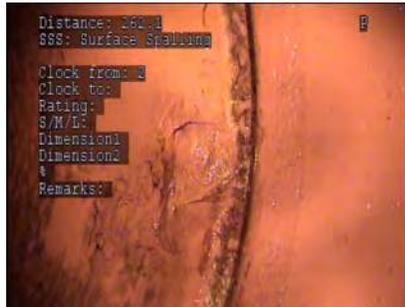
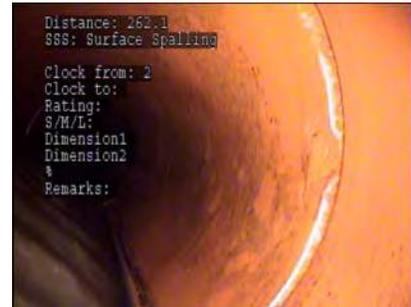
262.1		SSS	No	2 /			Structural	
-------	--	-----	----	-----	--	--	------------	--

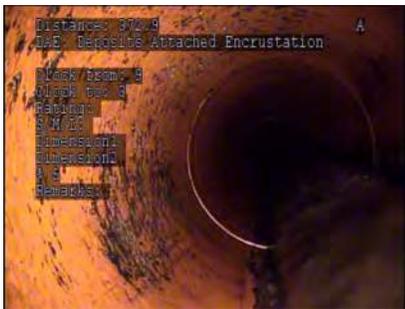
372.9		DAE	No	9 / 3			O&M	
-------	--	-----	----	-------	--	--	-----	--

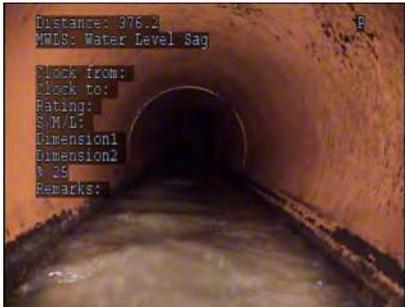
376.2		MWLS	No	/			Structural	
-------	--	------	----	---	--	--	------------	--

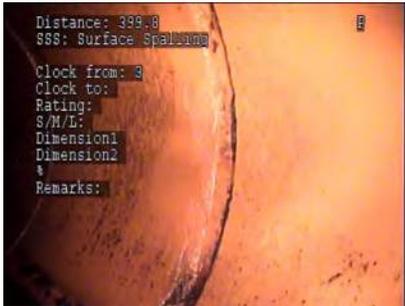
399.8		SSS	No	3 /			Structural	
-------	--	-----	----	-----	--	--	------------	--

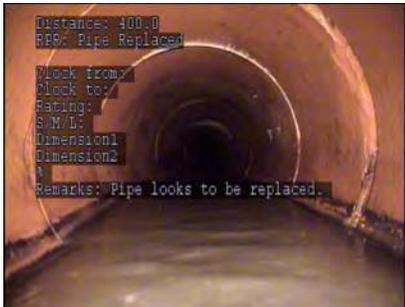
400.0		RPR	No	/				Pipe looks to be replaced.
-------	--	-----	----	---	--	--	--	----------------------------

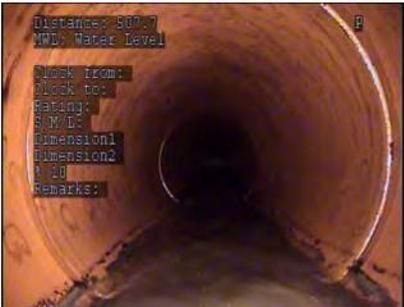
507.7		MWL	No	/				
-------	--	-----	----	---	--	--	--	--

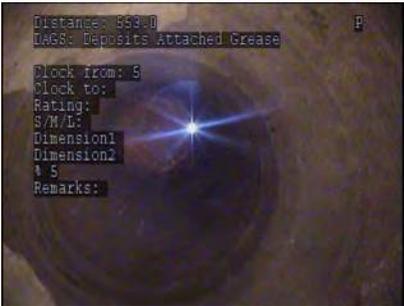
553.0		DAGS	No	5 /			O&M	
-------	--	------	----	-----	--	--	-----	--

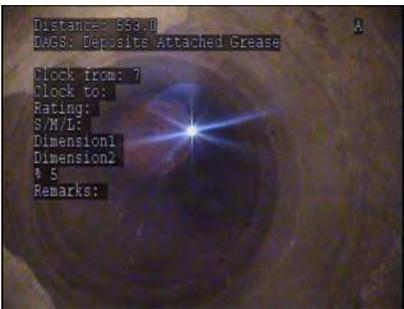
553.0		DAGS	No	7 /			O&M	
-------	--	------	----	-----	--	--	-----	--

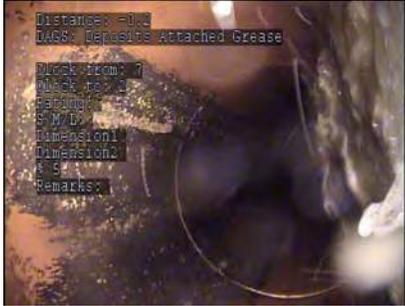
0.0		DAGS	No	7 / 5			O&M	
-----	--	------	----	-------	--	--	-----	--

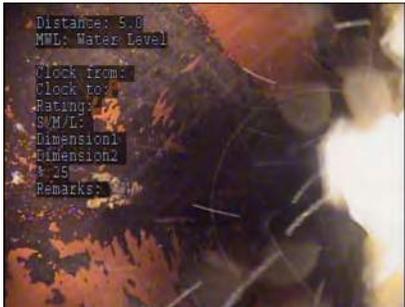
5.0	MWL		No	/				
-----	-----	--	----	---	--	--	--	--

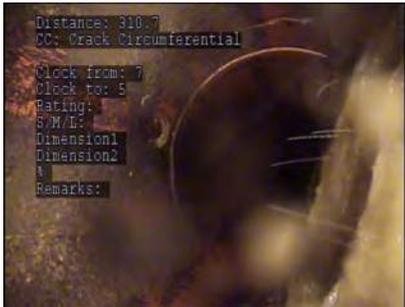
310.7		CM	No	7 / 5			Structural	
-------	--	----	----	-------	--	--	------------	--

Distance	Length	Code	Reversed	Clock Pos.	Severity	Rating	Category	Comment
9/18/2017	8:19 AM	310.6 FT						Upstream manhole No:9 Downstream manhole No:10 Cam Dir: Downstream
9/18/2017	8:19 AM	310.6 FT						Upstream manhole No:9 Downstream manhole No:10 Cam Dir: Downstream
9/18/2017	8:19 AM	310.6 FT						Upstream manhole No:9 Downstream manhole No:10 Cam Dir: Downstream
9/18/2017	8:19 AM	310.6 FT						Upstream manhole No:9 Downstream manhole No:10 Cam Dir: Downstream
9/18/2017	8:19 AM	310.6 FT						Upstream manhole No:9 Downstream manhole No:10 Cam Dir: Downstream
9/18/2017	8:19 AM	310.1 FT						Upstream manhole No:9 Downstream manhole No:10 Cam Dir: Downstream
Distance: 310.1		CM: Crack Multiple						
Clock from:								
Clock to:								
Rating:								
S/M/L:								
Dimension1								
Dimension2								
Remarks:								
Distance: 310.1		CM: Crack Multiple						
Clock from:								
Clock to:								
Rating:

Distance	Length	Code	Reversed	Clock Pos.	Severity	Rating	Category	Comment
376.3		AMH	No	/				END OF INSPECTION. FOUND DAGS THROUGHOUT LINE SEGMENT AND FOUND CM @ 310 FT.

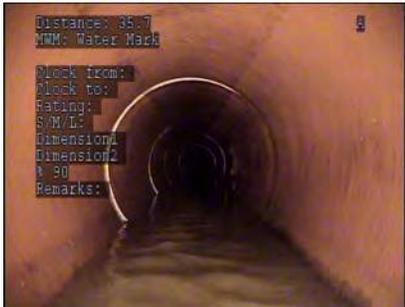
35.7		MWM	No	/			O&M	
------	--	-----	----	---	--	--	-----	--

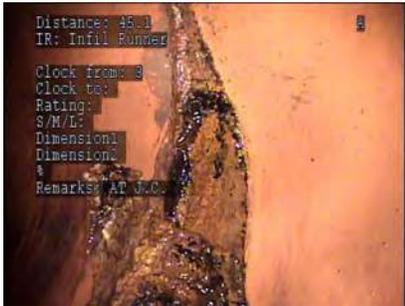
45.1		IR	No	3 /			O&M	AT J.C.
------	--	----	----	-----	--	--	-----	---------

END OF INSPECTION.
 FOUND DAGS
 THROUGHOUT LINE
 SEGMENT. MULTIPLE
 MWLS AND MWM
 @90%. ALSO FOUND
 IR @ J.C. OVERALL
 PIPE STRUCTURE
 GOOD

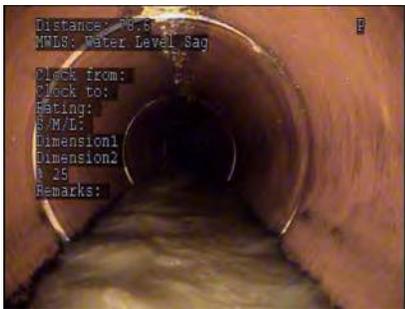
78.6		MWLS	No	/			Structural	
------	--	------	----	---	--	--	------------	--

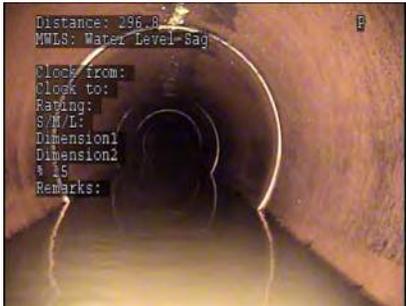
296.8		MWLS	No	/			Structural	
-------	--	------	----	---	--	--	------------	--

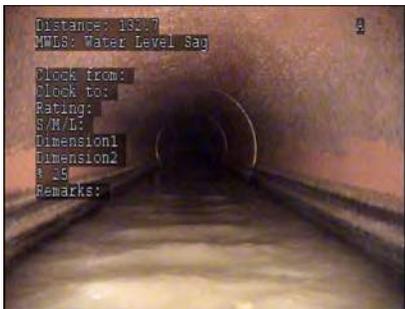
132.7		MWLS	No	/			Structural	
-------	--	------	----	---	--	--	------------	--

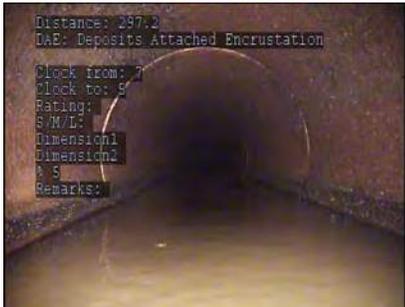
Distance	Length	Code	Reversed	Clock Pos.	Severity	Rating	Category	Comment
297.2		DAE	No	7 / 5			O&M

424.9		DAGS	No	7 /			O&M	
424.9		DAGS	No	5 /			O&M	
424.9		DAE	No	6 / 5			O&M	
424.9		AMH	No	/				END OF INSPECTION. DAGS THROUGHOUT LINE SEGMENT. FOUND MINOR MWLS AND MWM, ALSO DAE STARTING AT 297 FT

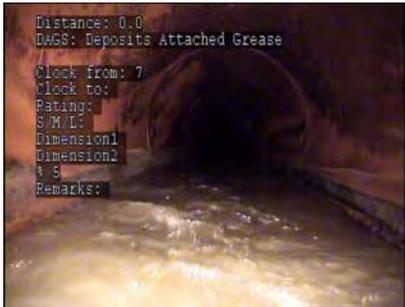
0.0		DAGS	No	7 /			O&M	
-----	--	------	----	-----	--	--	-----	--

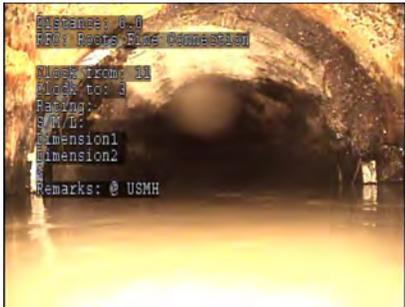
Distance	Length	Code	Reversed	Clock Pos.	Severity	Rating	Category	Comment
0.0		RFC	No	11 / 3			O&M	@ USMH

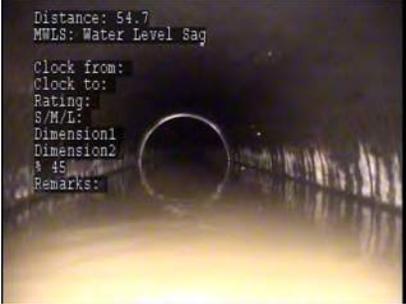
Distance	Length	Code	Reversed	Clock Pos.	Severity	Rating	Category	Comment
54.7		MWLS	No	/			Structural

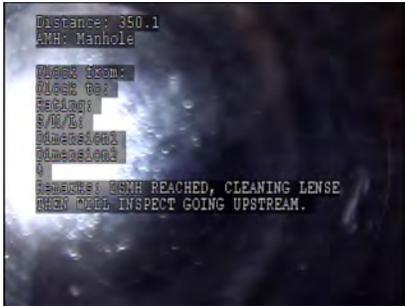
Distance	Length	Code	Reversed	Clock Pos.	Severity	Rating	Category	Comment
350.1		AMH	No	/				DSMH REACHED, CLEANING LENSE THEN WILL INSPECT GOING UPSTREAM.

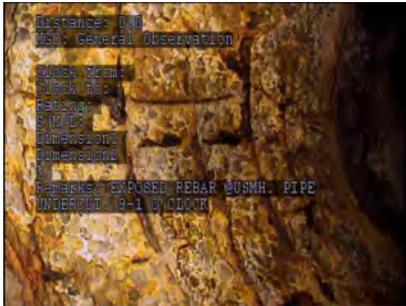
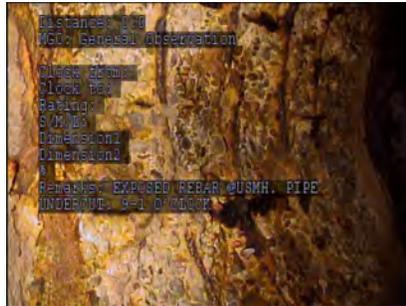
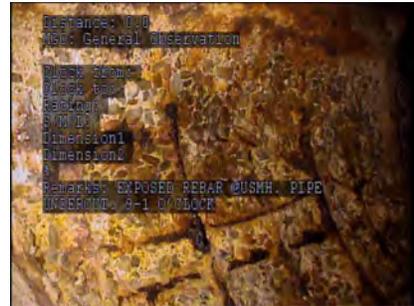
0.0		MGO	No	/				EXPOSED REBAR @USMH. PIPE UNDERCUT. 9-1 O'CLOCK
-----	--	-----	----	---	--	--	--	---

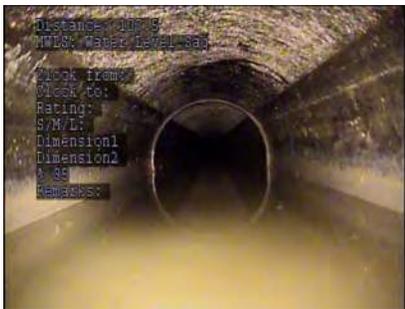
107.5		MWLS	No	/			Structural	
-------	--	------	----	---	--	--	------------	--

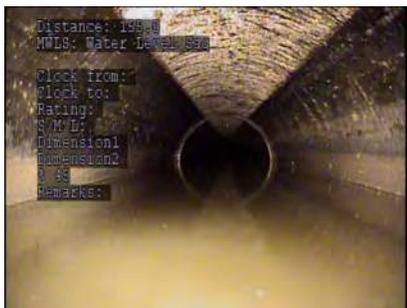
155.0		MWLS	No	/			Structural	
-------	--	------	----	---	--	--	------------	--

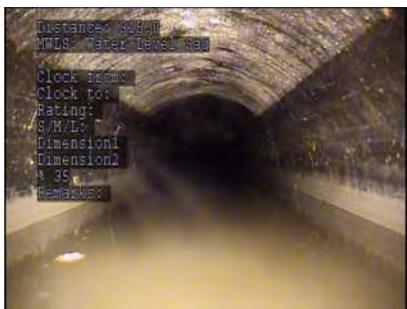
315.0		MWLS	No	/			Structural	
-------	--	------	----	---	--	--	------------	--

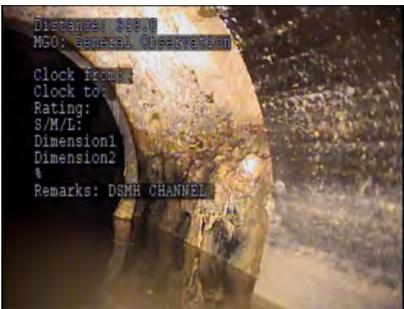
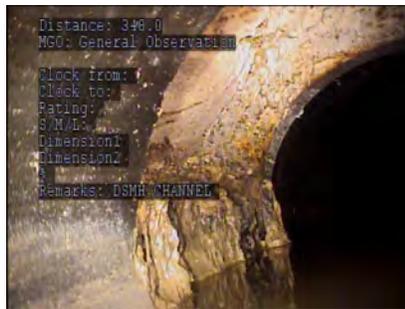
348.0 MGO No / DSMH CHANNEL

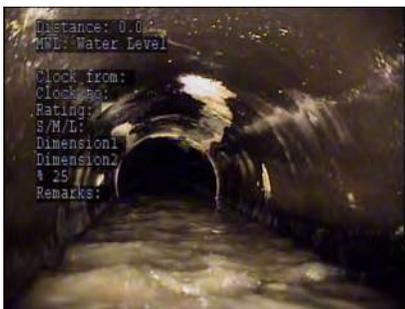
0.0		MWL	No	/				
-----	--	-----	----	---	--	--	--	--

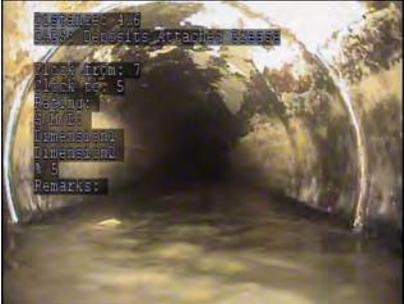
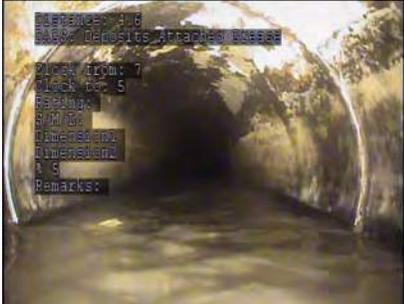
Distance	Length	Code	Reversed	Clock Pos.	Severity	Rating	Category	Comment
5.0		DAGS	No	7 / 5			O&M	
<div style="display: flex; justify-content: space-around;">
