Final City of Salinas Sanitary Sewer Master Plan Update

City of Salinas
Final Sanitary Sewer Master
Plan Update
May 2023

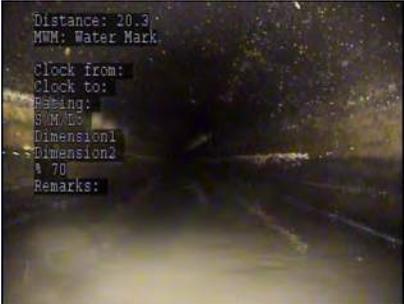
</div>								
20.3		MWM	No	/			O&M

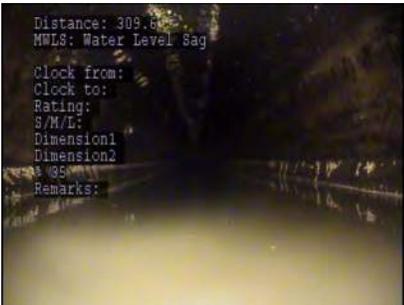
309.6		MWLS	No	/			Structural

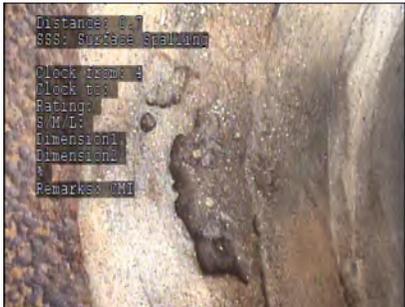
Distance	Length	Code	Reversed	Clock Pos.	Severity	Rating	Category	Comment
0.7		SSS	No	4 /			Structural	CMI

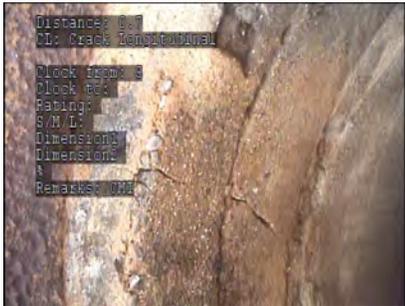
0.7		CL	No	3 /			Structural	CMI
-----	--	----	----	-----	--	--	------------	-----

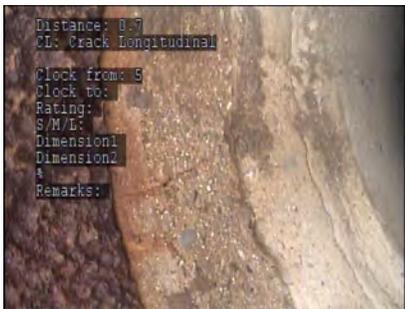
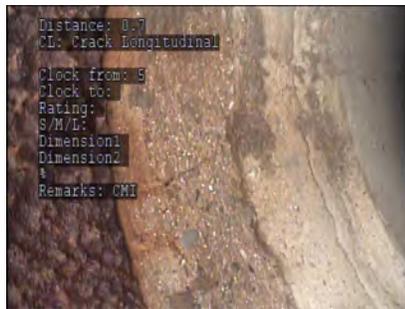
0.7		CL	No	5 /			Structural	CMI
-----	--	----	----	-----	--	--	------------	-----

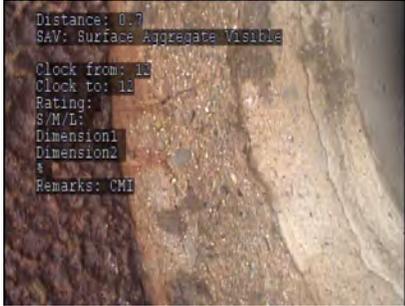
0.7		SAV	No	12 / 12			Structural	CMI
-----	--	-----	----	---------	--	--	------------	-----

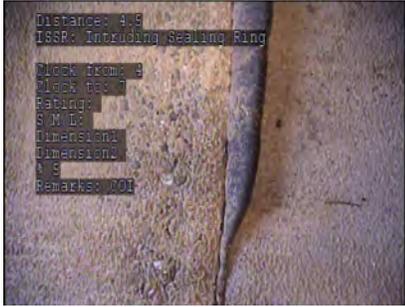
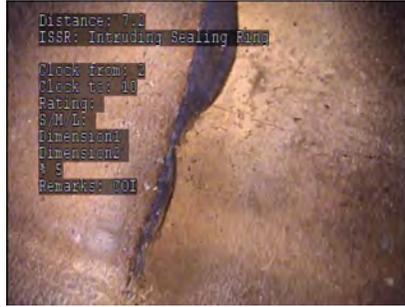
5.0		ISSR	No	2 / 10			O&M	COI
-----	--	------	----	--------	--	--	-----	-----

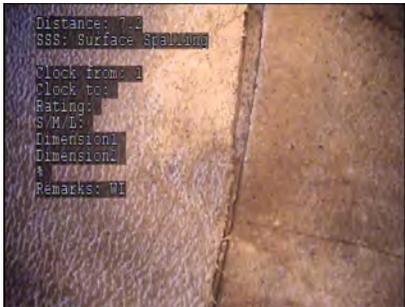
7.2		SSS	No	1 /			Structural	WI
-----	--	-----	----	-----	--	--	------------	----

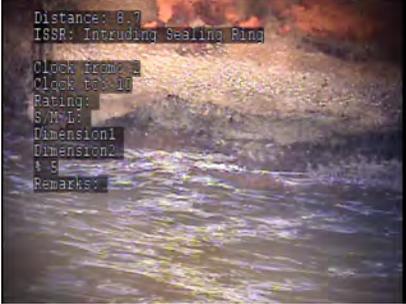
Distance	Length	Code	Reversed	Clock Pos.	Severity	Rating	Category	Comment
8.7		ISSR	No	2 / 10			O&M

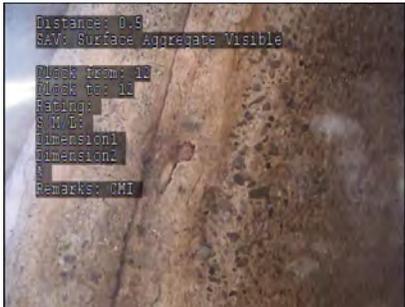
Distance	Length	Code	Reversed	Clock Pos.	Severity	Rating	Category	Comment
0.5		SAV	No	12 / 12			Structural	CMI

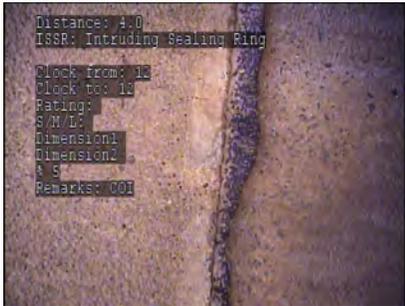
4.0		ISSR	No	12 / 12			O&M	COI
-----	--	------	----	---------	--	--	-----	-----

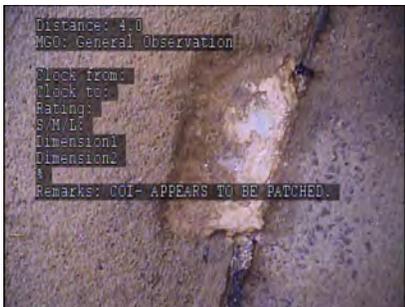
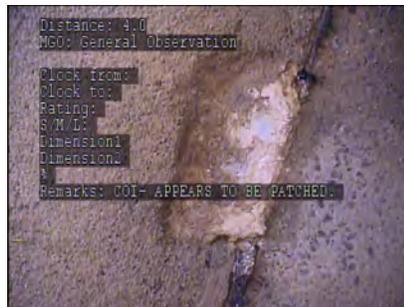
4.0		MGO	No	/				COI- APPEARS TO BE PATCHED.
-----	--	-----	----	---	--	--	--	-----------------------------

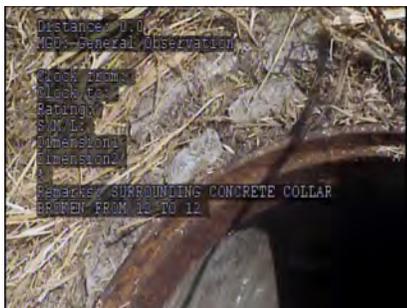
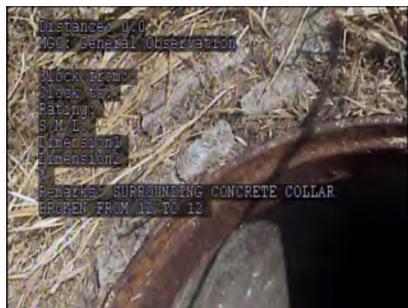
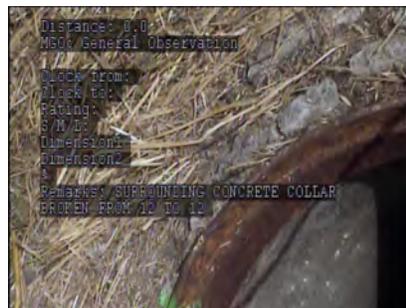
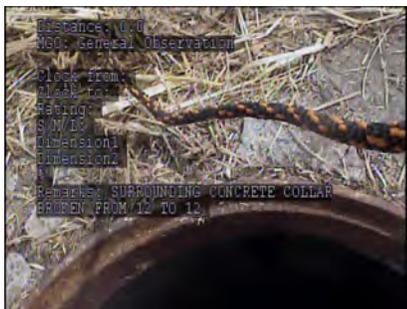
0.0		MGO	No	/				SURROUNDING CONCRETE COLLAR BROKEN FROM 12 TO 12
-----	--	-----	----	---	--	--	--	---

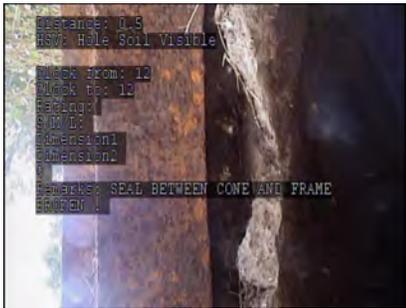
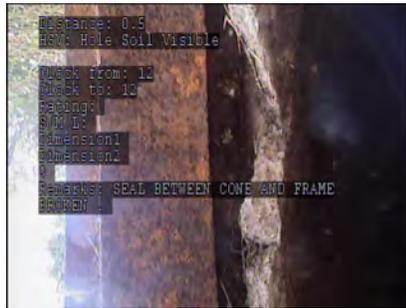
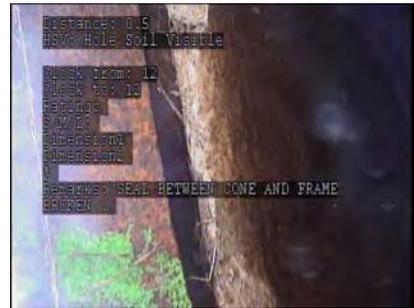
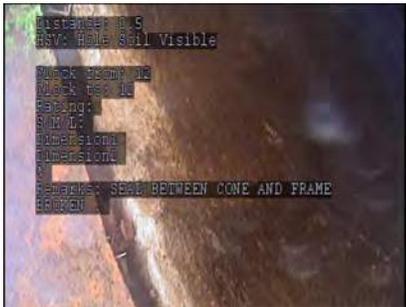
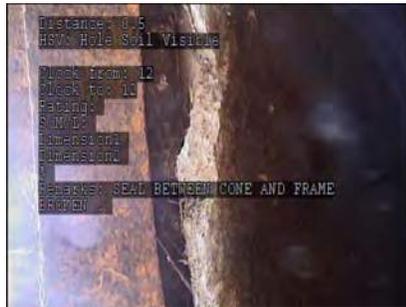
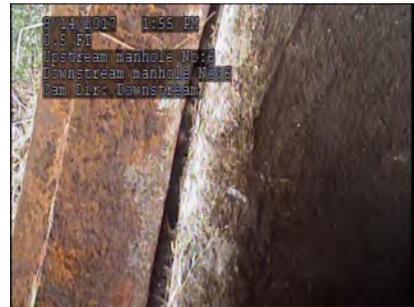
Distance	Length	Code	Reversed	Clock Pos.	Severity	Rating	Category	Comment
0.5		HSV	No	12 / 12			Structural	CMI- SEAL BETWEEN CONE AND FRAME BROKEN .

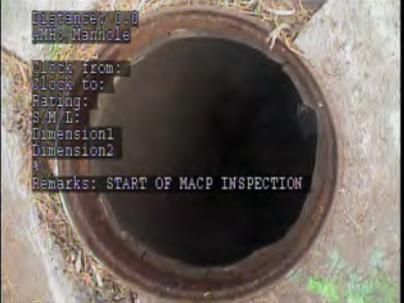
Distance	Length	Code	Reversed	Clock Pos.	Severity	Rating	Category	Comment
0.0		START WITH FLOW	No	/				
0.0		AMH	No	/				START OF MACP INSPECTION

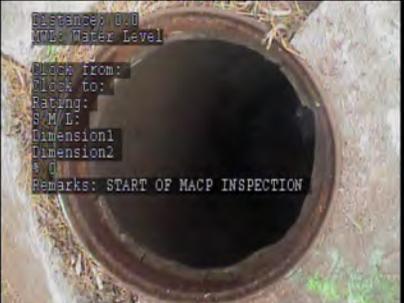
0.0		MWL	No	/				START OF MACP INSPECTION

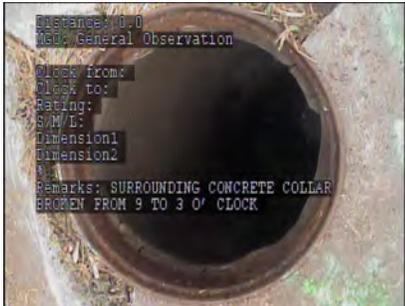
0.0		MGO	No	/				SURROUNDING CONCRETE COLLAR BROKEN FROM 9 TO 3 O' CLOCK
-----	--	-----	----	---	--	--	--	--

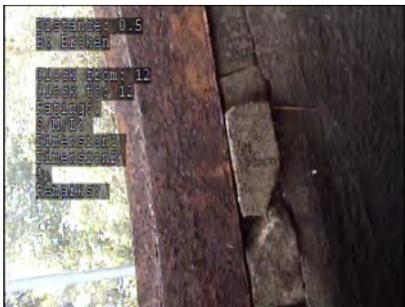
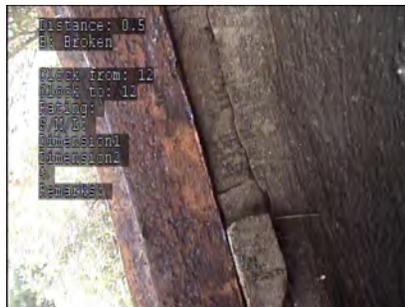
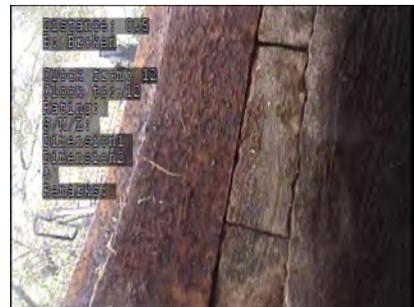
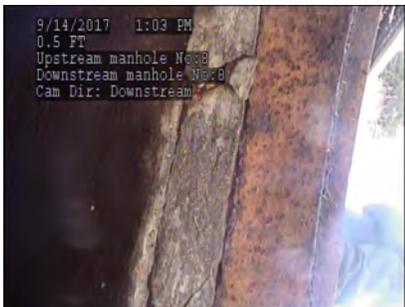
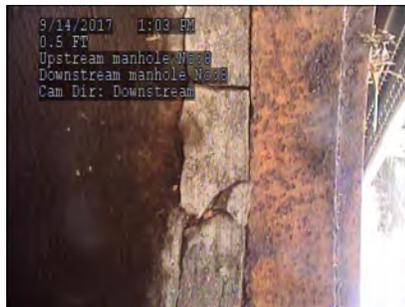
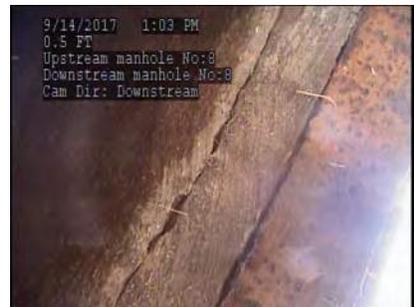
0.5		B	No	12 / 12			Structural	
-----	--	---	----	---------	--	--	------------	--

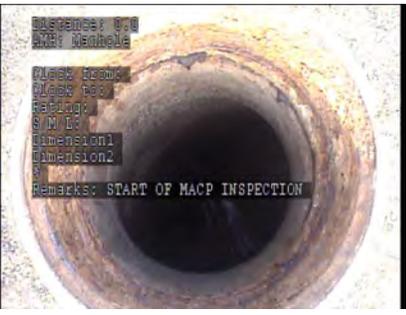
Distance	Length	Code	Reversed	Clock Pos.	Severity	Rating	Category	Comment
0.0		START WITH FLOW	No	/				
0.0		AMH	No	/				START OF MACP INSPECTION

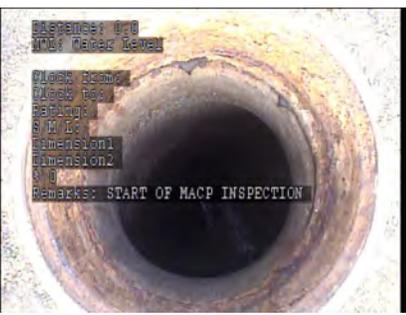
0.0		MWL	No	/				START OF MACP INSPECTION

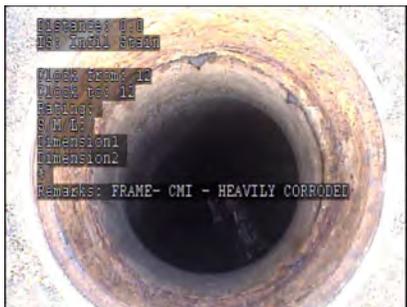
Distance	Length	Code	Reversed	Clock Pos.	Severity	Rating	Category	Comment
0.0		IS	No	12 / 12				FRAME- CMI - HEAVILY CORRODED

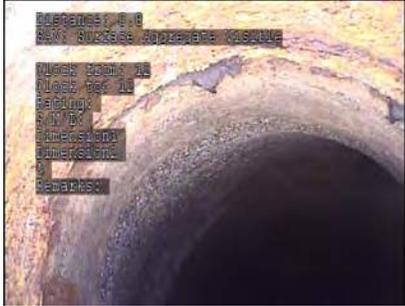
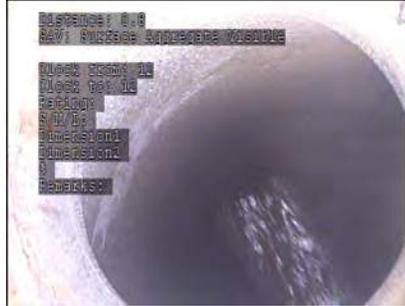
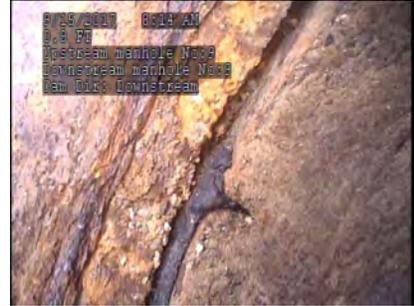
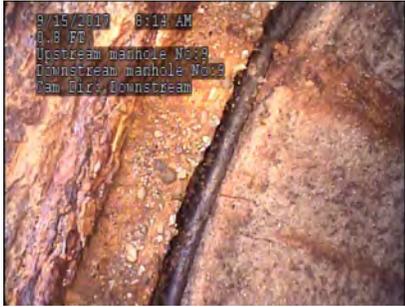
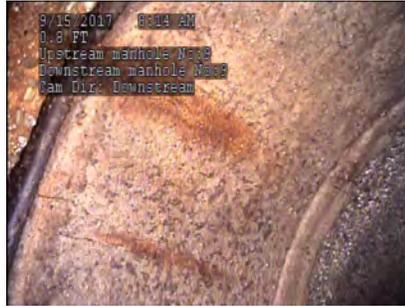
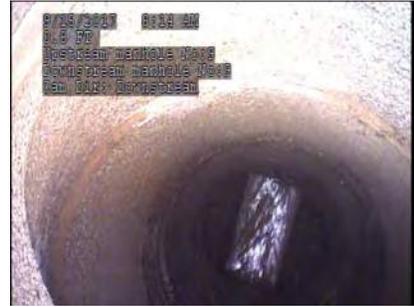
0.8	SAV	No	12 / 12				Structural	
-----	-----	----	---------	--	--	--	------------	--

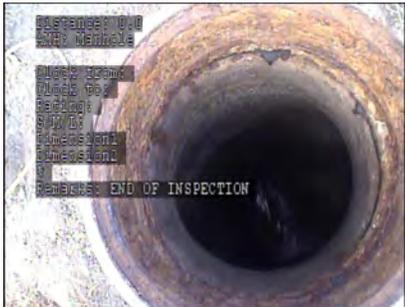
Distance	Length	Code	Reversed	Clock Pos.	Severity	Rating	Category	Comment
17.9		AMH	No	/				END OF INSPECTION

17.9		SAV	No	12 / 12			Structural	
------	--	-----	----	---------	--	--	------------	--

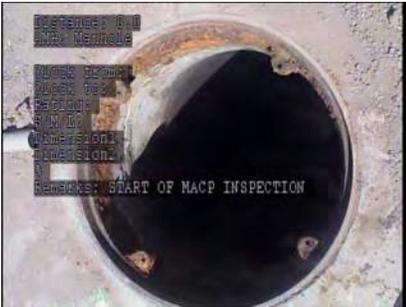
Distance	Length	Code	Reversed	Clock Pos.	Severity	Rating	Category	Comment
0.0		START WITH FLOW	No	/				
0.0		AMH	No	/				START OF MACP INSPECTION

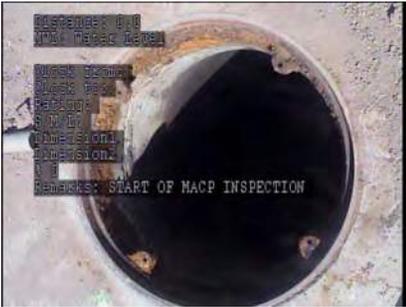
0.0		MWL	No	/				START OF MACP INSPECTION

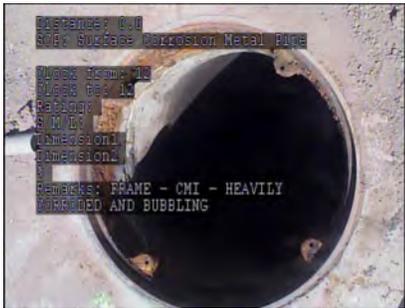
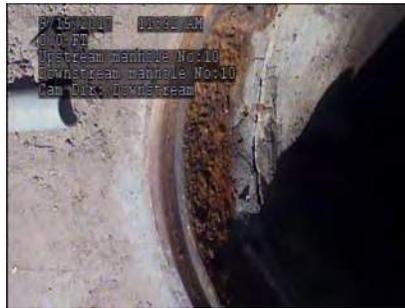
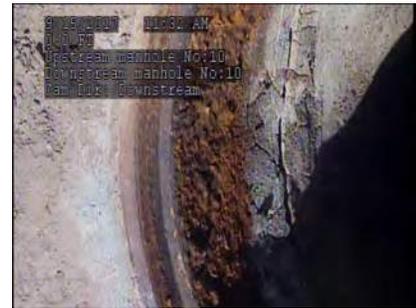
Distance	Length	Code	Reversed	Clock Pos.	Severity	Rating	Category	Comment
0.0		SCP	No	12 / 12			Structural	FRAME - CMI - HEAVILY CORRODED AND BUBBLING

0.0		MGO	No	/				MORTAR SEAL LOOSE
-----	--	-----	----	---	--	--	--	-------------------

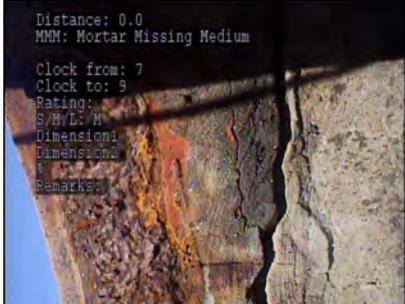
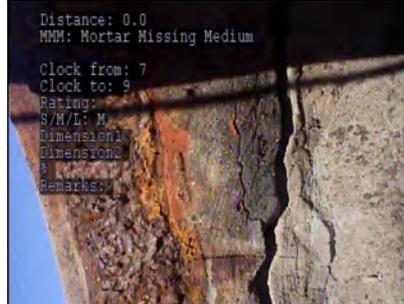
Distance	Length	Code	Reversed	Clock Pos.	Severity	Rating	Category	Comment
0.5	MMM		No	7 / 9			Structural

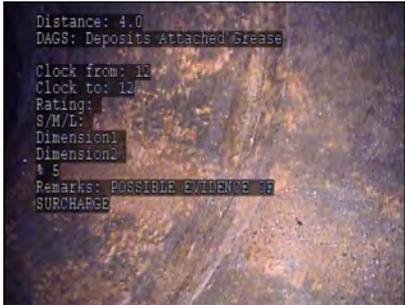
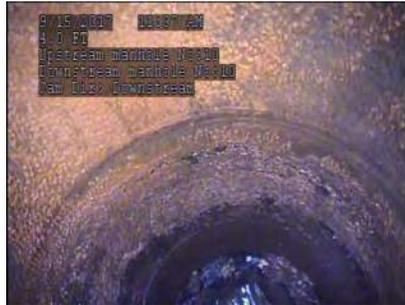
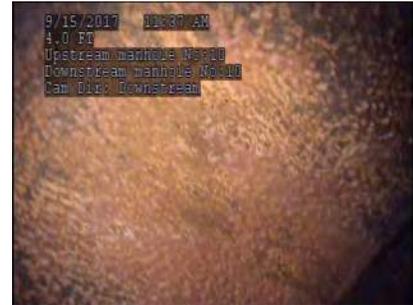
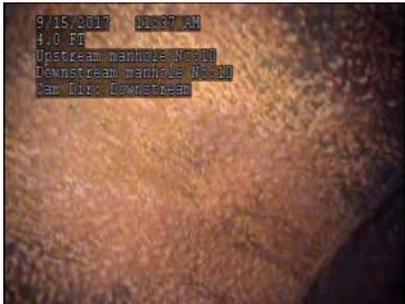
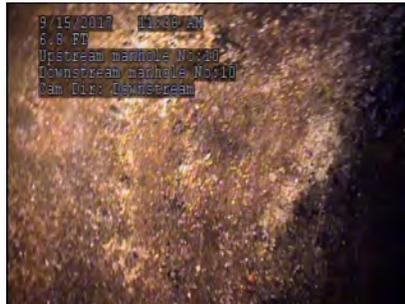
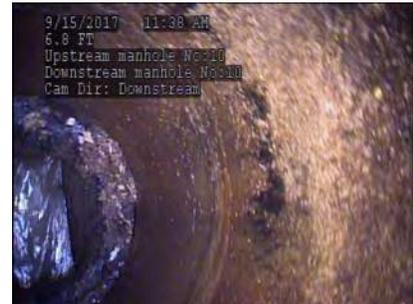
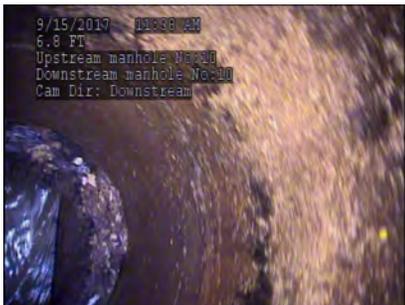
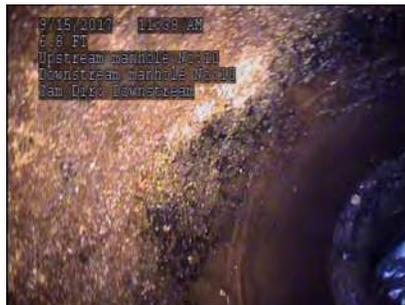
4.0		DAGS	No	12 / 12			O&M	POSSIBLE EVIDENCE OF SURCHARGE
-----	--	------	----	---------	--	--	-----	--------------------------------

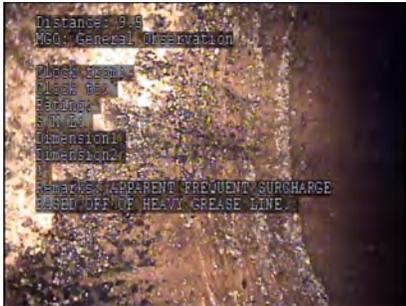
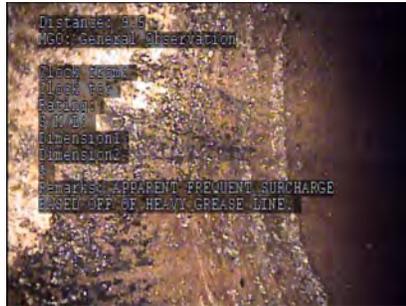
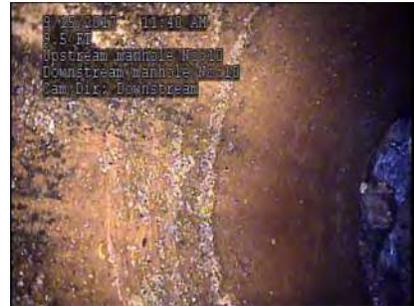
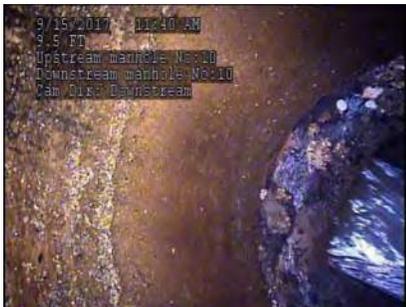
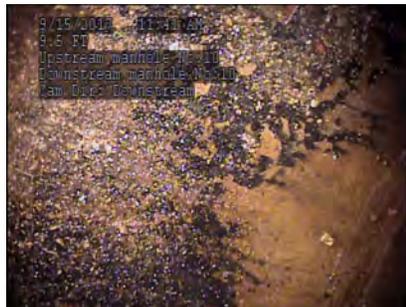
Distance	Length	Code	Reversed	Clock Pos.	Severity	Rating	Category	Comment
9.5		MGO	No	/				APPARENT FREQUENT SURCHARGE BASED OFF OF HEAVY GREASE LINE.

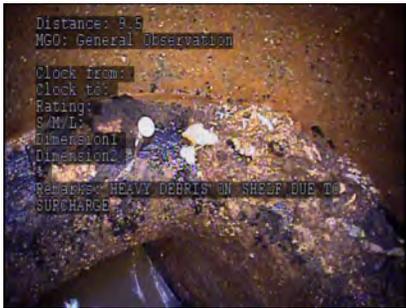
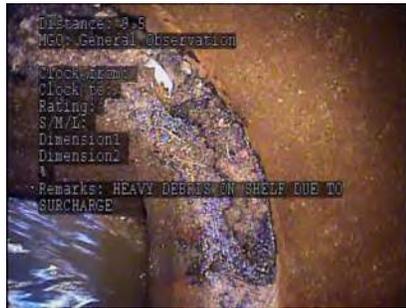
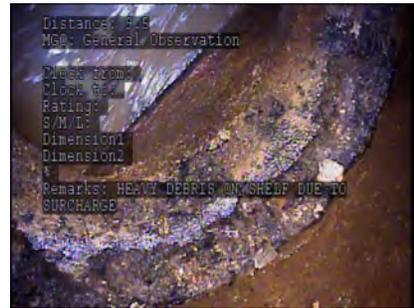
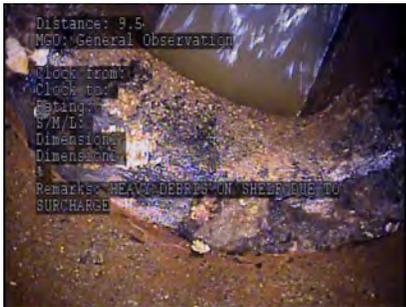
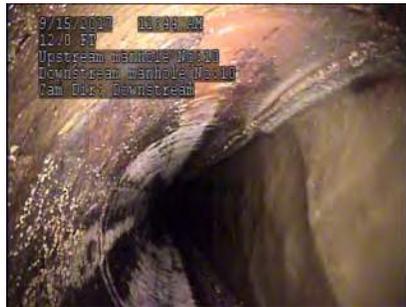
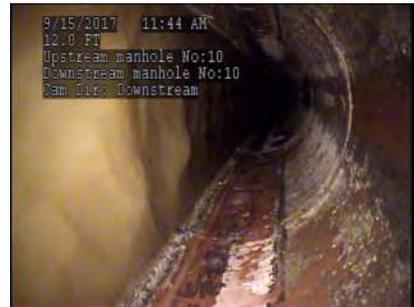
9.5		MGO	No	/				HEAVY DEBRIS ON SHELF DUE TO SURCHARGE
-----	--	-----	----	---	--	--	--	--

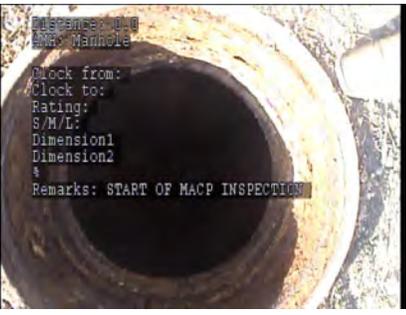
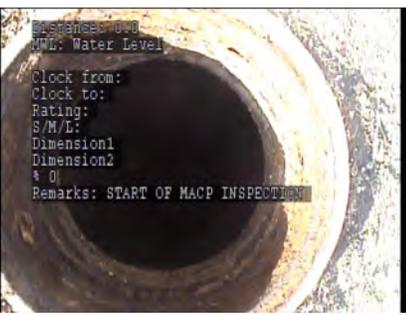
Distance	Length	Code	Reversed	Clock Pos.	Severity	Rating	Category	Comment
0.0		START WITH FLOW	No	/				
0.0		AMH	No	/				START OF MACP INSPECTION

0.0		MWL	No	/				START OF MACP INSPECTION

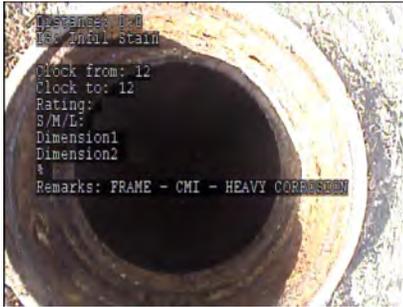
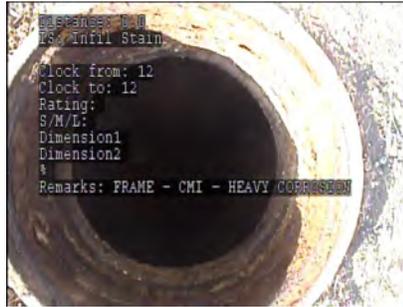
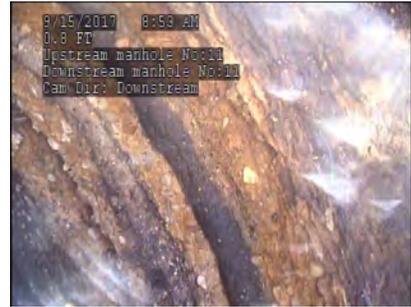
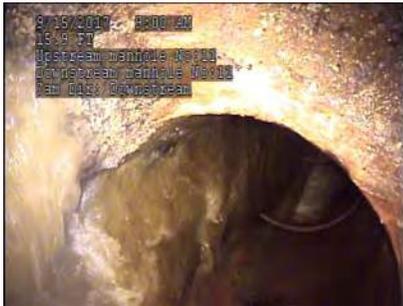
Distance	Length	Code	Reversed	Clock Pos.	Severity	Rating	Category	Comment
0.0		IS	No	12 / 12				FRAME - CMI - HEAVY CORROSION

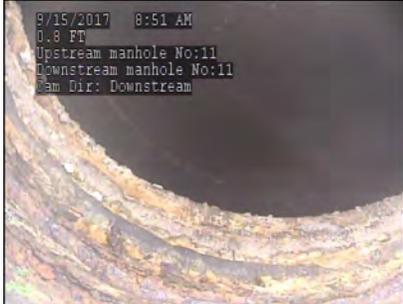
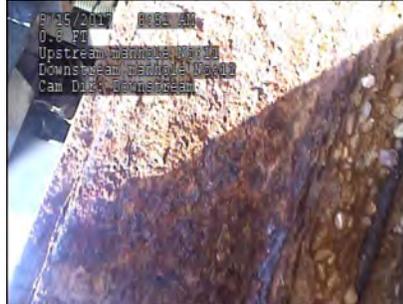
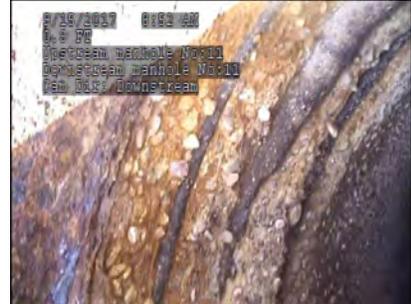
0.8 SAP No 12 / 12 Structural

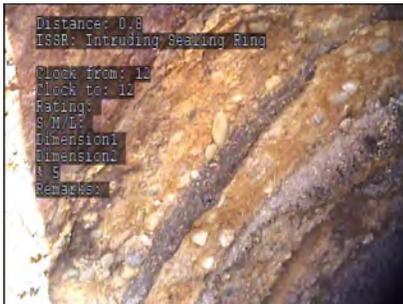
0.8 ISSR No 12 / 12 O&M

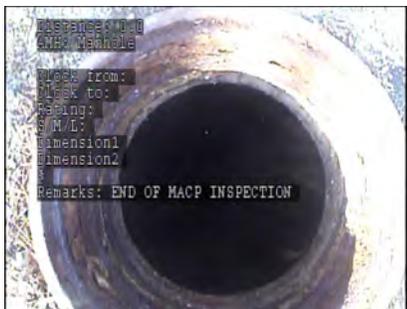
Distance	Length	Code	Reversed	Clock Pos.	Severity	Rating	Category	Comment
15.9		SAP	No	12 / 12			Structural	
15.9		ISSR	No	12 / 12			O&M	
15.9		AMH	No	/				END OF MACP INSPECTION

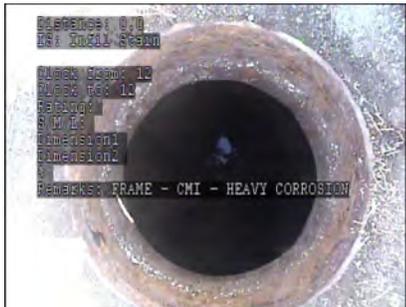
Distance	Length	Code	Reversed	Clock Pos.	Severity	Rating	Category	Comment
0.0		IS	No	12 / 12				FRAME - CMI - HEAVY CORROSION

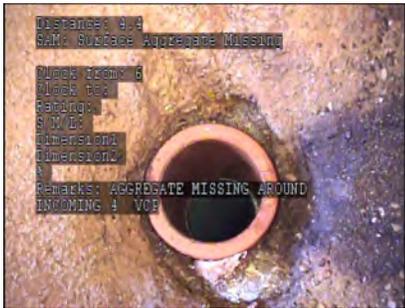
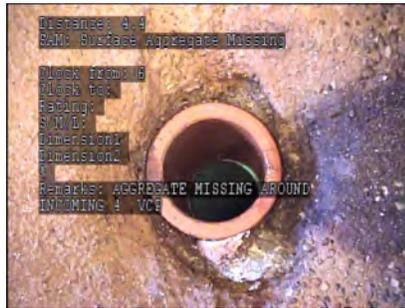
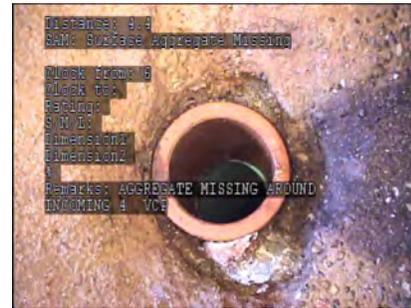
Distance	Length	Code	Reversed	Clock Pos.	Severity	Rating	Category	Comment
4.4		SAM	No	6 /			Structural	AGGREGATE MISSING AROUND INCOMING 4" VCP

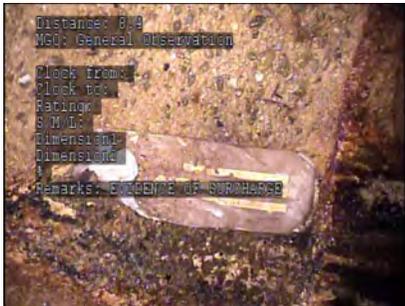
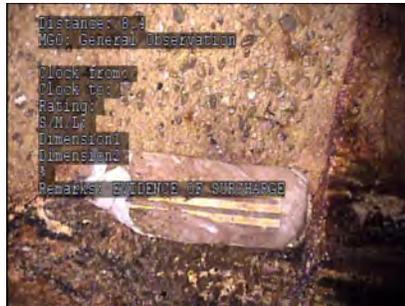
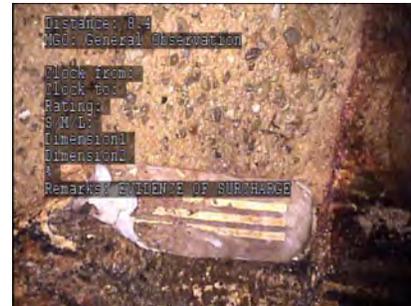
8.4		MGO	No	/				EVIDENCE OF SURCHARGE
-----	--	-----	----	---	--	--	--	-----------------------

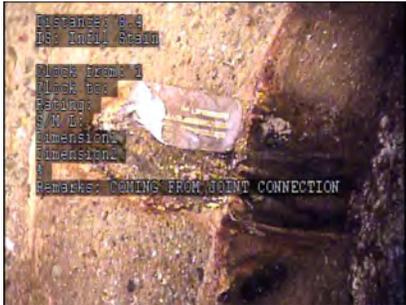
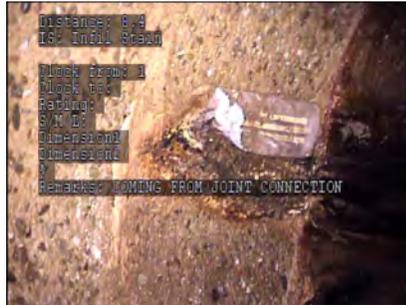
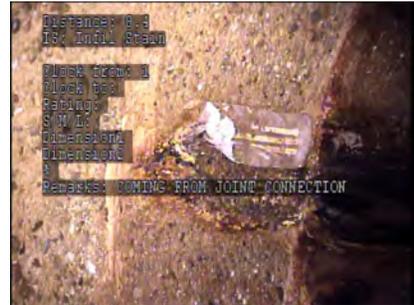
Distance	Length	Code	Reversed	Clock Pos.	Severity	Rating	Category	Comment
8.4		IS	No	1 /				COMING FROM JOINT CONNECTION

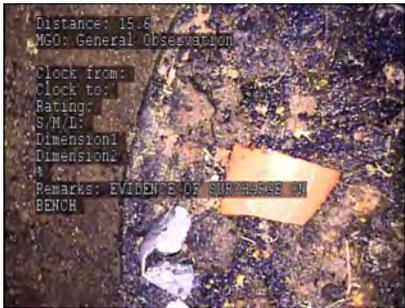
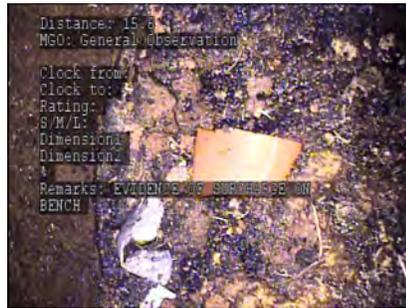
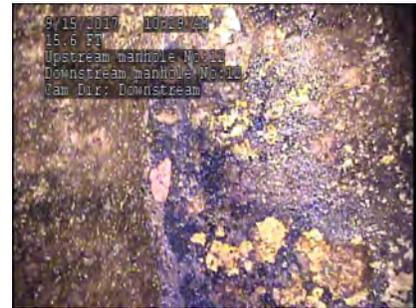
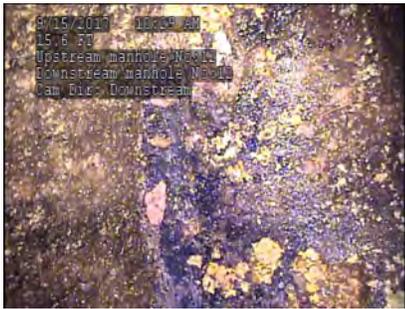
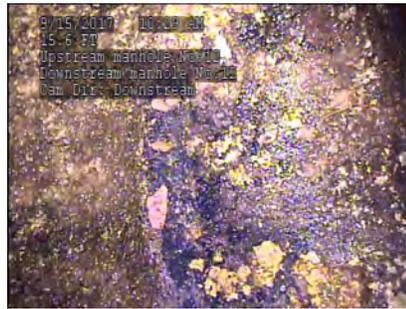
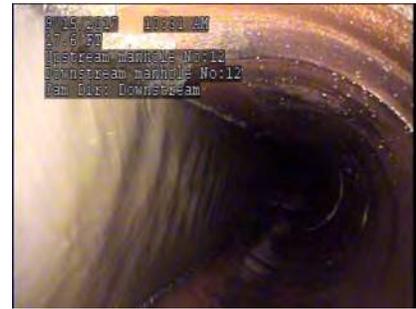
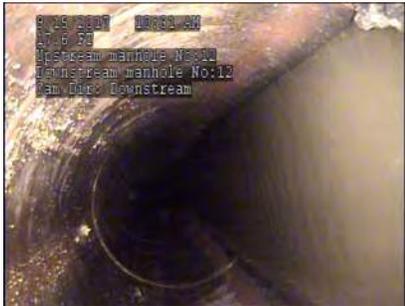
15.6		MGO	No	/				EVIDENCE OF SURCHARGE ON BENCH
------	--	-----	----	---	--	--	--	--------------------------------

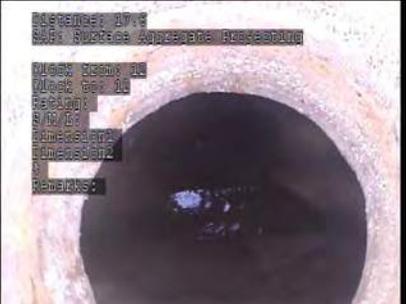
Distance	Length	Code	Reversed	Clock Pos.	Severity	Rating	Category	Comment
17.6		SAP	No	12 / 12			Structural

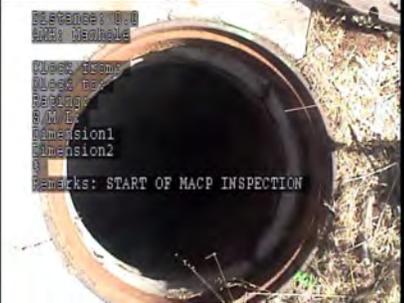
Distance	Length	Code	Reversed	Clock Pos.	Severity	Rating	Category	Comment
0.0		START WITH FLOW	No	/				
0.0		AMH	No	/				START OF MACP INSPECTION

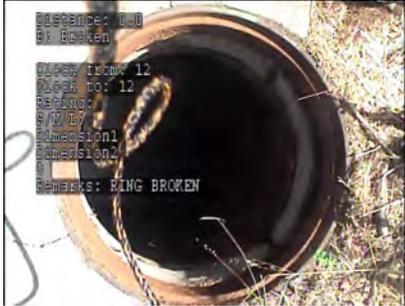
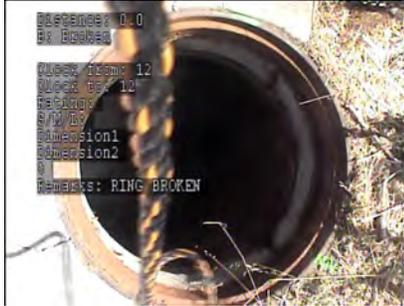
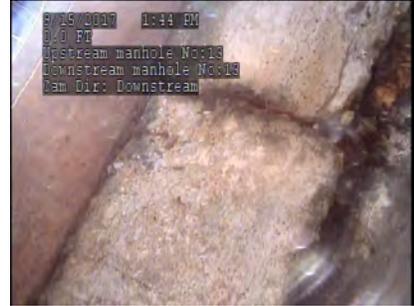
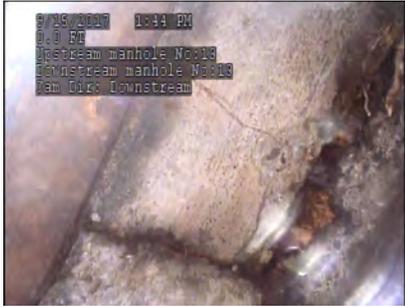
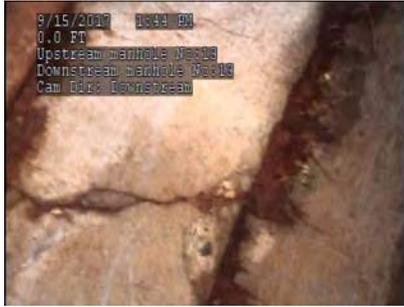
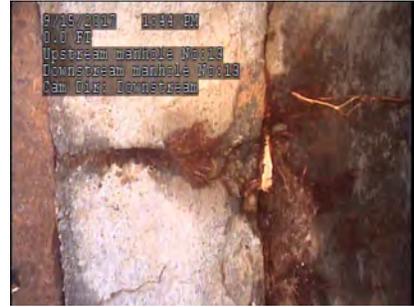
Distance	Length	Code	Reversed	Clock Pos.	Severity	Rating	Category	Comment
0.5	B		No	12 / 12			Structural	RING BROKEN

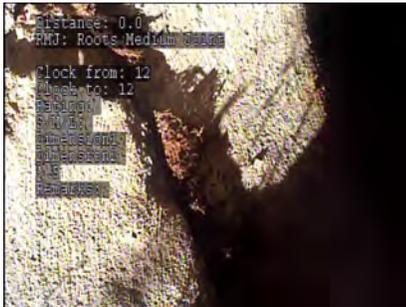
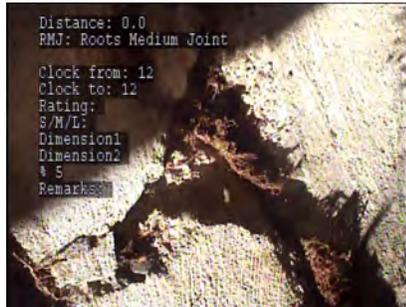
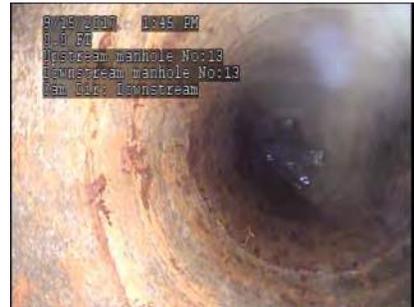
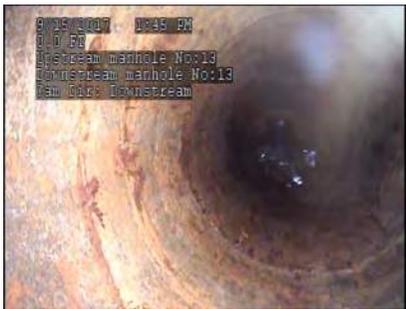
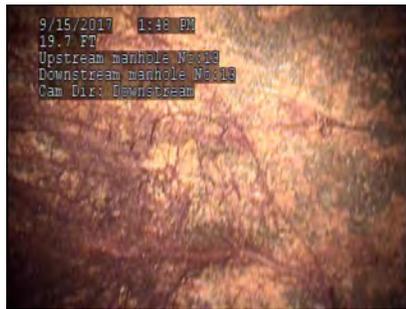
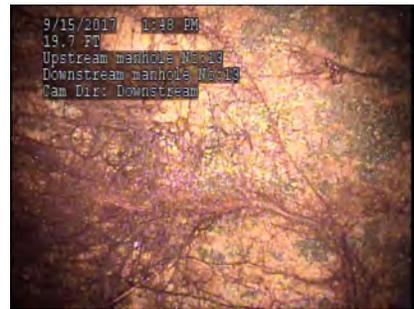
0.5		RMJ	No	12 / 12			O&M	
-----	--	-----	----	---------	--	--	-----	--

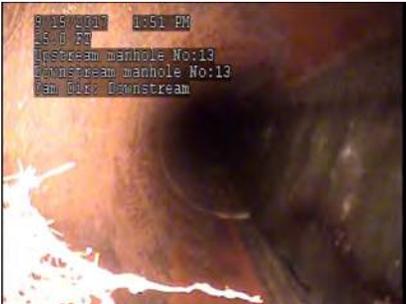
25.0		RMJ	No	12 / 12			O&M

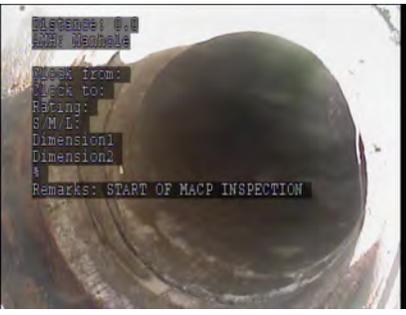
Distance	Length	Code	Reversed	Clock Pos.	Severity	Rating	Category	Comment
0.0		START WITH FLOW	No	/				
0.0		AMH	No	/				START OF MACP INSPECTION

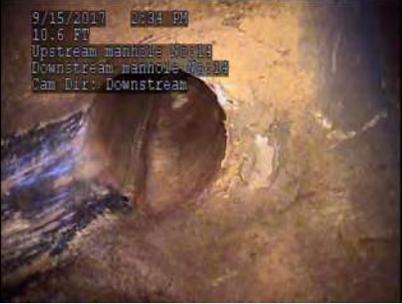
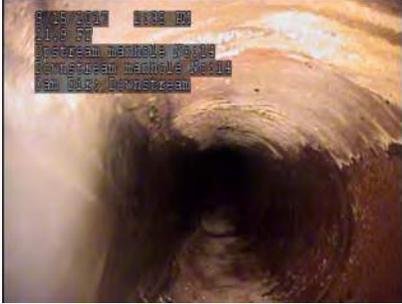
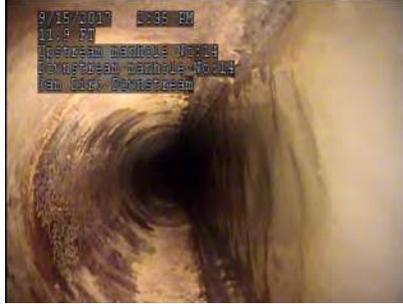
Distance	Length	Code	Reversed	Clock Pos.	Severity	Rating	Category	Comment
1.0		MGO	No	/				CMI - GRADE RINGS NOT SEALED

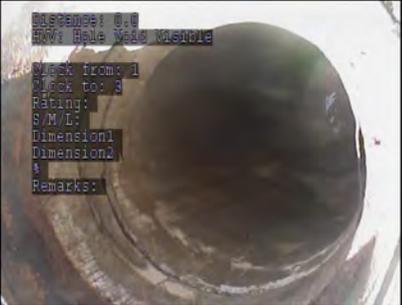
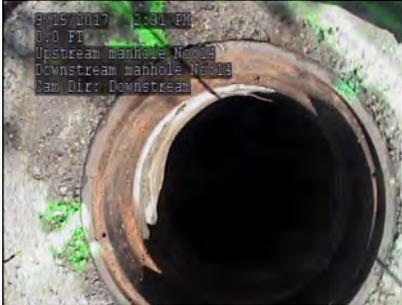
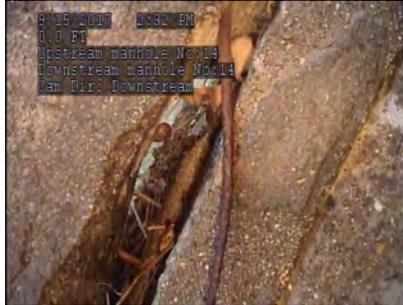
</div>								
1.0		HVV	No	1 / 3			Structural	
<div style="display: flex; justify-content: space-around;">

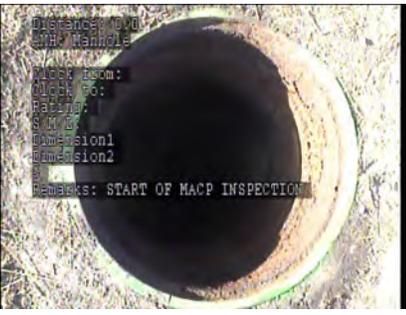
Distance	Length	Code	Reversed	Clock Pos.	Severity	Rating	Category	Comment
0.0		START WITH FLOW	No	/				
0.0		AMH	No	/				START OF MACP INSPECTION

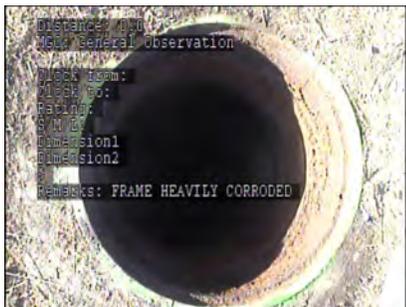
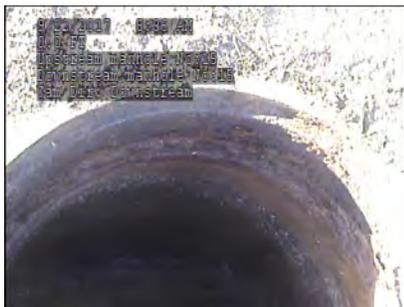
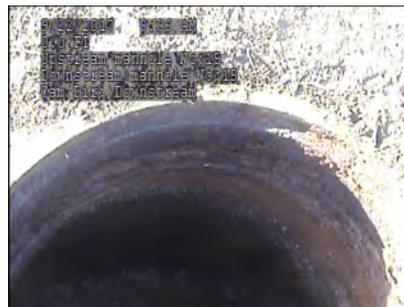
Distance	Length	Code	Reversed	Clock Pos.	Severity	Rating	Category	Comment
0.0		MGO	No	/				FRAME HEAVILY CORRODED

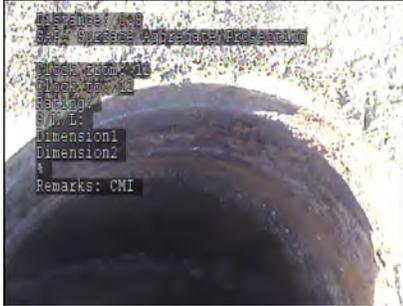
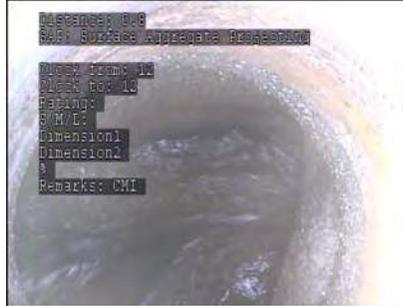
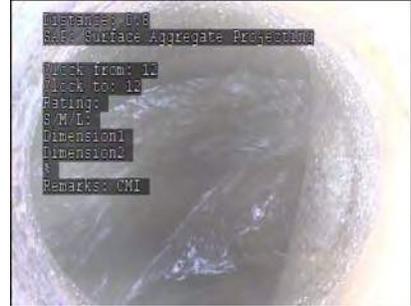
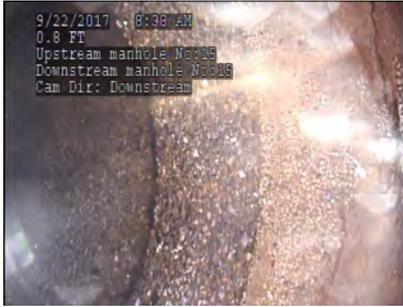
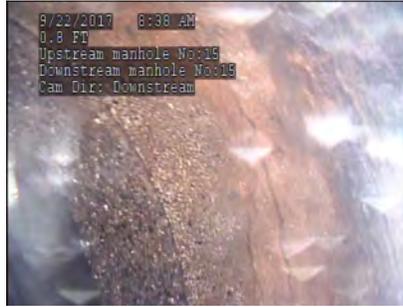
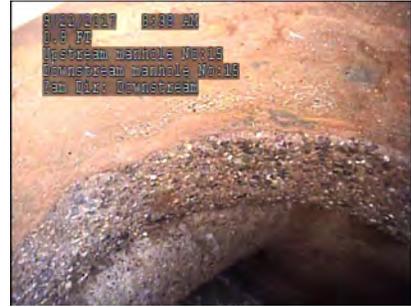
Distance	Length	Code	Reversed	Clock Pos.	Severity	Rating	Category	Comment
0.8		SAP	No	12 / 12			Structural	CMI

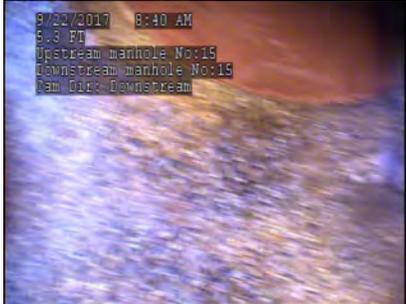
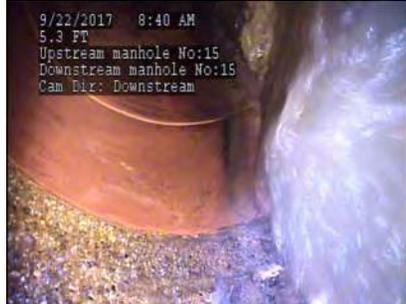
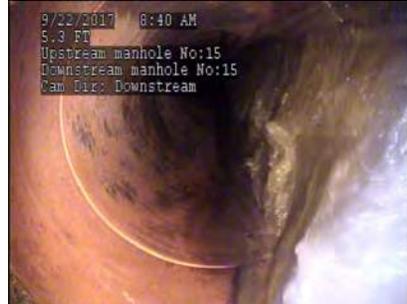
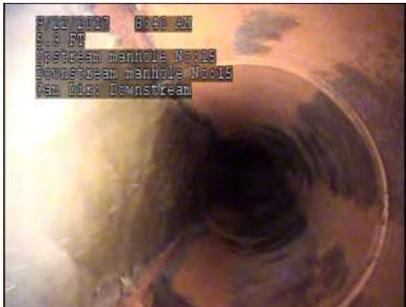
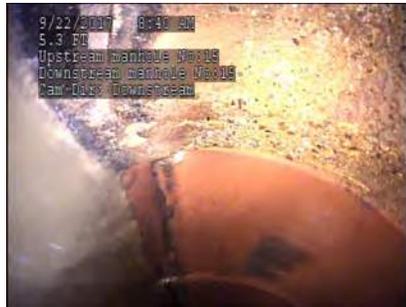
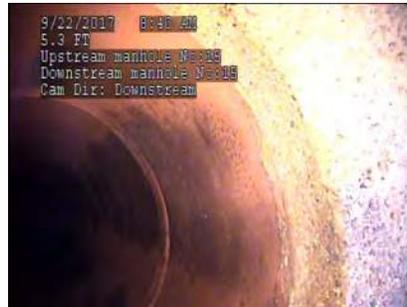
Distance	Length	Code	Reversed	Clock Pos.	Severity	Rating	Category	Comment
5.3		SAP	No	12 / 12			Structural	CMI - CHANNEL
5.3		AMH	No	/				END OF MACP INSPECTION
5.3		STOP	No	/

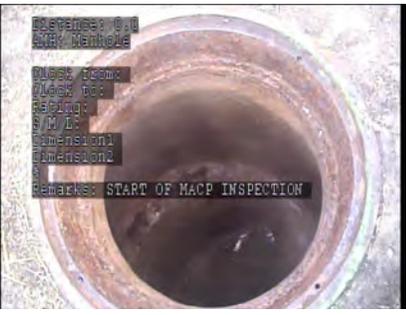
Distance	Length	Code	Reversed	Clock Pos.	Severity	Rating	Category	Comment
0.0		START WITH FLOW	No	/				
0.0		AMH	No	/				START OF MACP INSPECTION

0.0		MWL	No	/				START OF MACP INSPECTION

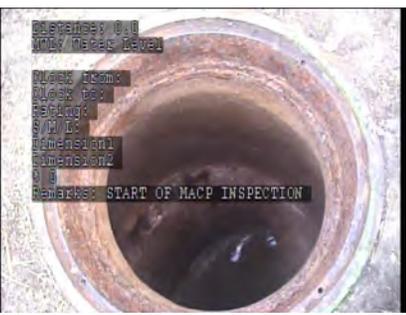
Distance	Length	Code	Reversed	Clock Pos.	Severity	Rating	Category	Comment
0.0		MGO	No	/				FRAME HEAVILY CORRODED
0.8		DAGS	No	12 / 12			O&M	GREASY FILM COVERING ENTIRE MANHOLE.

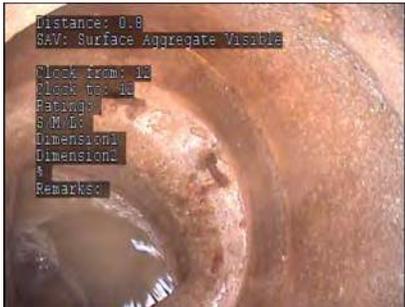
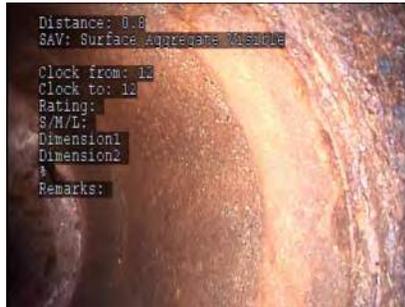
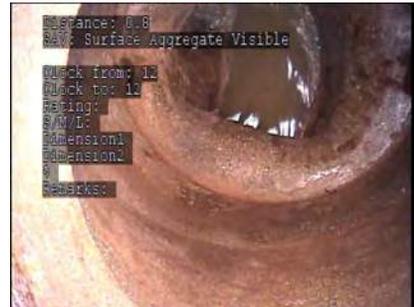
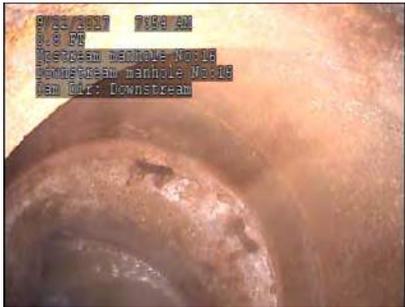
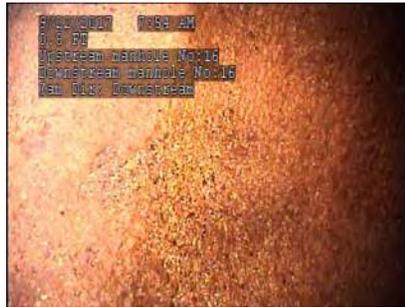
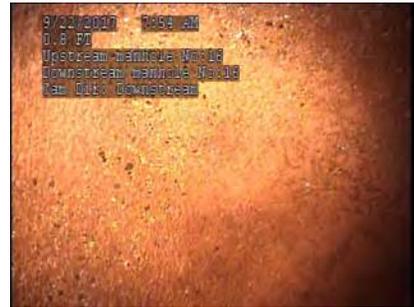
Distance	Length	Code	Reversed	Clock Pos.	Severity	Rating	Category	Comment
0.8	SAV	No		12 / 12			Structural

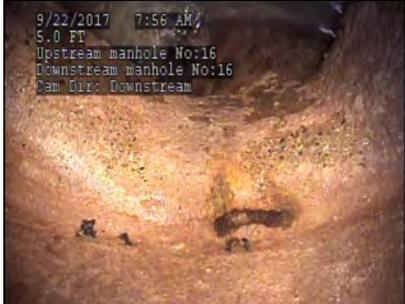
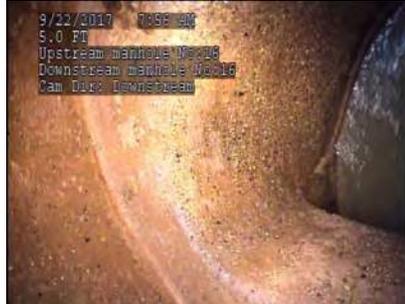
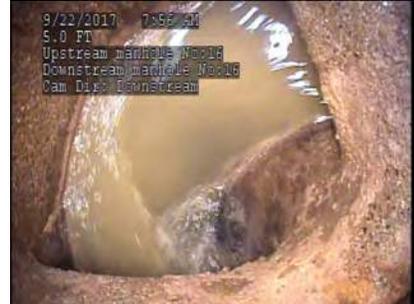
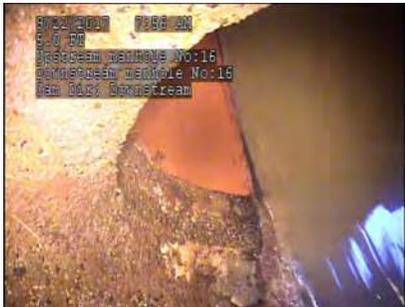
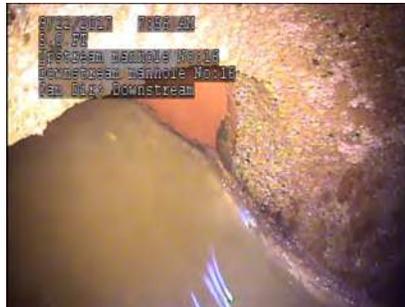
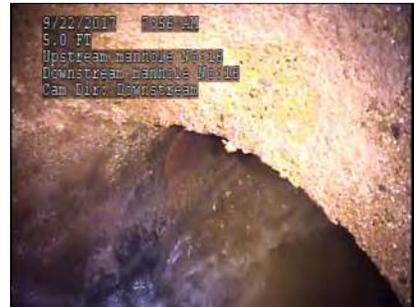
Distance	Length	Code	Reversed	Clock Pos.	Severity	Rating	Category	Comment
8.7		DAGS	No	12 / 12			O&M	CMI - CHANNEL
8.7		SAV	No	12 / 12			Structural	CMI - CHANNEL

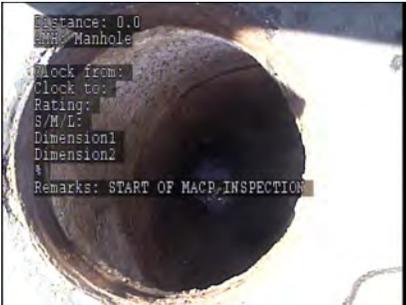
Distance	Length	Code	Reversed	Clock Pos.	Severity	Rating	Category	Comment
0.0		START WITH FLOW	No	/				
0.0		AMH	No	/				START OF MACP INSPECTION

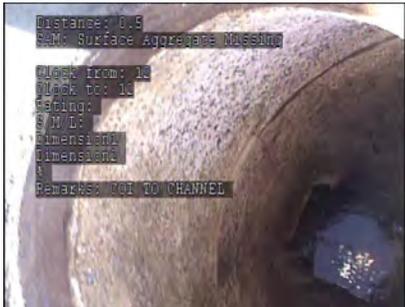
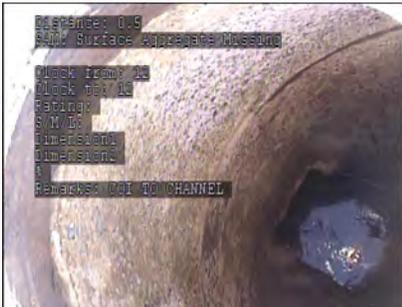
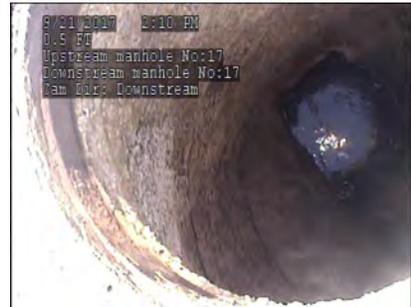
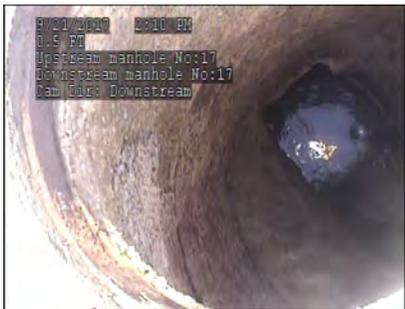
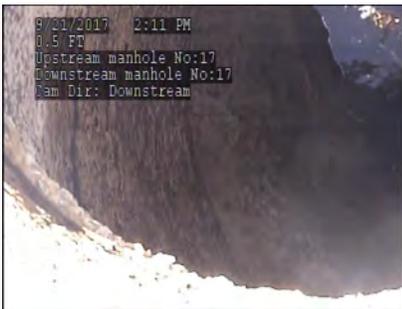
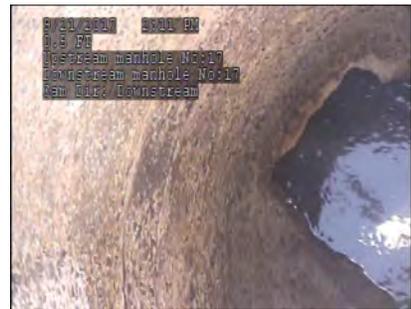
Distance	Length	Code	Reversed	Clock Pos.	Severity	Rating	Category	Comment
0.5		SAM	No	12 / 12			Structural	COI TO CHANNEL

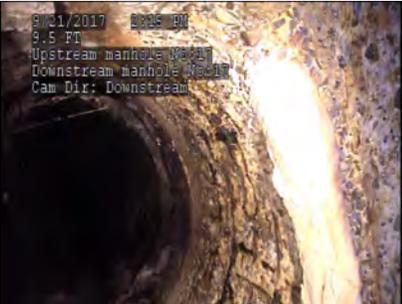
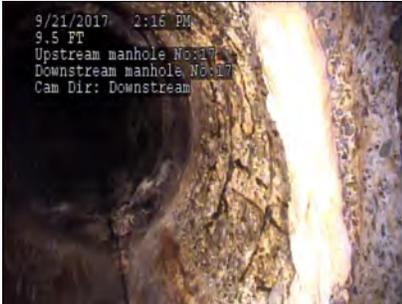
Distance	Length	Code	Reversed	Clock Pos.	Severity	Rating	Category	Comment
9.5		MGO	No	/				EXPOSED REBAR

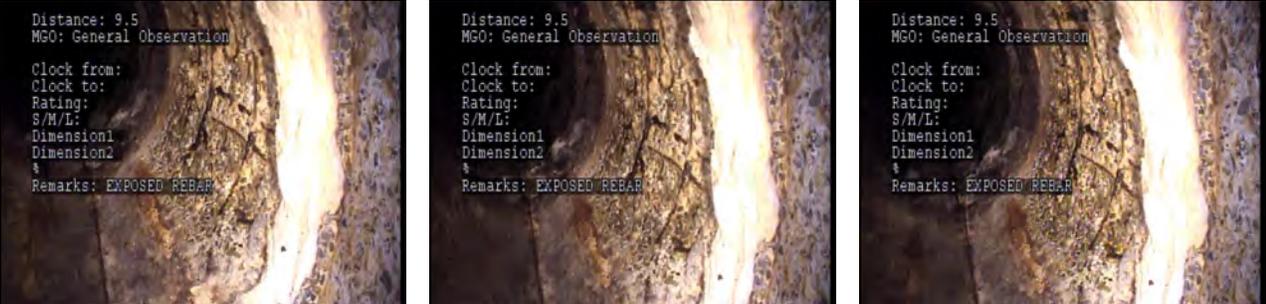
9.5		AMH	No	/				END OF MACP INSPECTION

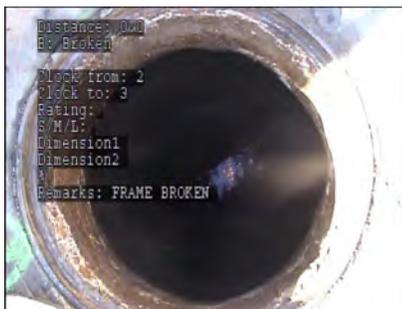
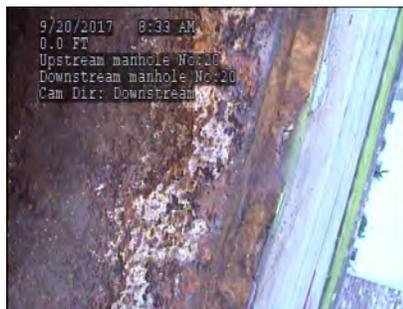
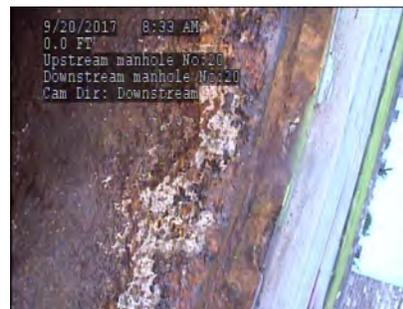
Distance	Length	Code	Reversed	Clock Pos.	Severity	Rating	Category	Comment
0.0	B		No	2 / 3			Structural	FRAME BROKEN

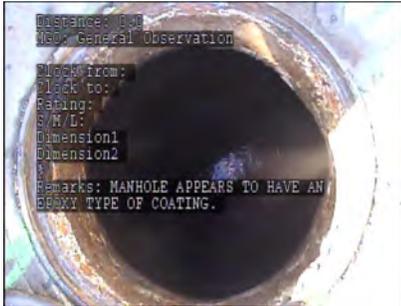
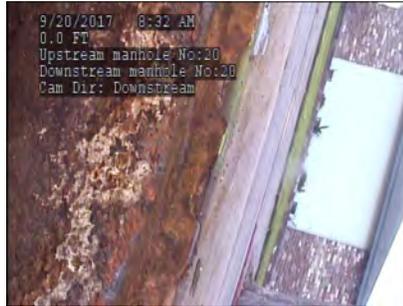
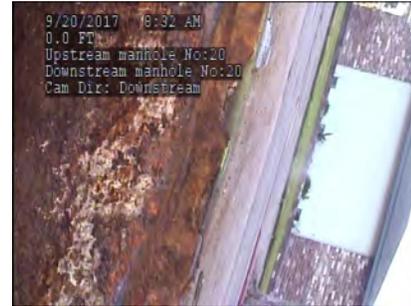
0.0		MGO	No	/				MANHOLE APPEARS TO HAVE AN EPOXY TYPE OF COATING.
-----	--	-----	----	---	--	--	--	---
