Final City of Salinas Sanitary Sewer Master Plan Update

City of Salinas
Final Sanitary Sewer Master
Plan Update
May 2023

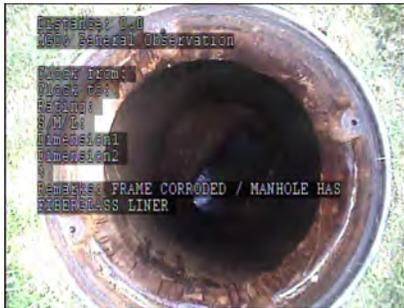
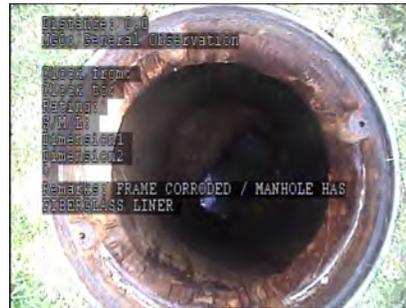
Distance	Length	Code	Reversed	Clock Pos.	Severity	Rating	Category	Comment
0.0		MGO	No	/				FRAME CORRODED / MANHOLE HAS FIBERGLASS LINER

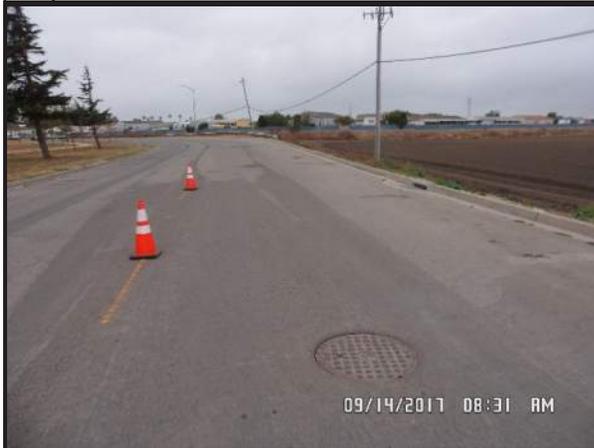
Photo SSMH - 1

Ref	Description	Remark
1	SSMH - 1	No work need at pavement surface
2	SSMH - 2	No work need at ground surface
3	SSMH - 3	No work need at pavement surface
4	SSMH - 6	Recommend PCC collar and bring MH lid 6" up & install marker
5	SSMH - 8	Redo PCC collar around the rim and install marker
6	SSMH - 9	Recommend PCC collar and bring MH lid 6" up & install marker

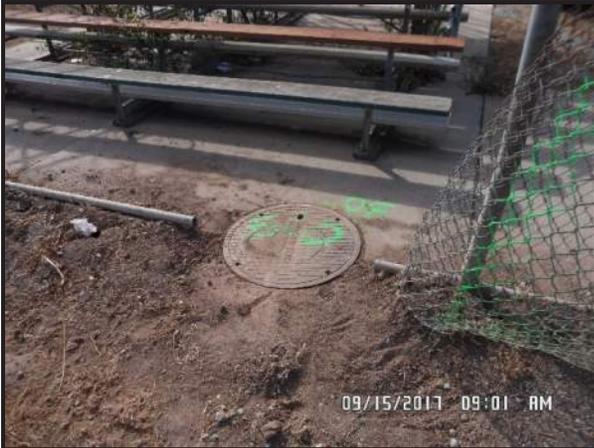
Photo SSMH - 10

Ref	Description	Remark
1	SSMH - 10	Replace exist cone with eccentric cone, MH will be outside the fence
2	SSMH - 11	Recommend PCC collar and bring MH lid 6" up & install marker
3	SSMH - 12	Recommend PCC collar and bring MH lid 6" up & install marker
4	SSMH - 13	No work need at top surface
5	SSMH - 14	Recommend PCC collar and install marker
6	SSMH - 15	Recommend PCC collar and bring MH lid 6" up slope away MH lid to prevent I/I & install marker

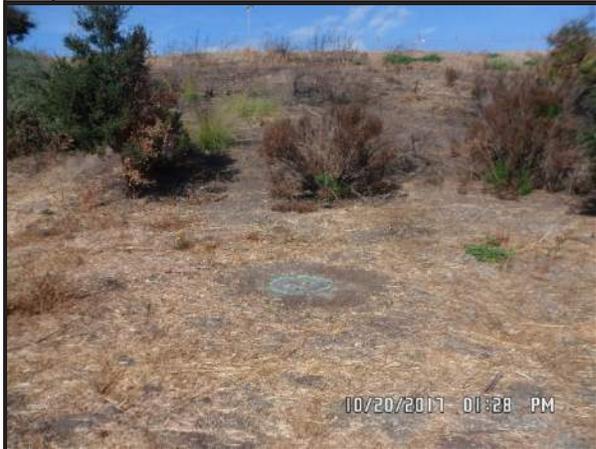
Photo SSMH – 16

Ref	Description	Remark
1	SSMH – 16	Recommend PCC collar and bring MH lid 6" up slope away MH lid to prevent I/I & install marker
2	SSMH – 17	Replace exist lid with new MH lid have an "S" stamp
3	SSMH – 18	No work need at pavement surface
4	SSMH – 19	No work need at pavement surface
5	SSMH – 20	No work need at pavement surface
6	SSMH - 21	No work need at pavement surface

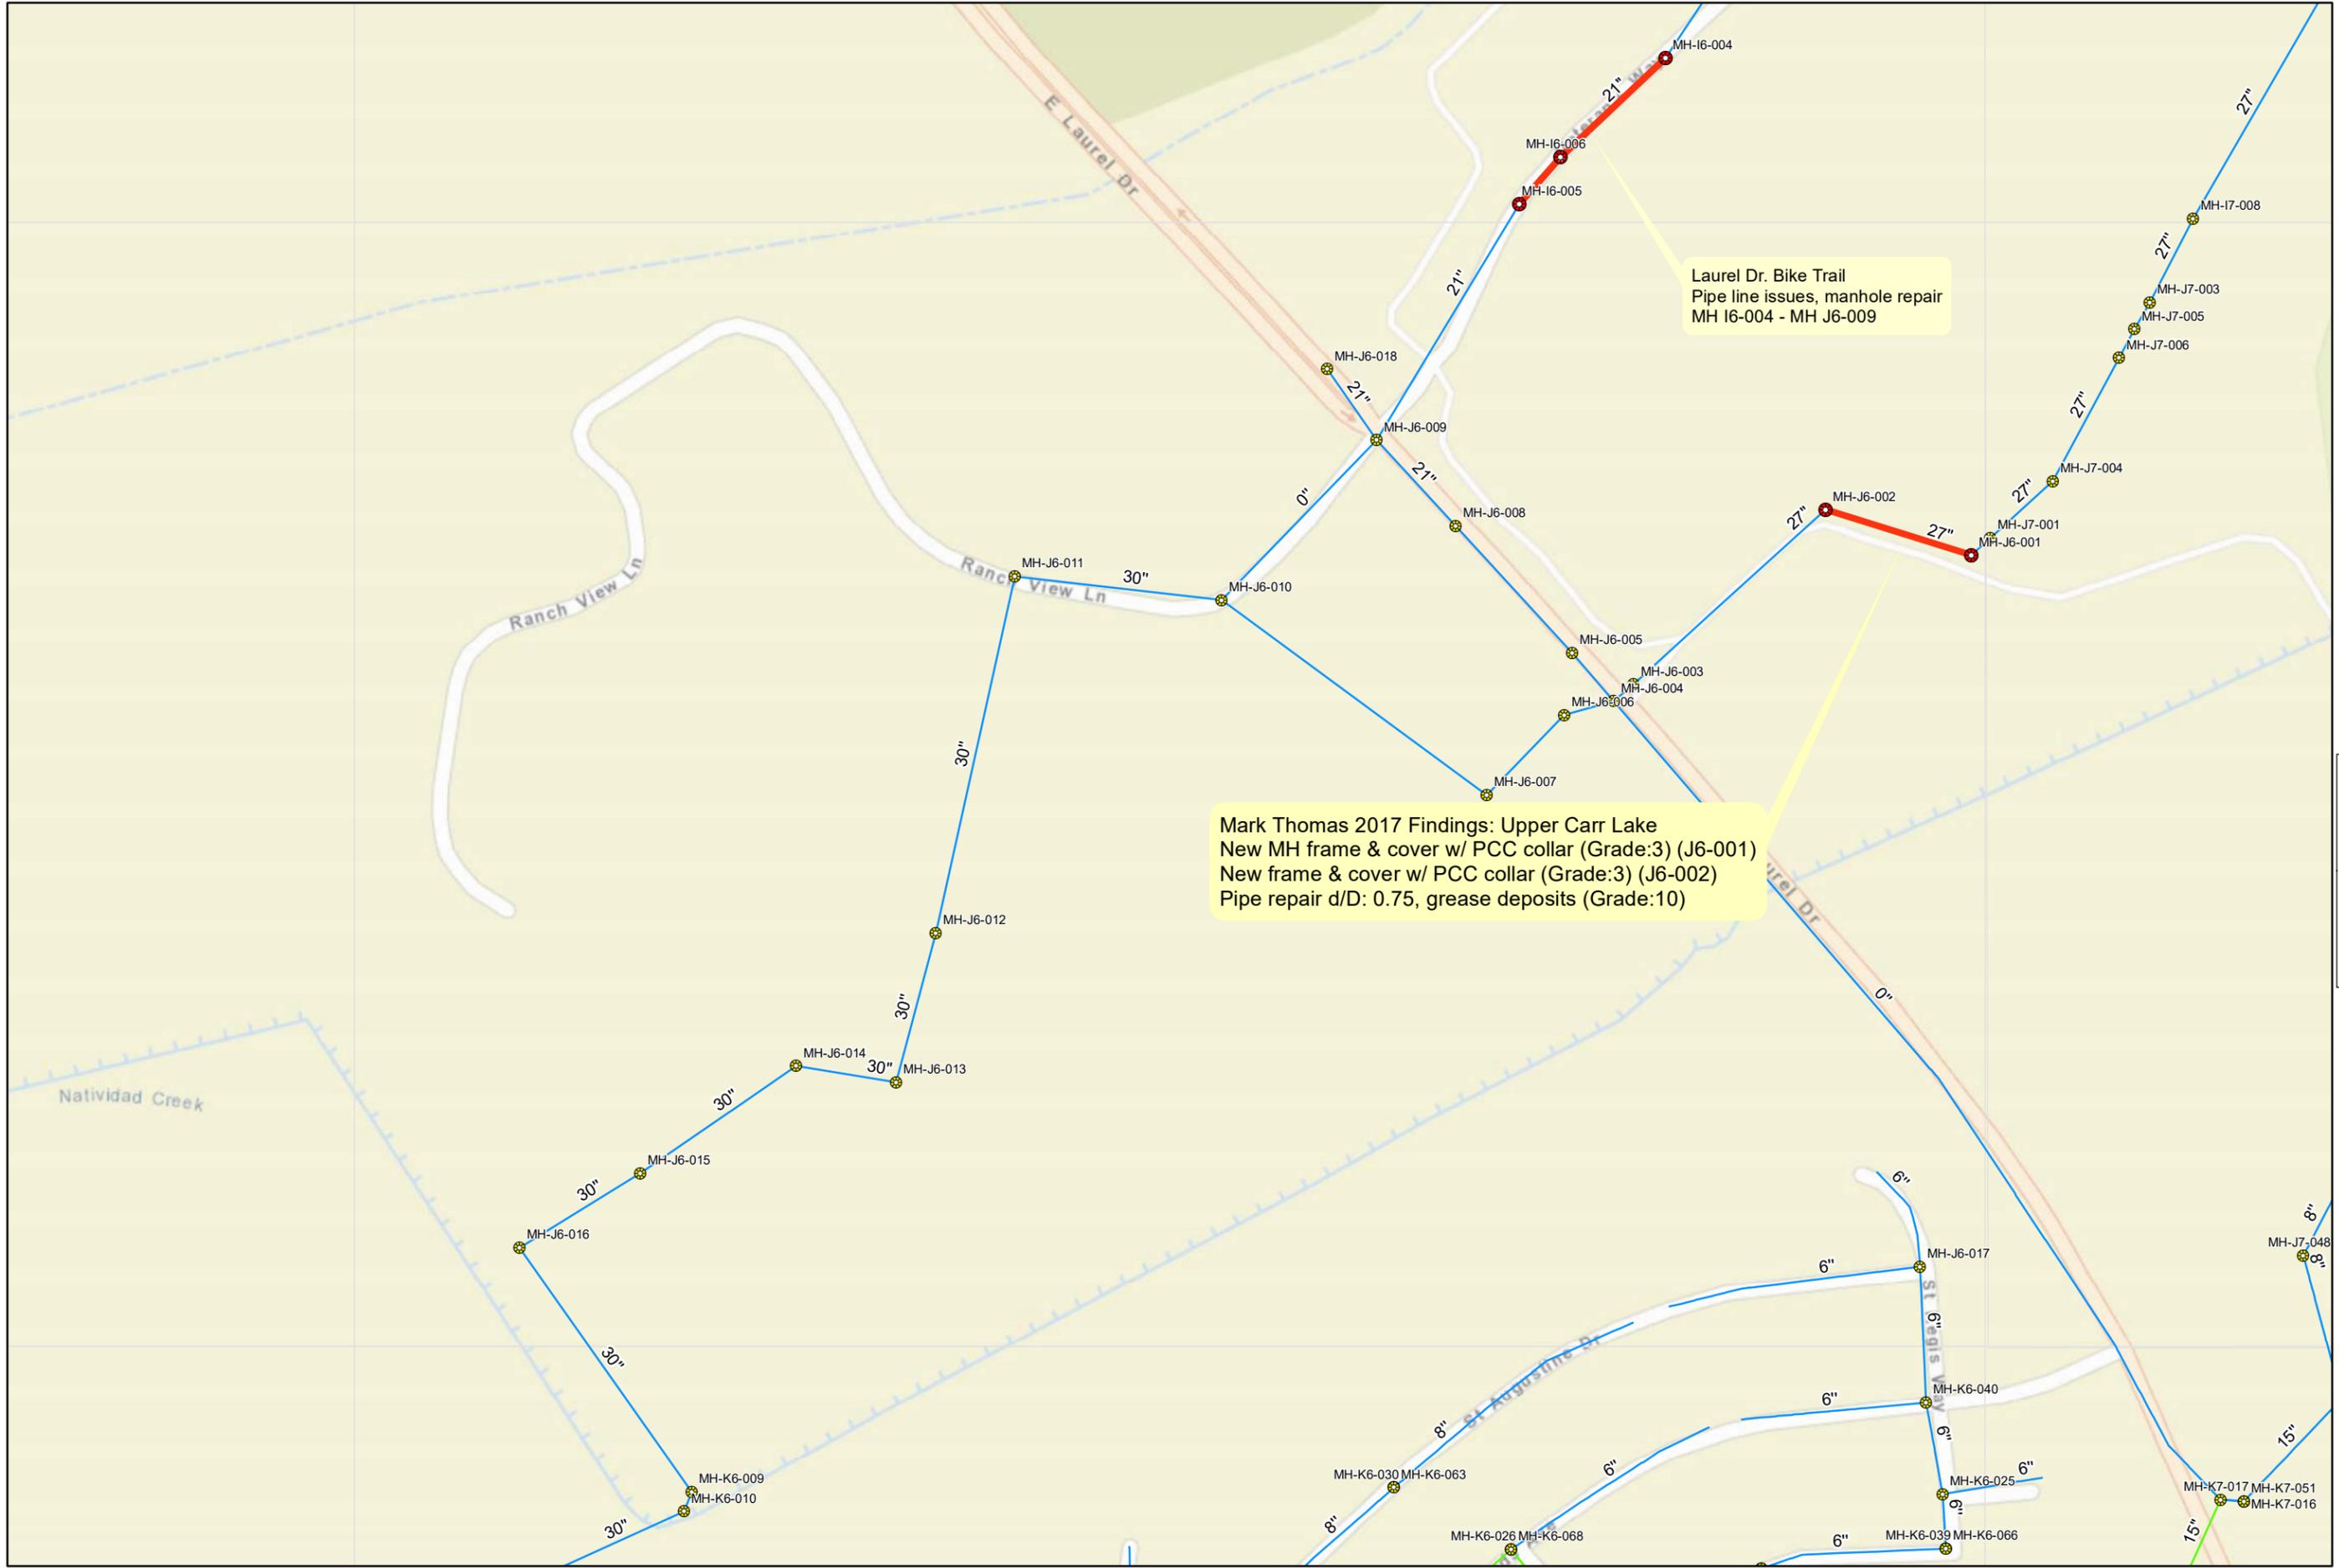
Laurel Dr. Bike Trail
 Pipe line issues, manhole repair
 MH I6-004 - MH J6-009

Mark Thomas 2017 Findings: Upper Carr Lake
 New MH frame & cover w/ PCC collar (Grade:3) (J6-001)
 New frame & cover w/ PCC collar (Grade:3) (J6-002)
 Pipe repair d/D: 0.75, grease deposits (Grade:10)

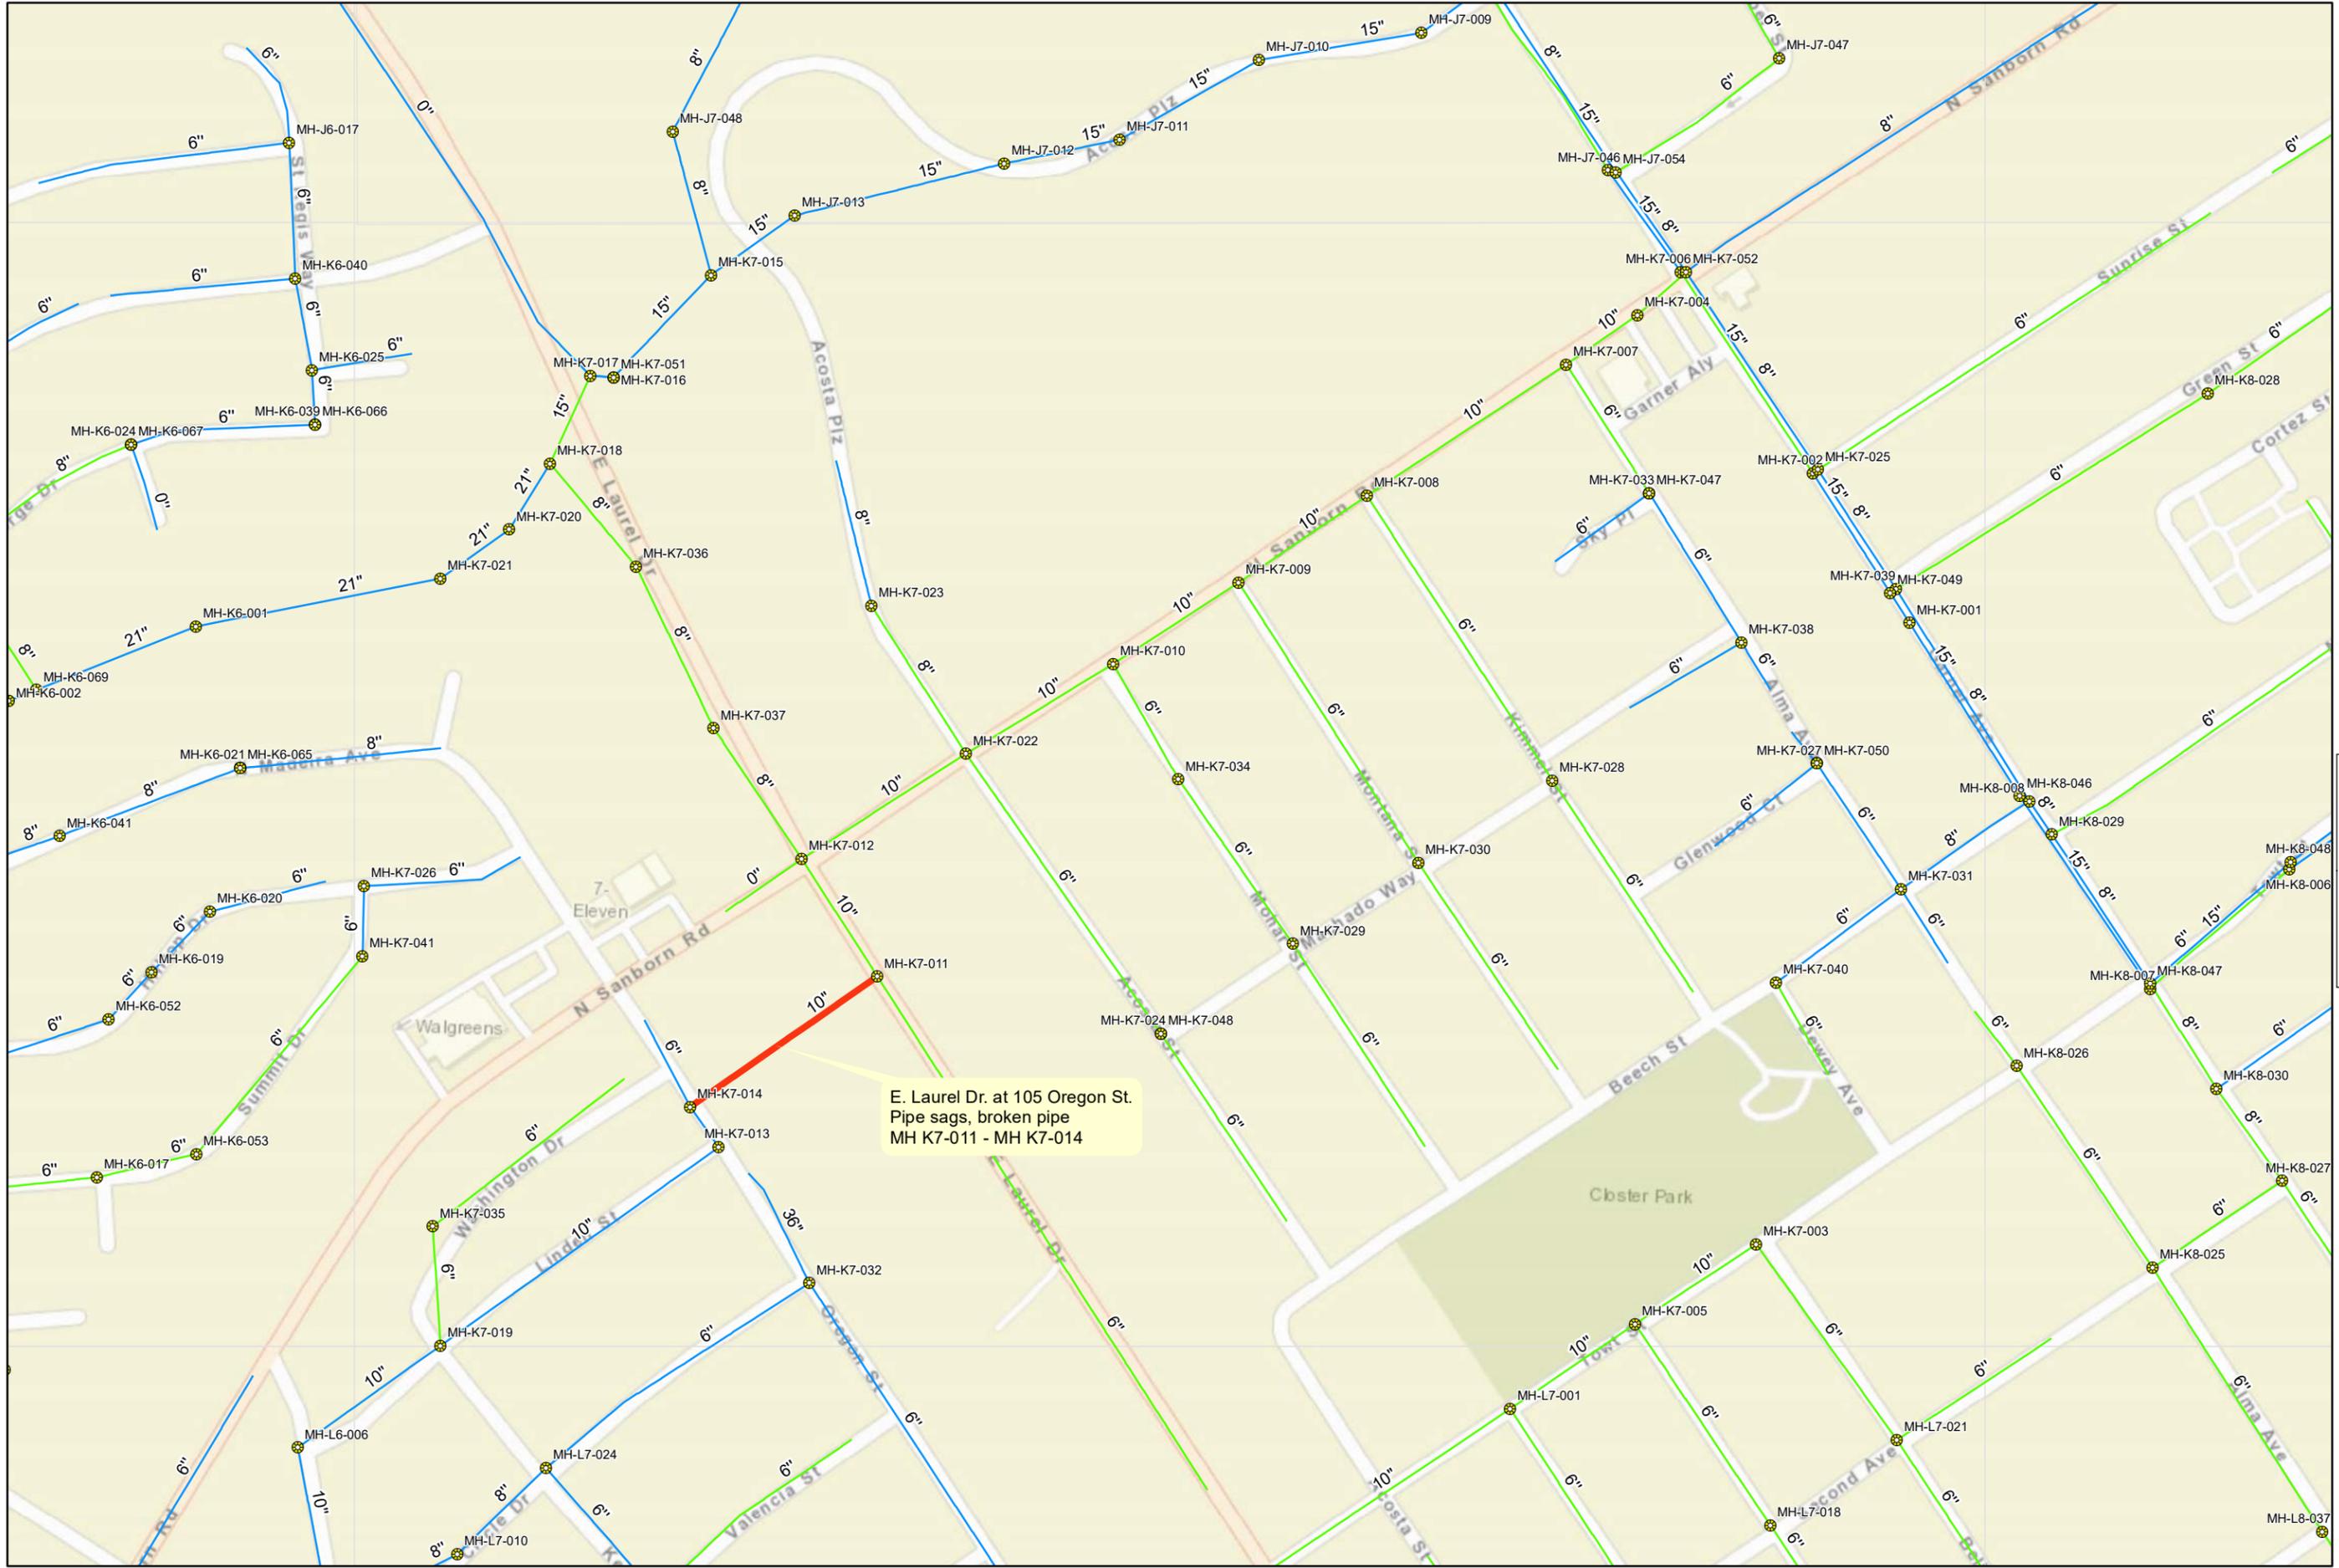
E. Laurel Dr. at 105 Oregon St.
 Pipe sags, broken pipe
 MH K7-011 - MH K7-014

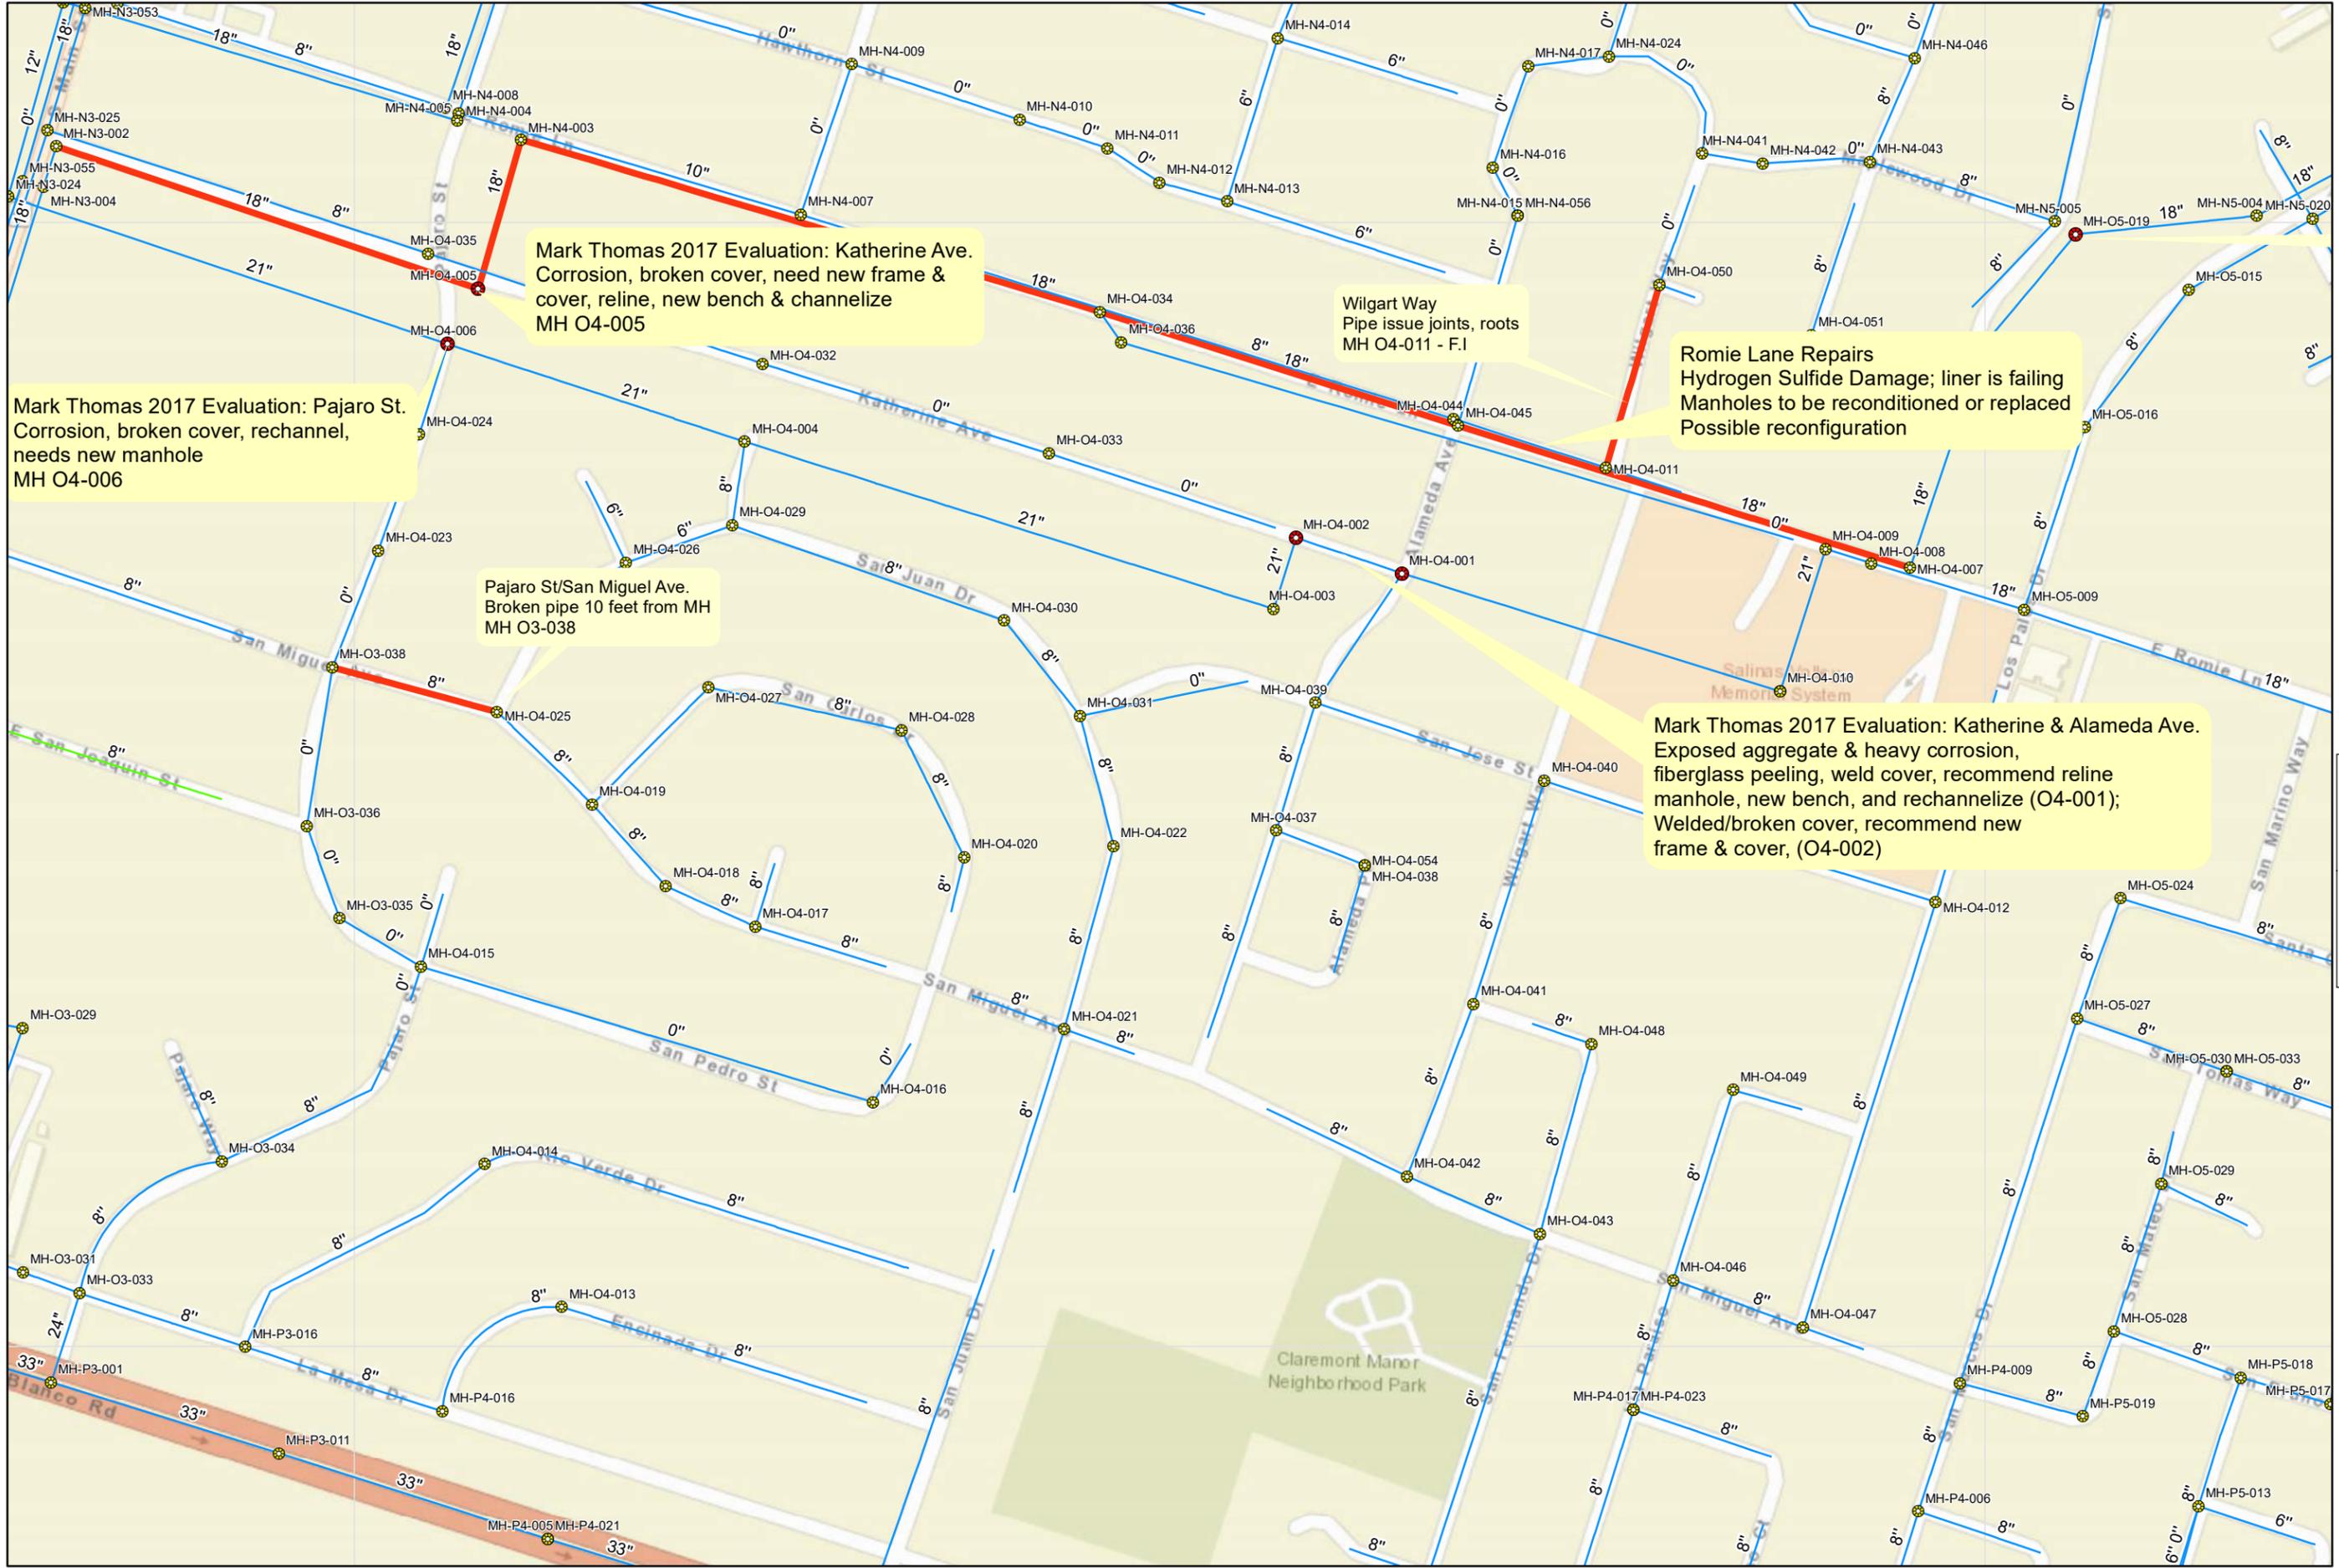
Mark Thomas 2017 Evaluation: Katherine Ave.
 Corrosion, broken cover, need new frame &
 cover, reline, new bench & channelize
 MH O4-005

Wilgart Way
 Pipe issue joints, roots
 MH O4-011 - F.I

Romie Lane Repairs
 Hydrogen Sulfide Damage; liner is failing
 Manholes to be reconditioned or replaced
 Possible reconfiguration

Mark Thomas 2017 Evaluation: Pajaro St.
 Corrosion, broken cover, rechannel,
 needs new manhole
 MH O4-006

Pajaro St/San Miguel Ave.
 Broken pipe 10 feet from MH
 MH O3-038

Mark Thomas 2017 Evaluation: Katherine & Alameda Ave.
 Exposed aggregate & heavy corrosion,
 fiberglass peeling, weld cover, recommend reline
 manhole, new bench, and rechannelize (O4-001);
 Welded/broken cover, recommend new
 frame & cover, (O4-002)

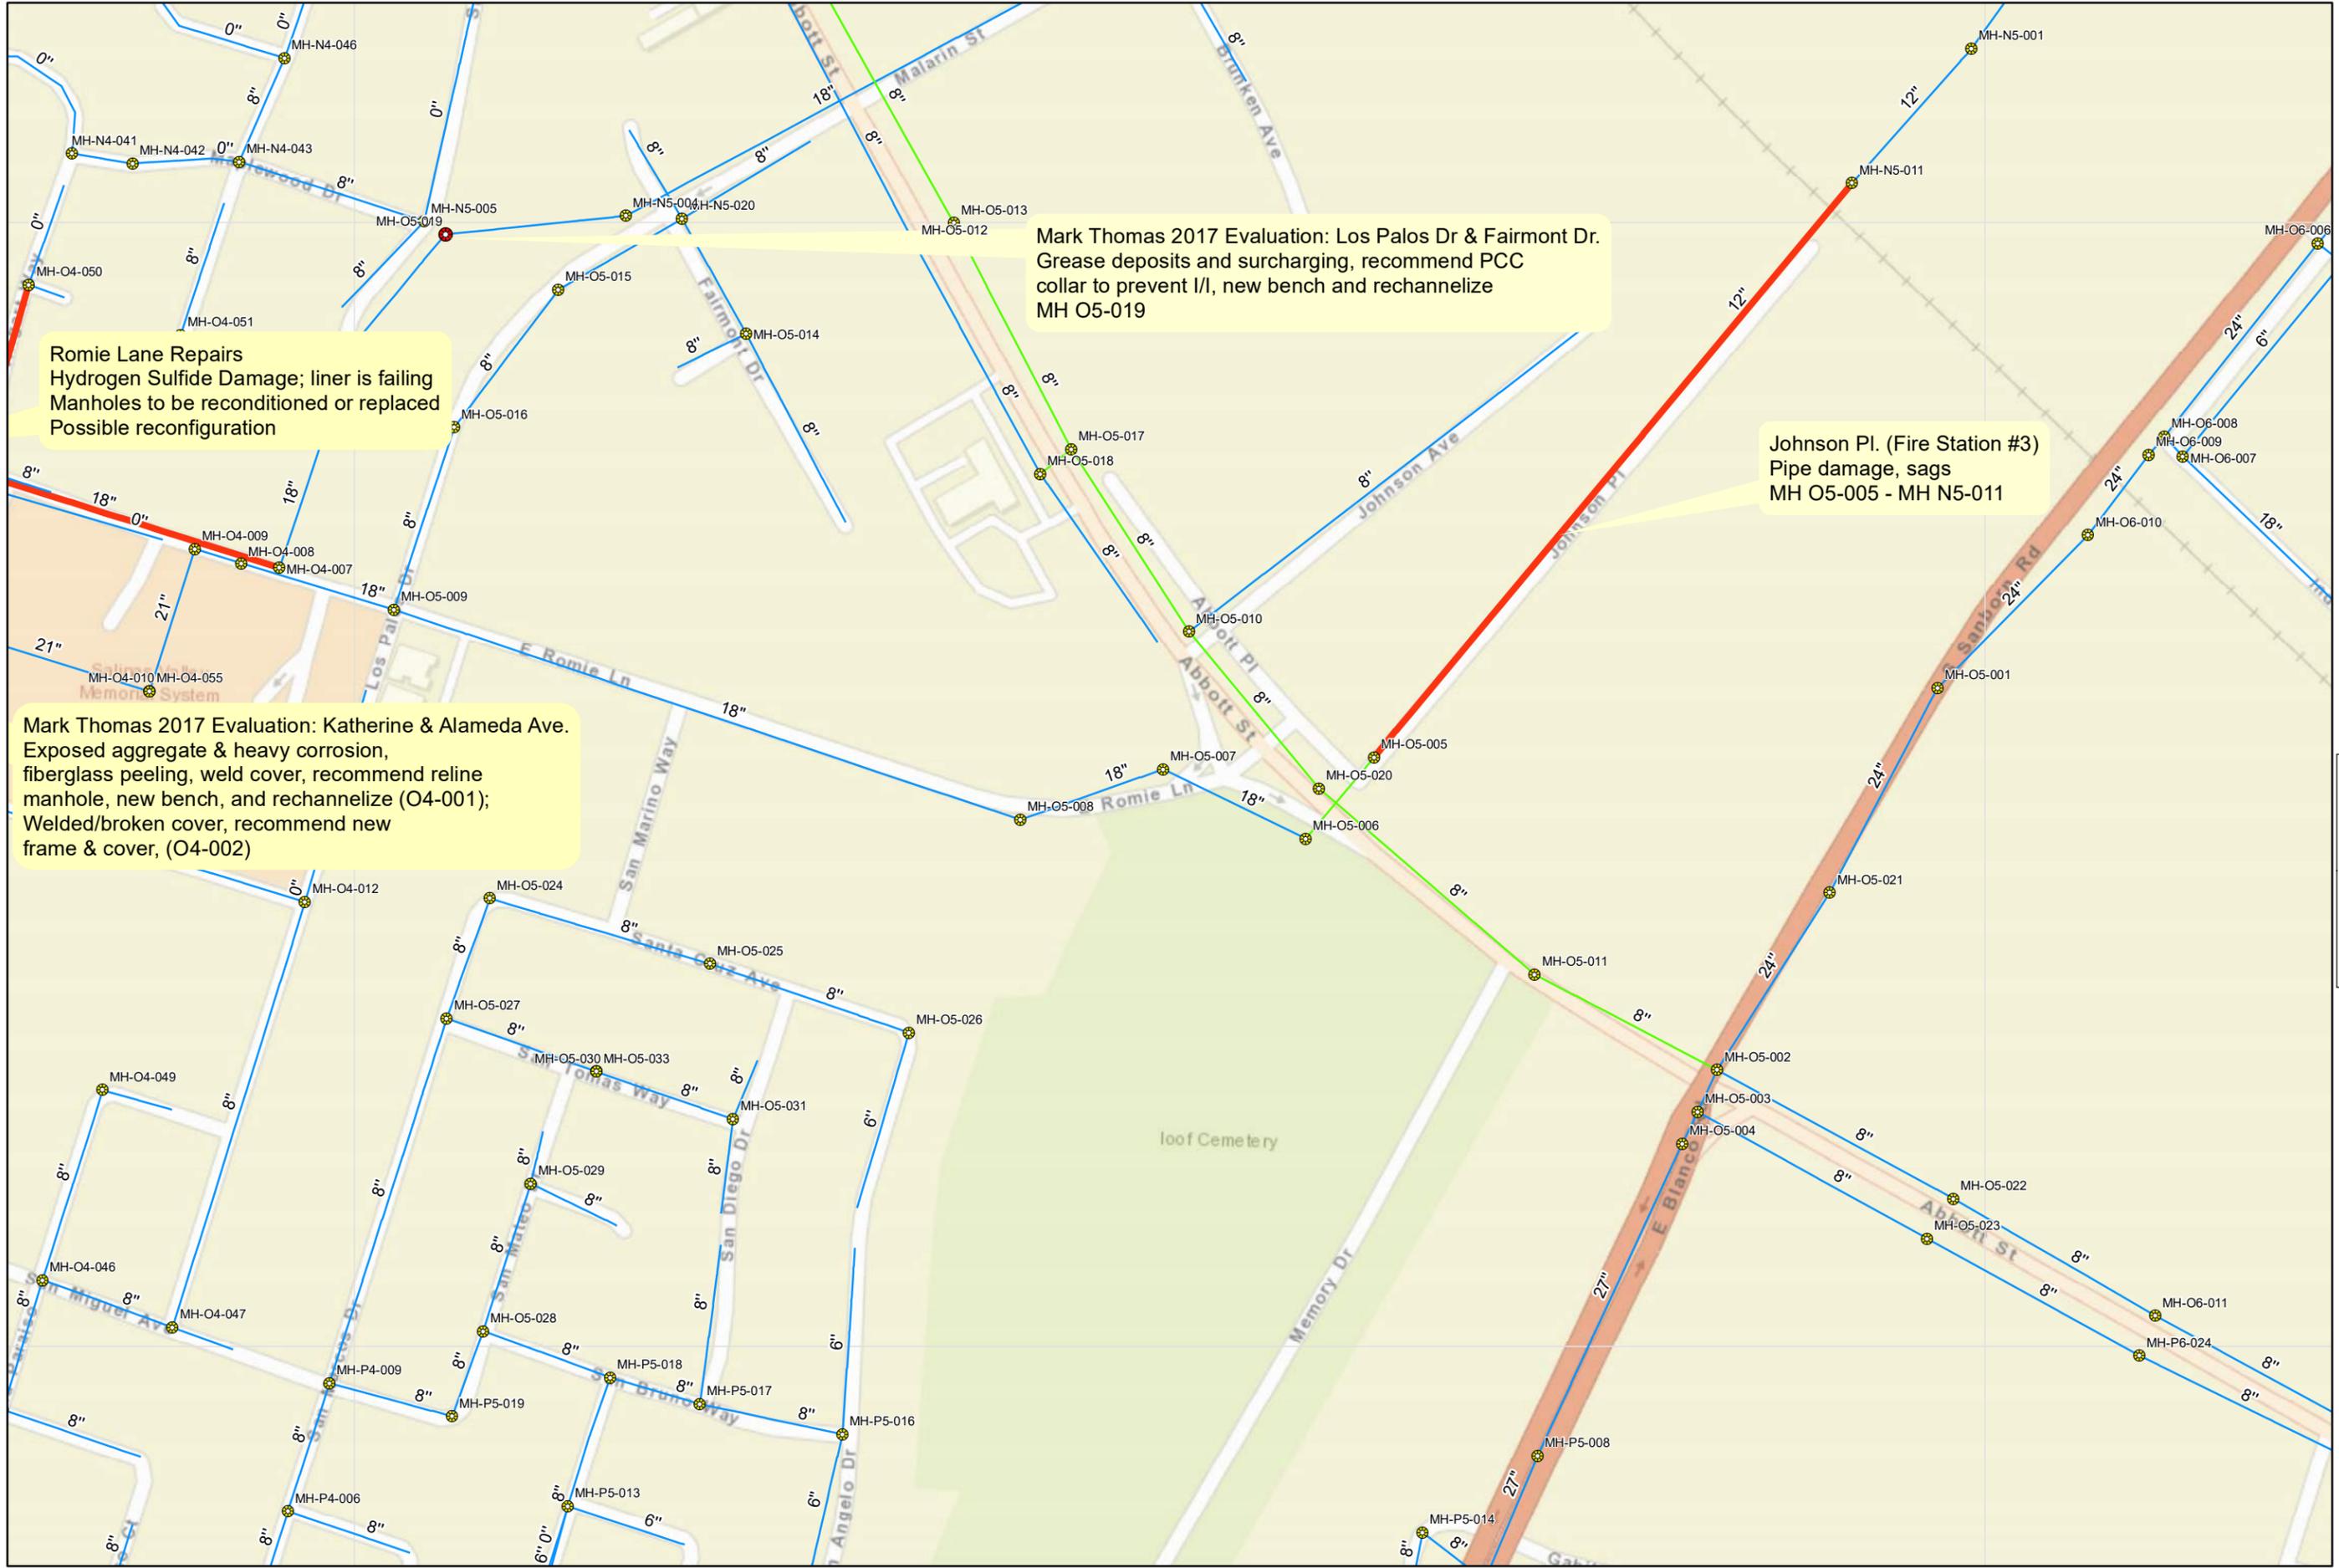
Romie Lane Repairs
 Hydrogen Sulfide Damage; liner is failing
 Manholes to be reconditioned or replaced
 Possible reconfiguration

Mark Thomas 2017 Evaluation: Los Palos Dr & Fairmont Dr.
 Grease deposits and surcharging, recommend PCC collar to prevent I/I, new bench and rechannelize
 MH 05-019

Johnson Pl. (Fire Station #3)
 Pipe damage, sags
 MH 05-005 - MH N5-011

Mark Thomas 2017 Evaluation: Katherine & Alameda Ave.
 Exposed aggregate & heavy corrosion, fiberglass peeling, weld cover, recommend reline manhole, new bench, and rechannelize (O4-001);
 Welded/broken cover, recommend new frame & cover, (O4-002)

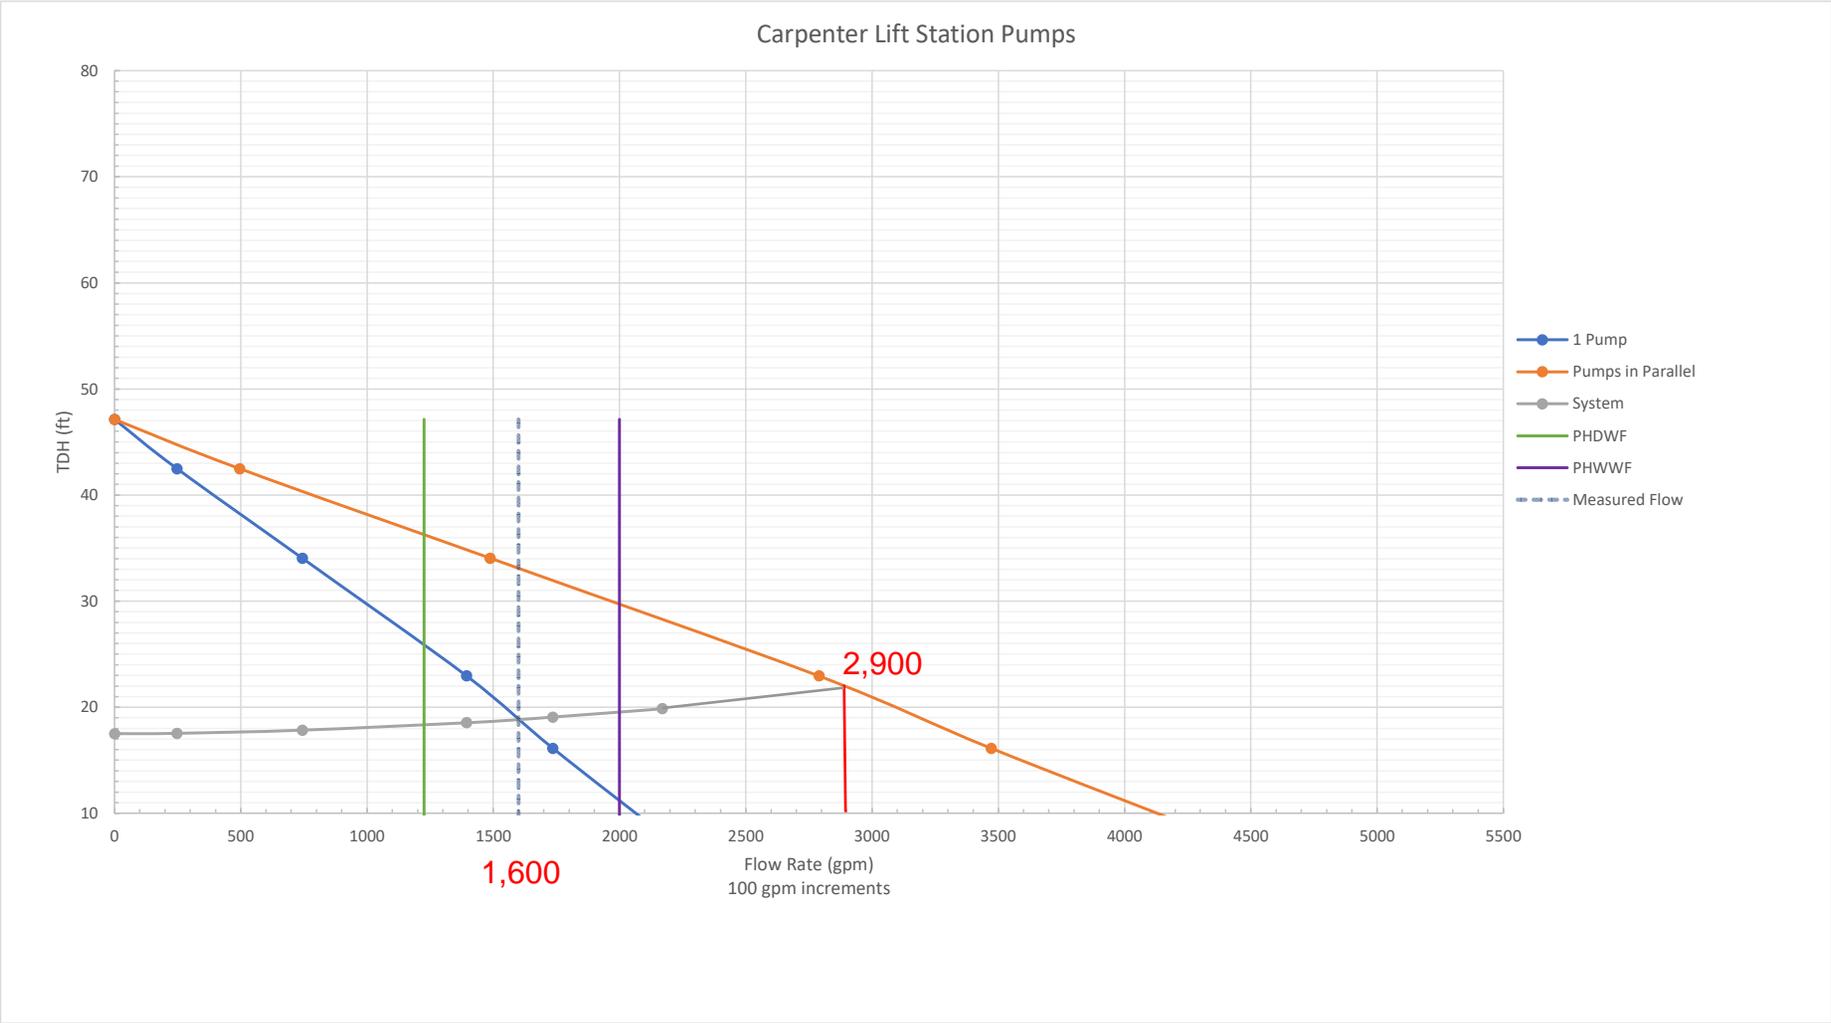
Carpenter Hall LS without VFD
Salinas Sewer Master Plan

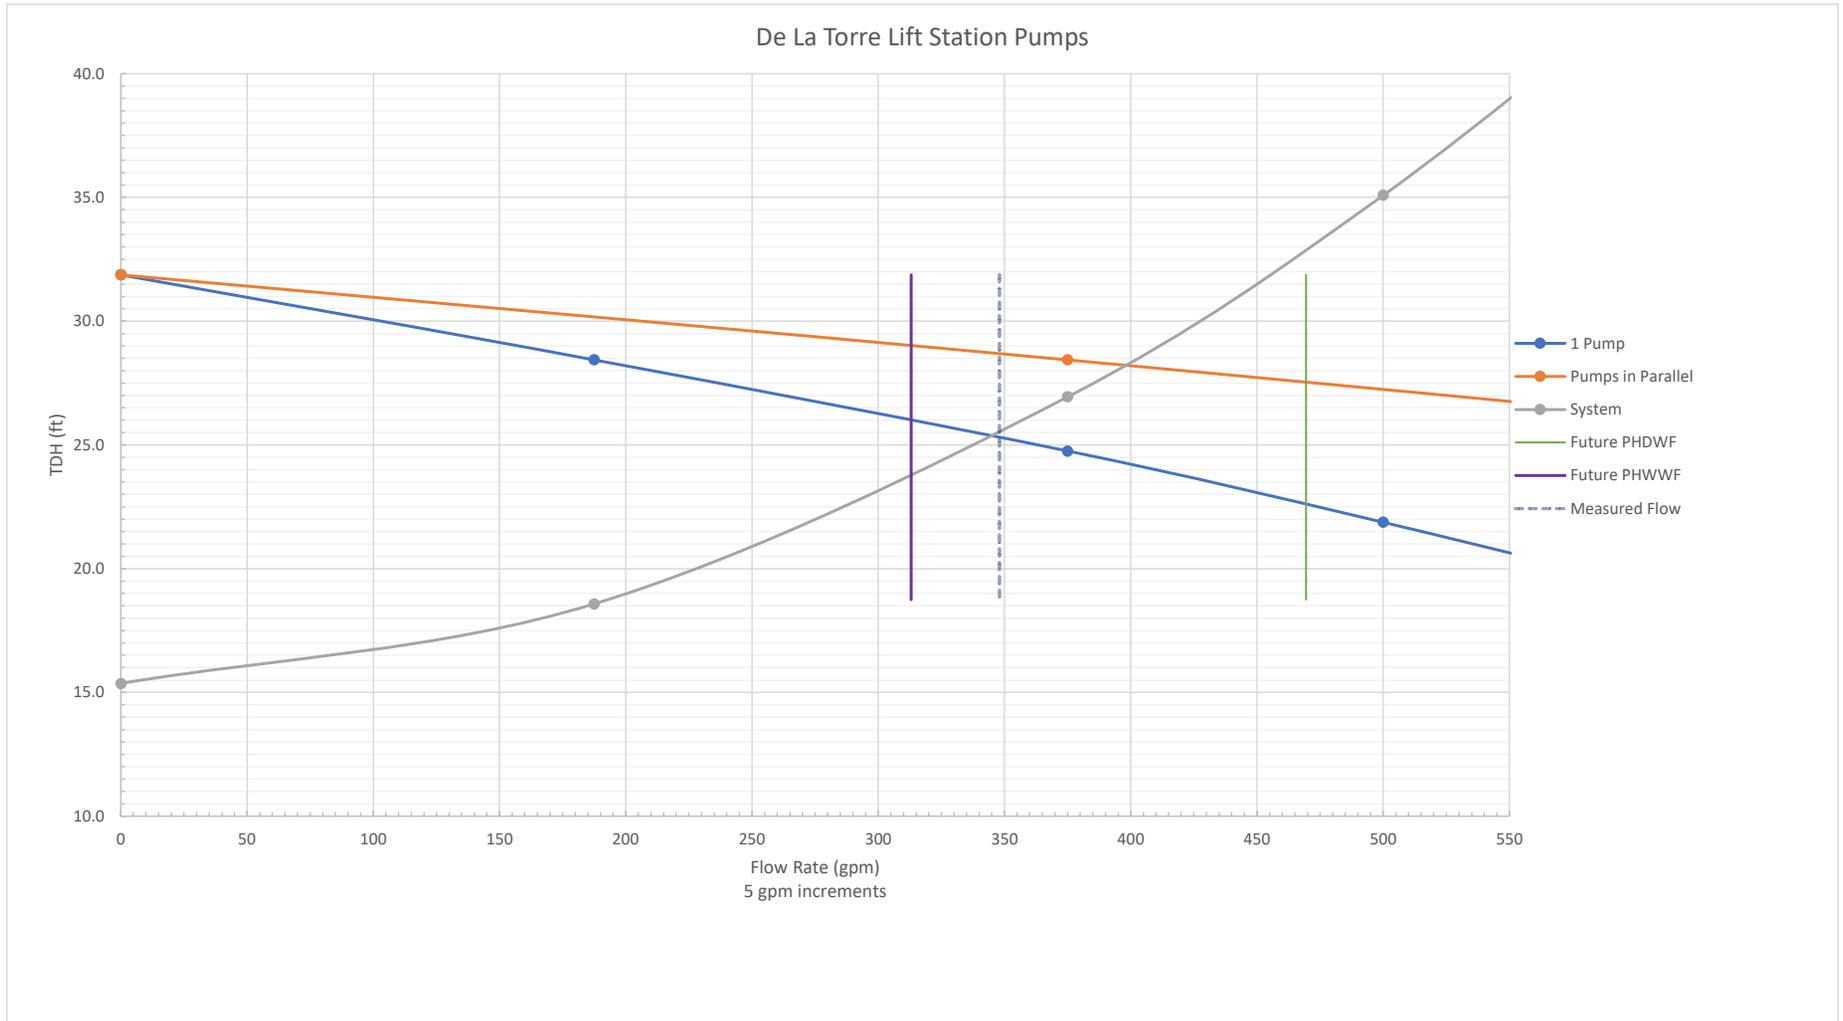
De La Torre LS
Salinas Sewer Master Plan

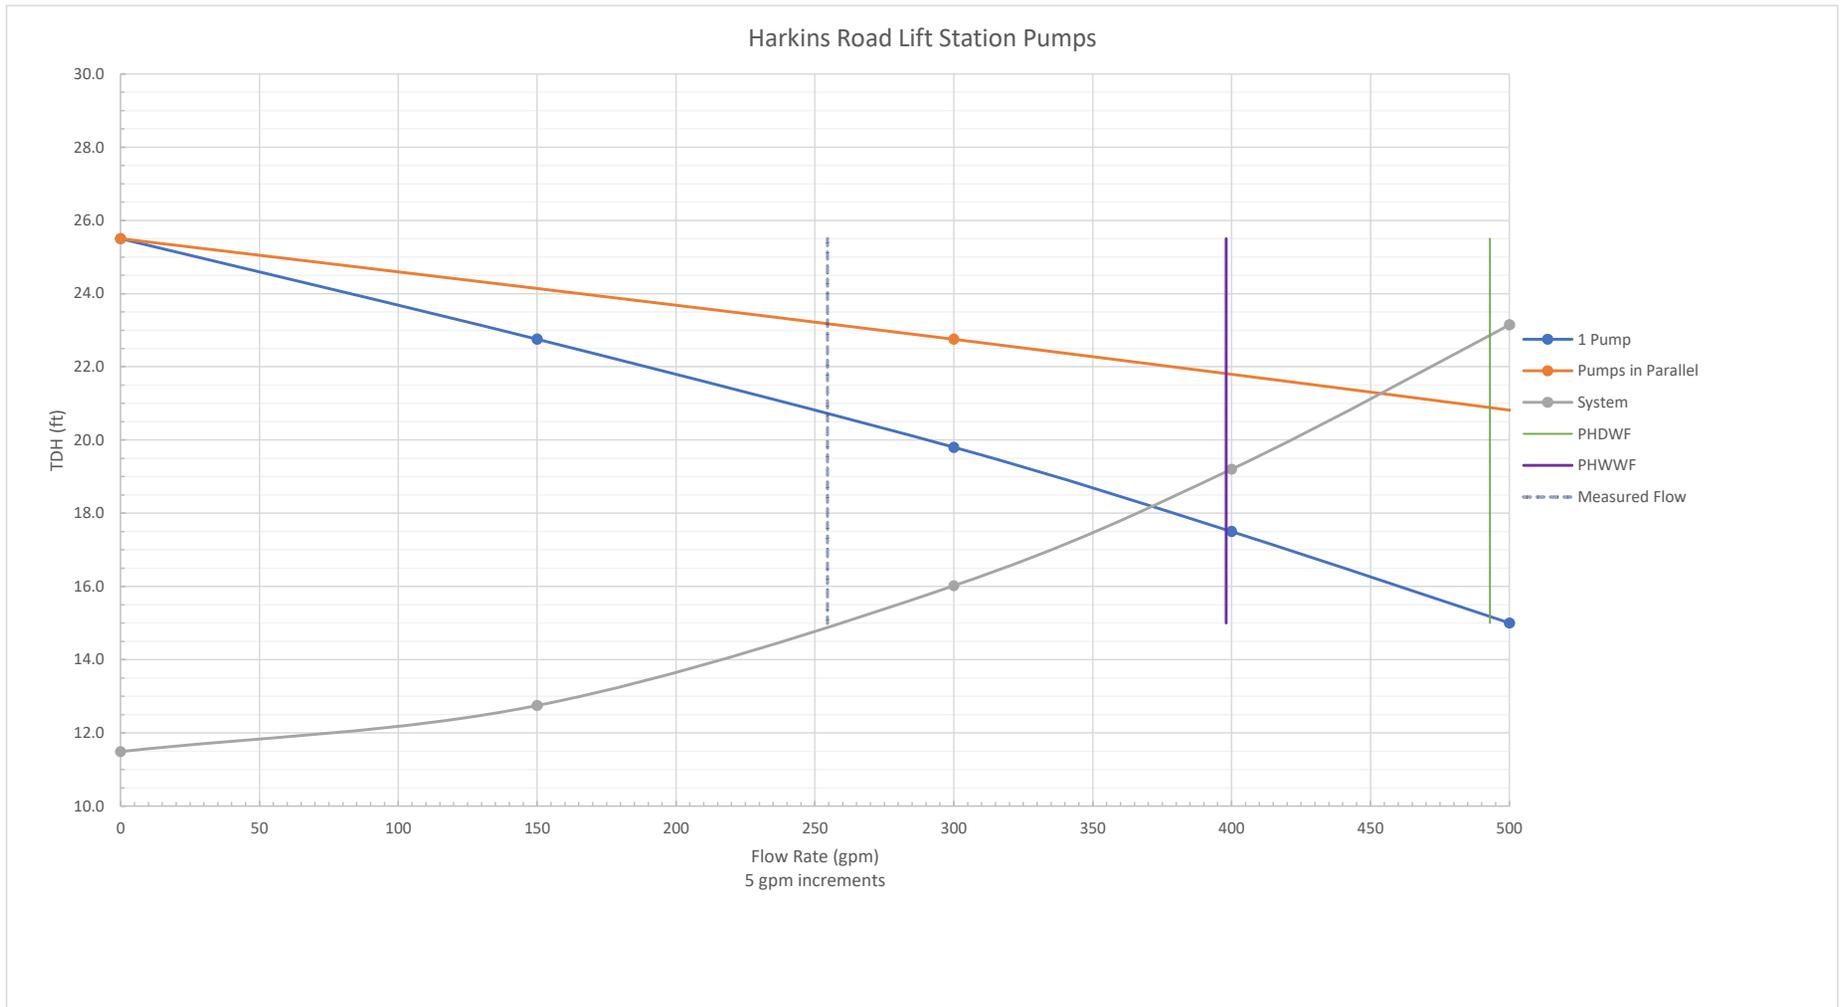
Harkins Road LS
Salinas Sewer Master Plan

Note: the flow was measured when there were potential problems with the check valves
