Final City of Salinas Sanitary Sewer Master Plan Update

City of Salinas
Final Sanitary Sewer Master
Plan Update
May 2023

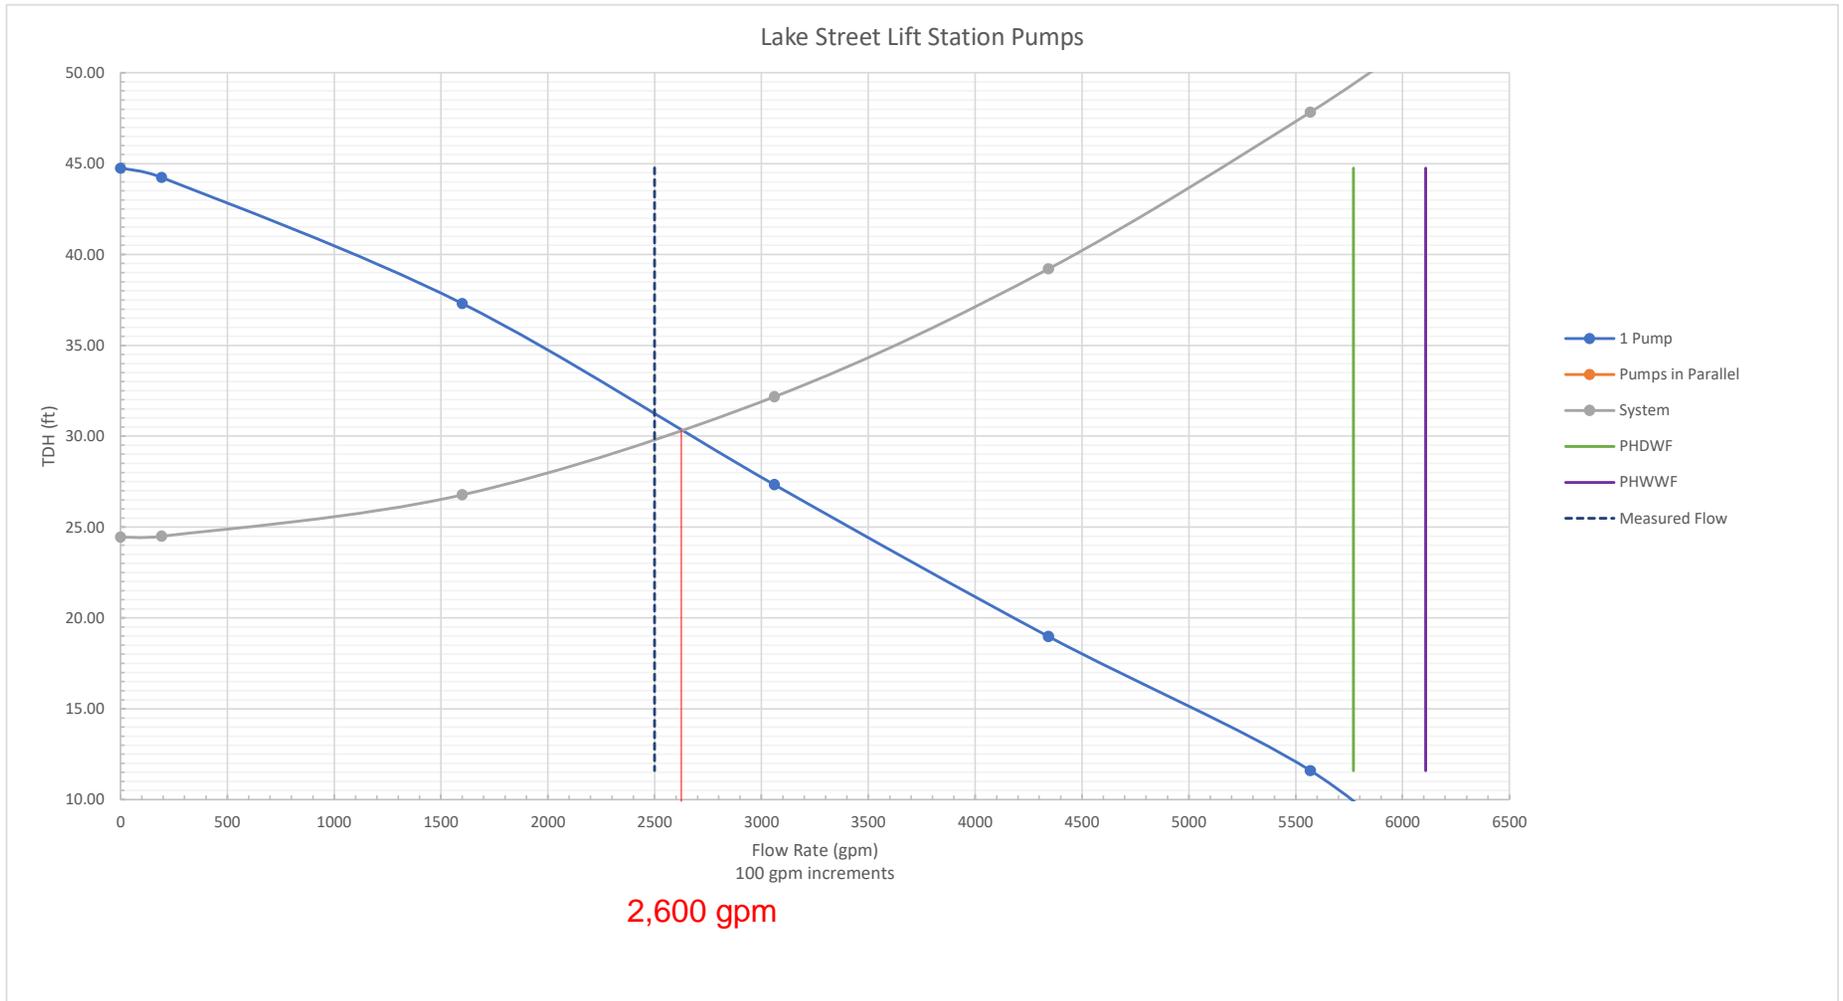
Lake Street Pumps 2 and 3 Existing Conditions Salinas Sewer Master Plan

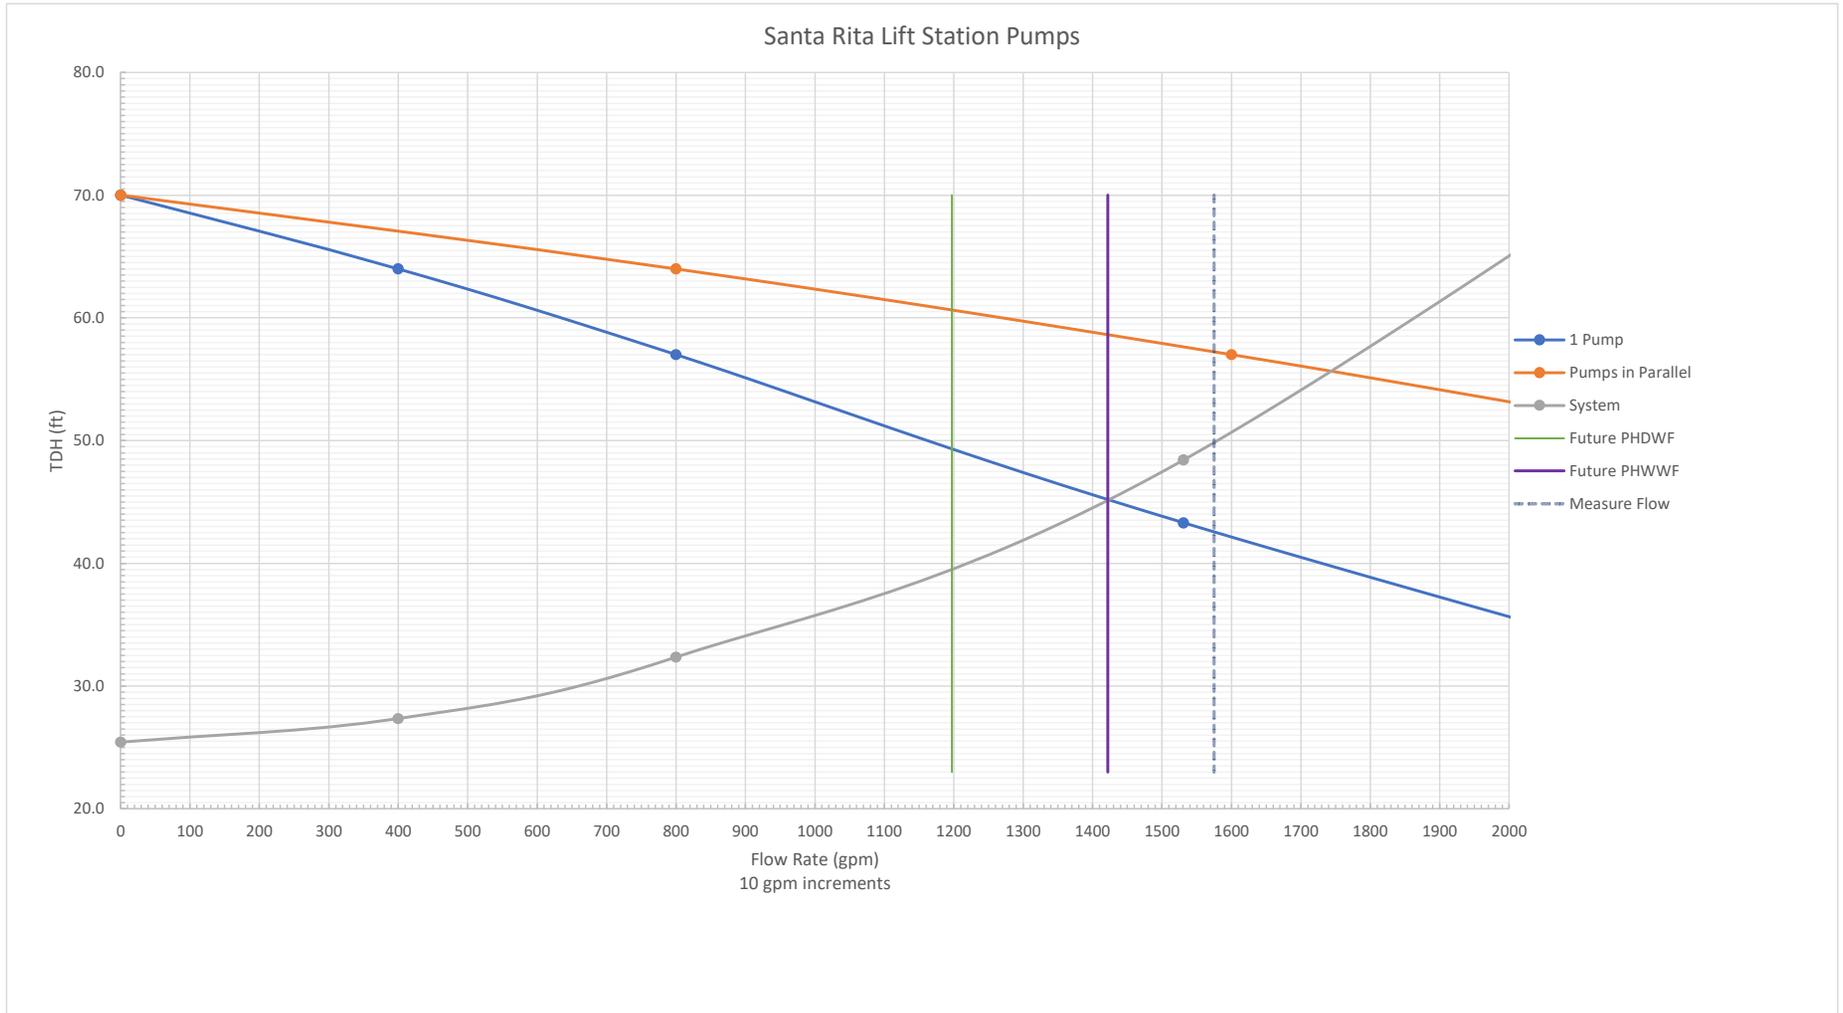
Santa Rita LS
Salinas Sewer Master Plan

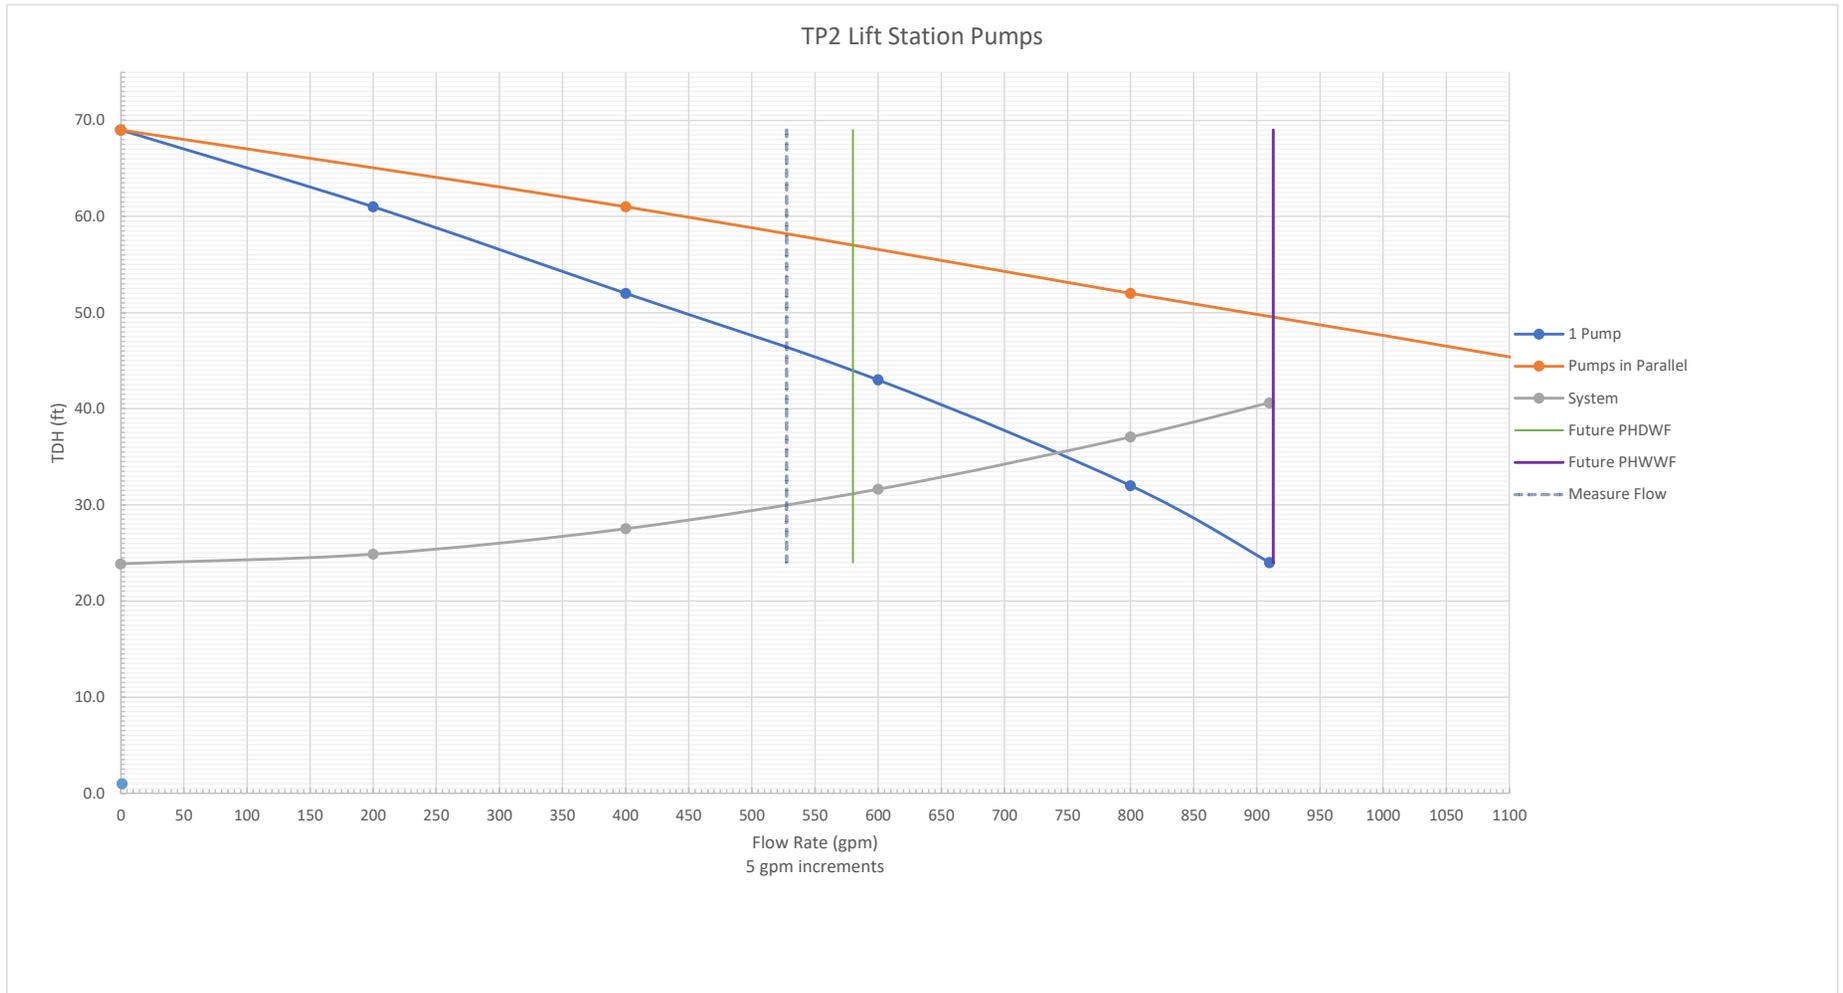
TP2 LS - Existing Conditions (VFD at 60 Hz max)
 Salinas Sewer Master Plan

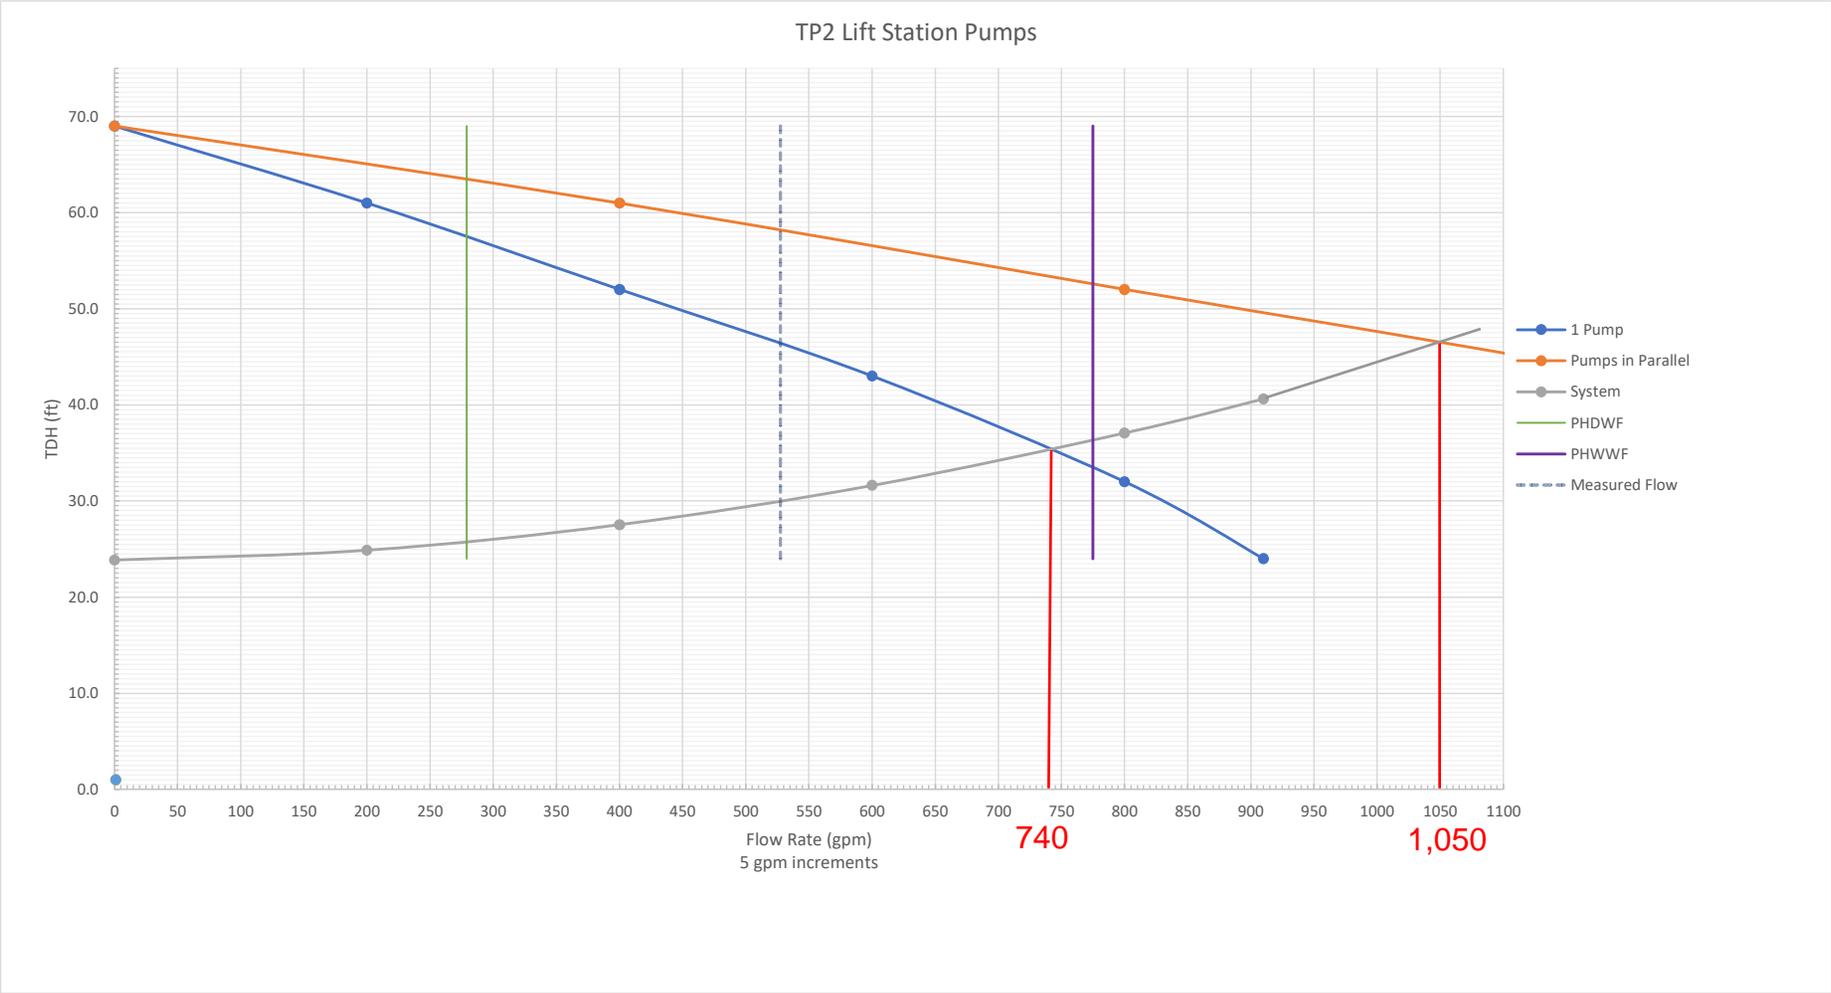
TP2 LS Existing Conditions (VFD at 48 Hz max)
 Salinas Sewer Master Plan

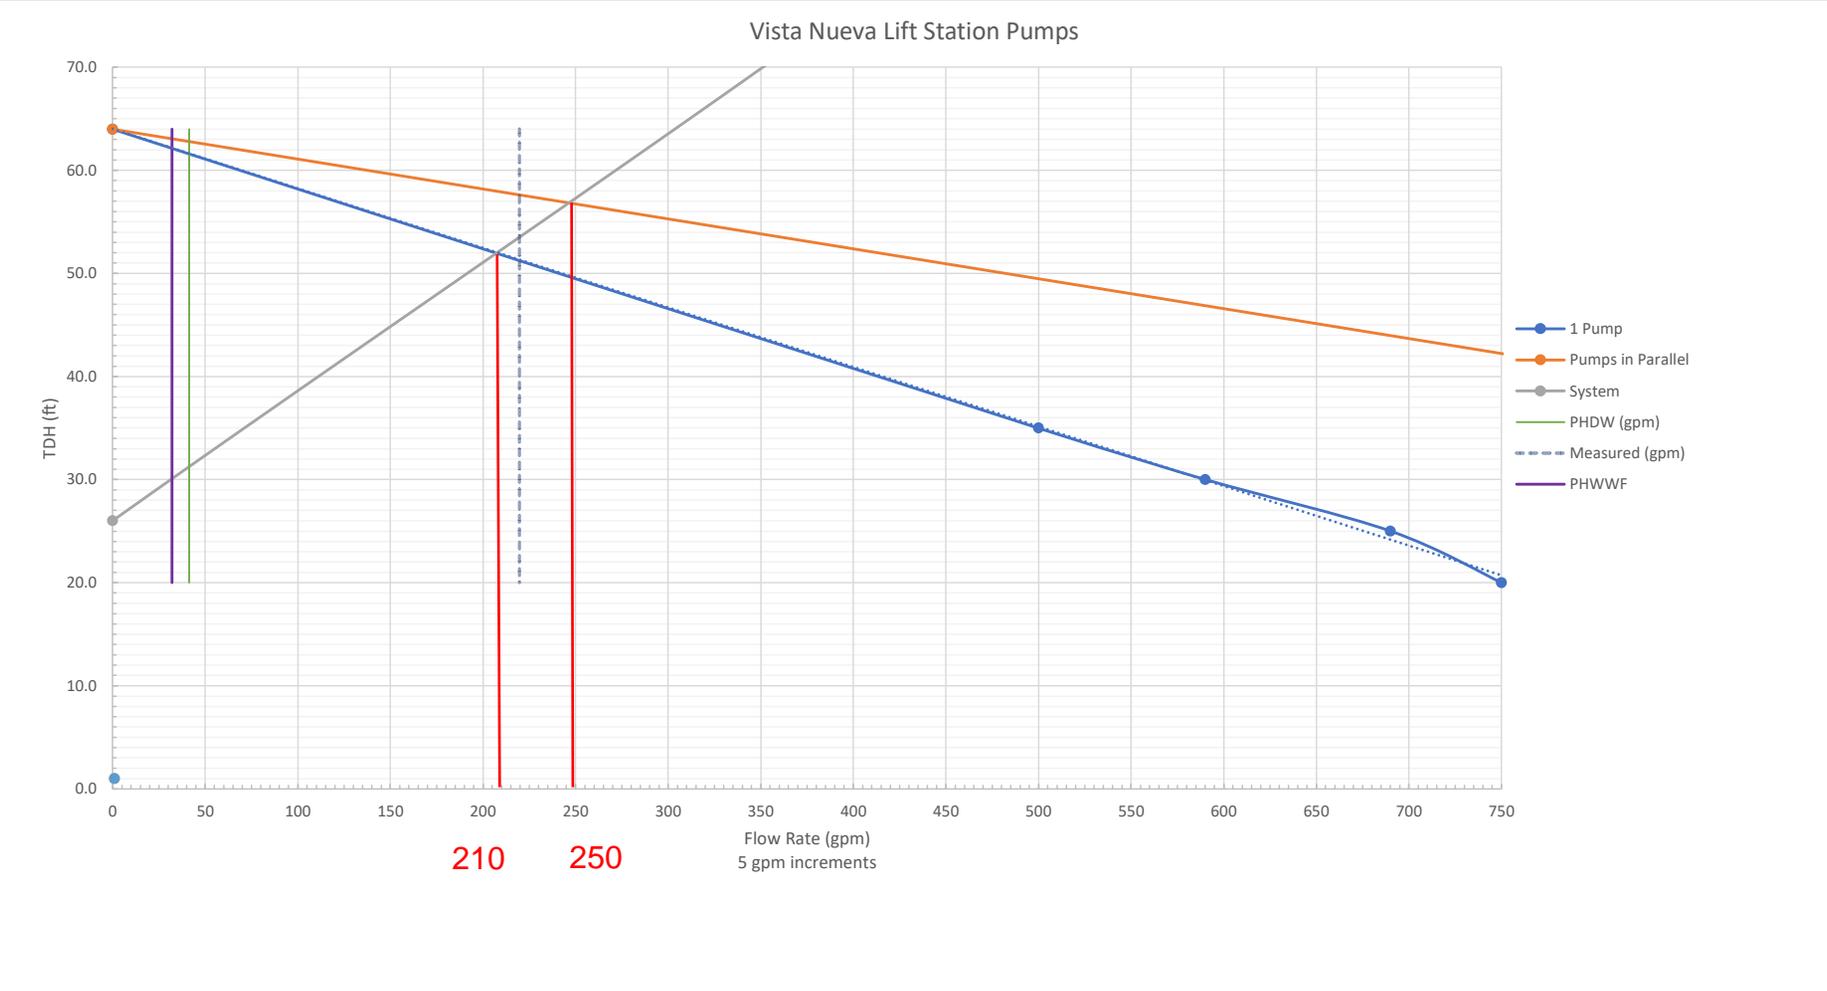
Vista Nueva LS Salinas Sewer Master Plan

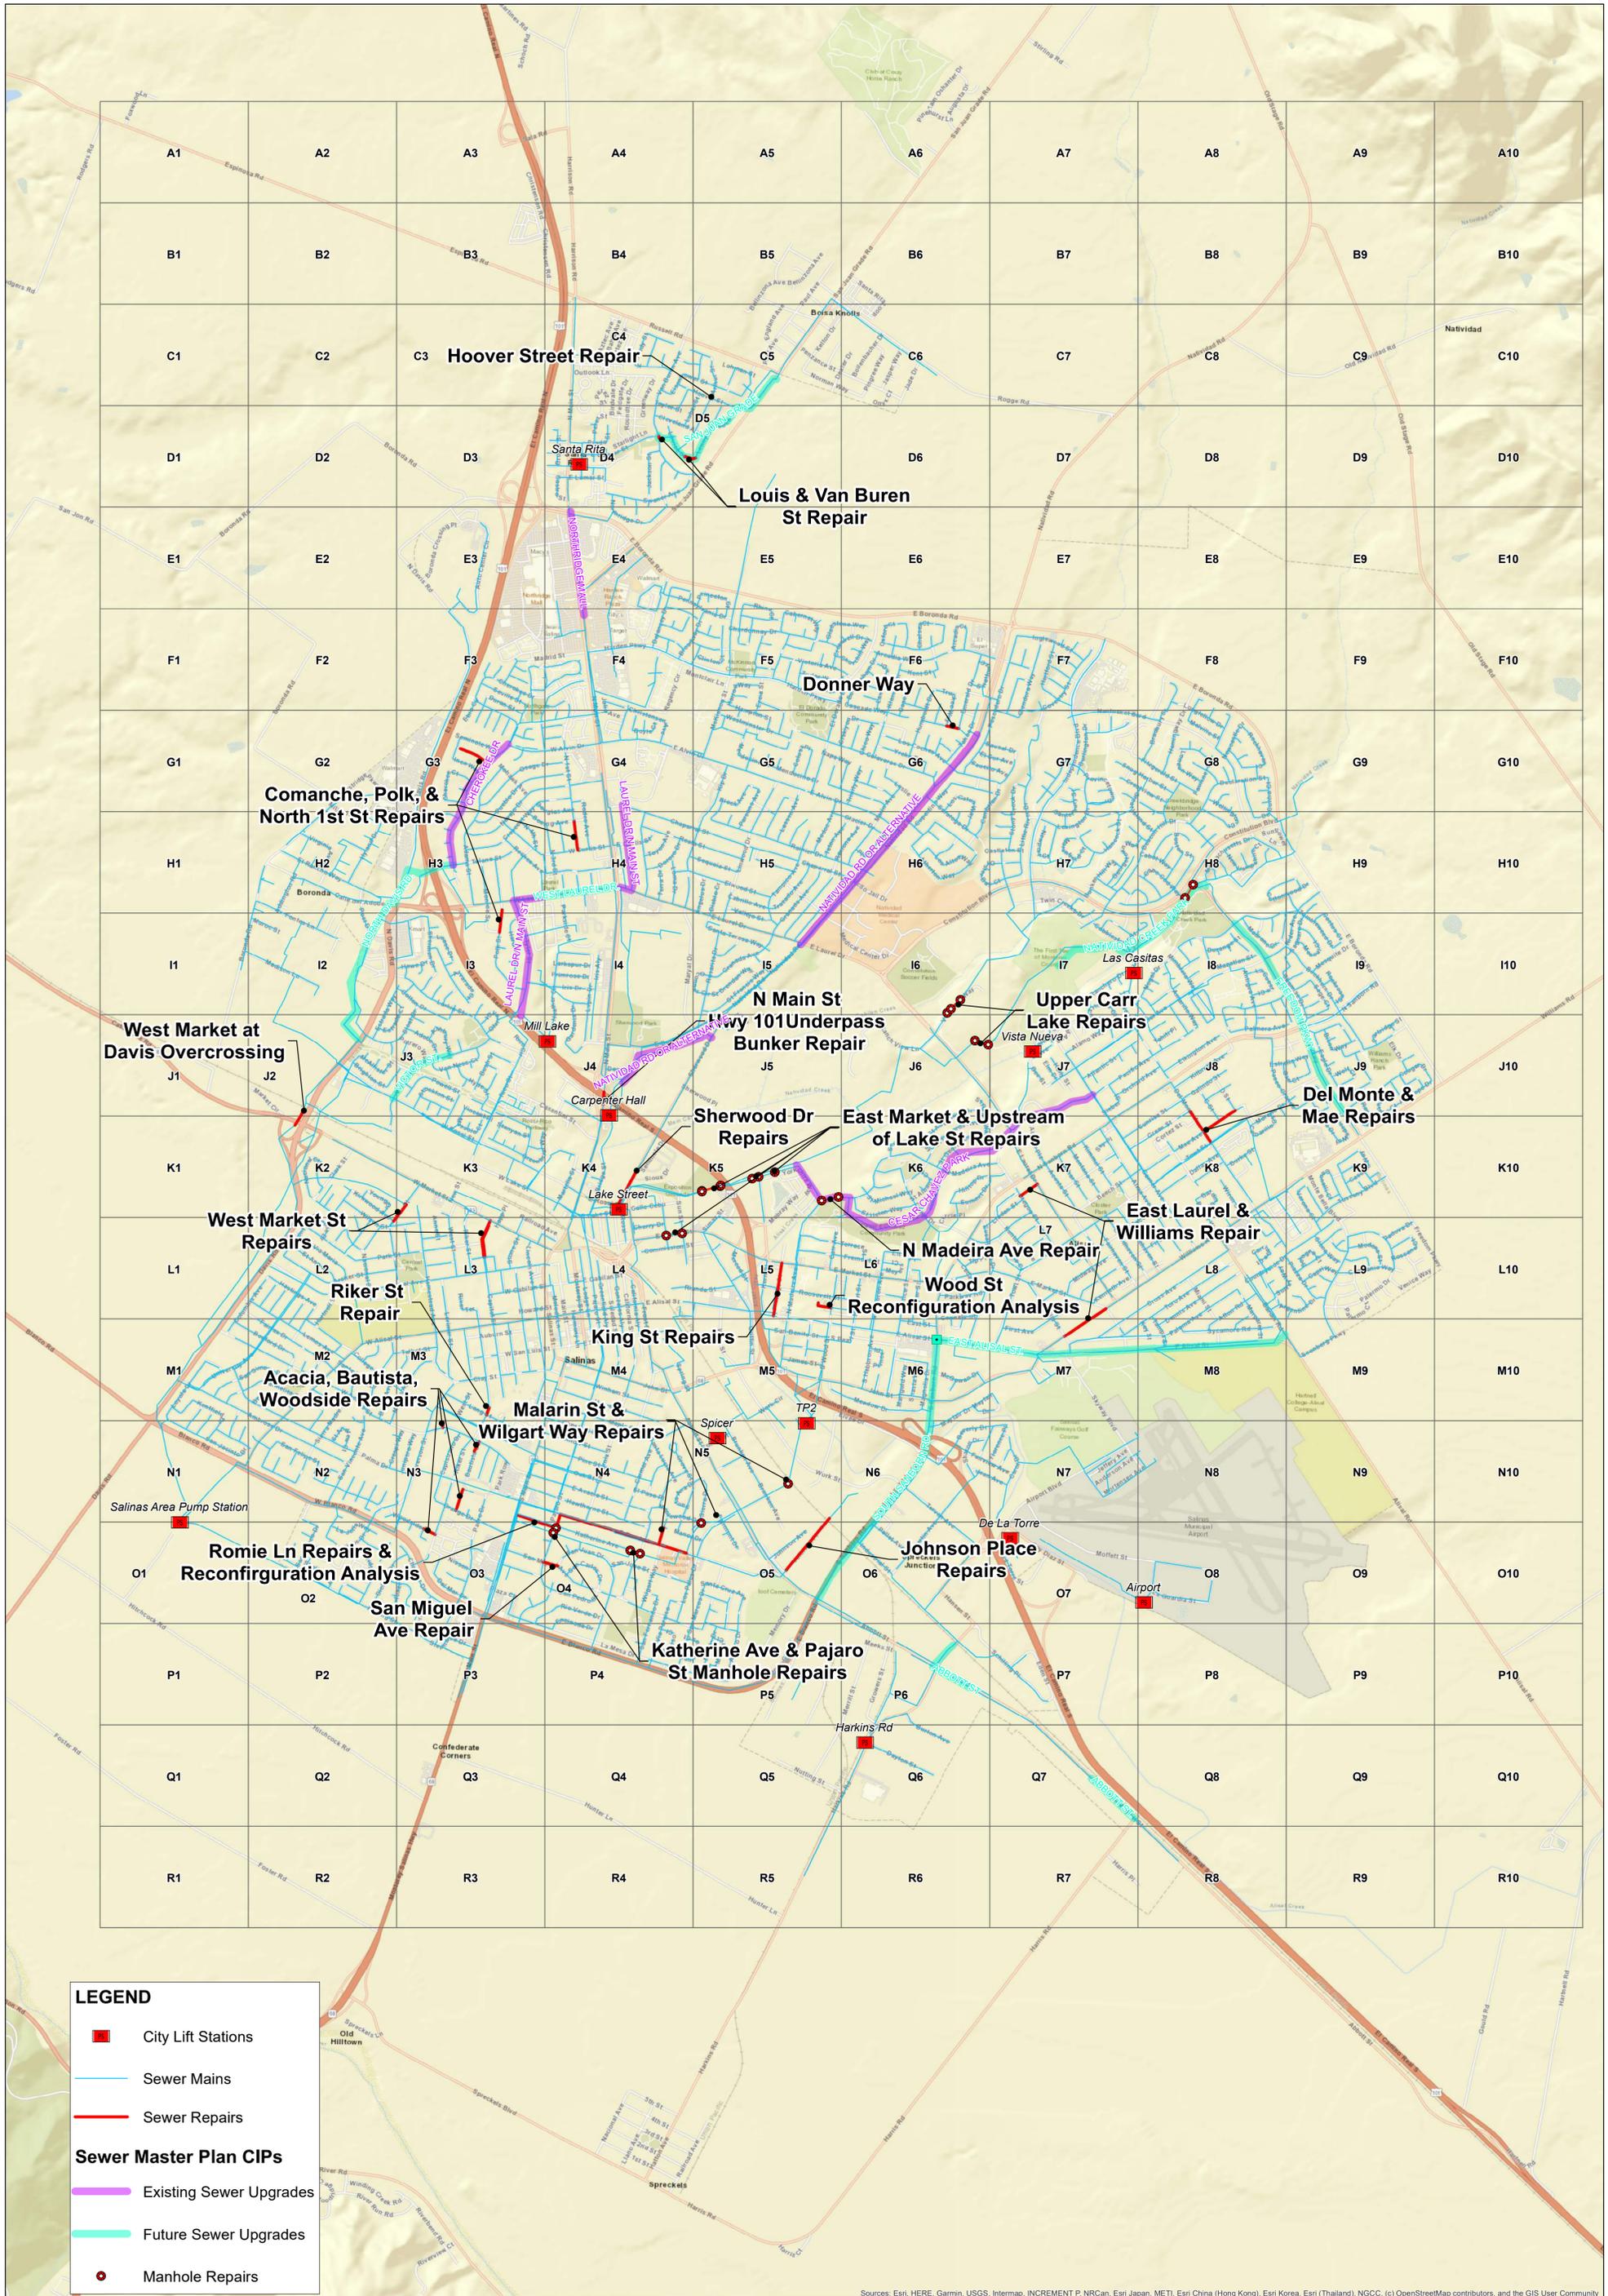
APPENDIX F: EXHIBIT 1 Existing and Future CIPs
